Solar PV Thermographic Inspection Report

HD-[2026021401]

Harrod Diagnostics

IEC TS 62446-3 compliant

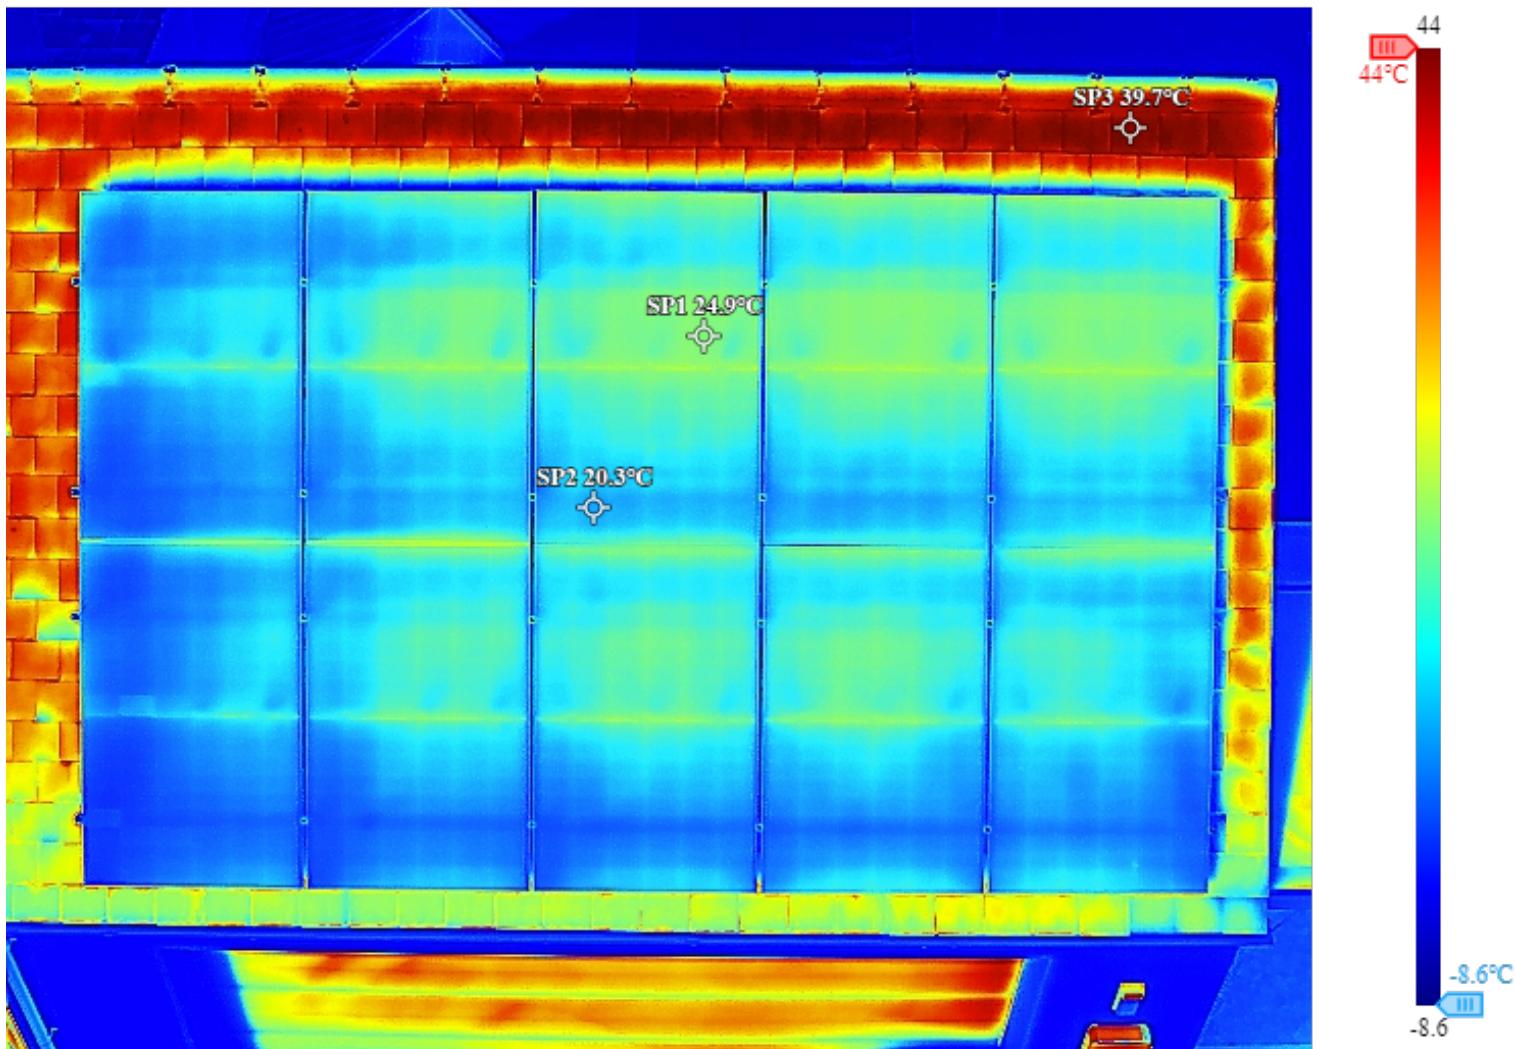
Thermal Array Layout

No thermal, electrical, or safety-related abnormalities were identified during this inspection. All modules exhibited uniform thermal behaviour under the recorded environmental conditions, and no hotspots, diode patterns, or irregular signatures were observed. The system is operating normally at the time of inspection.

SP1	VALUE	24.9°C
SP2	VALUE	20.3°C
SP3	VALUE	39.7°C

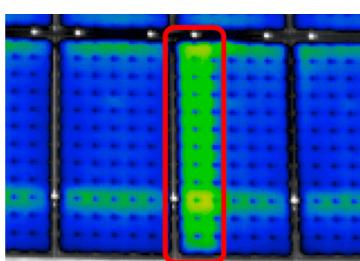
One Substring in Open Circuit

One substring has lost electrical continuity, causing the bypass diode to activate. This results in a uniformly warm area on part of the module, with heat often visible around the junction box. In some cases, arcing may occur at a failed connection.

A connection failure inside the module or junction box is preventing current flow through one substring.

Inspect the junction box, cell connectors, and bypass diode for disconnection or failure.

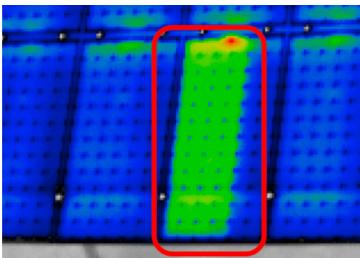
Two Substrings in Open Circuit

Two substrings are disconnected, activating multiple bypass diodes. This produces a larger uniformly warm region and increases the likelihood of internal arcing or diode failure.

There are multiple internal connection failures, or one or more bypass diodes may not be functioning correctly.

Investigate for multiple connection losses or bypass diode malfunction within the module or junction box.

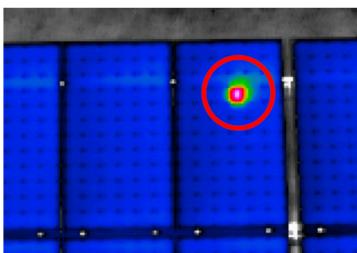
Single Cell With Elevated Temperature

One cell runs significantly hotter than the others. Mild cases show a moderate temperature rise, while severe cases show very high temperatures. The hotspot becomes more pronounced under higher load.

This is usually caused by a broken or damaged cell. If left unchecked, it can lead to permanent damage to the cell, encapsulation, or even the bypass diode.

Ensure the cell isn't being shaded or heavily soiled. If the hotspot persists, further inspection is required.

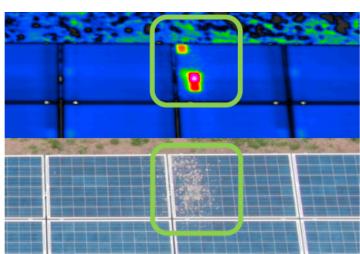
Module With Cells Shaded by Dirt

Dirt, dust, or bird droppings cause localised heating on the module surface. The severity depends on how much rain the site receives and how long the dirt remains.

Light, naturally washed dirt is usually harmless. Heavy or persistent soiling in dry climates can cause significant hotspots and long-term damage.

- Light soiling: No immediate action — rain will typically clean the module.
- Heavy or persistent soiling: Cleaning is recommended soon to prevent damage.

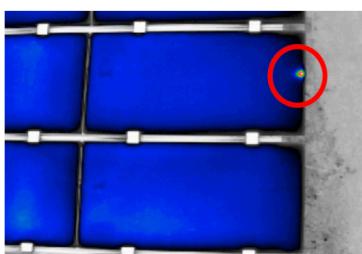
High Transfer Resistance at Cross-Connections (Thin Film)

A small, intense hotspot appears at a cross-connection point due to increased contact resistance. The hotspot becomes more pronounced under electrical load.

Poor soldering or degraded contacts are causing resistance heating at a specific point.

Have the module reviewed by a PV expert to confirm the cause and assess risk.

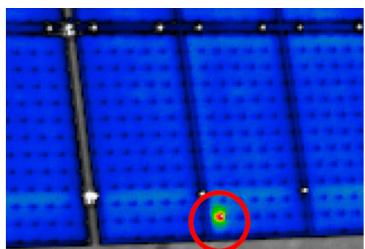
High Transfer Resistance at Cell Connections (Crystalline Si)

A point hotspot forms at a cell connection due to poor or missing soldering, a broken ribbon, or a failed joint. The hotspot intensifies with load.

A connection fault is creating resistance heating at a specific cell-to-ribbon junction.

A PV expert should inspect the module to confirm the defect and determine whether repair or replacement is needed.

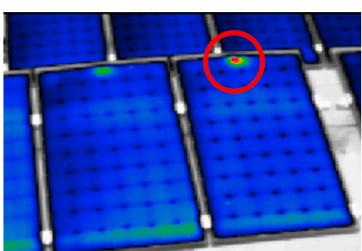
Heated Module Junction Box

The junction box is noticeably hotter than nearby junction boxes. The hotspot increases with electrical load.

There may be increased contact resistance inside the junction box, or a bypass diode may be conducting when it shouldn't.

Have the junction box inspected by a PV expert. Use caution — high voltages may be present.
