## Fire Performance Test Report

Test standard: BS 8414-2:2020

Products: Alubond (FR-A2 ACP) Rain Screen Facade System

Report number: DLR2139

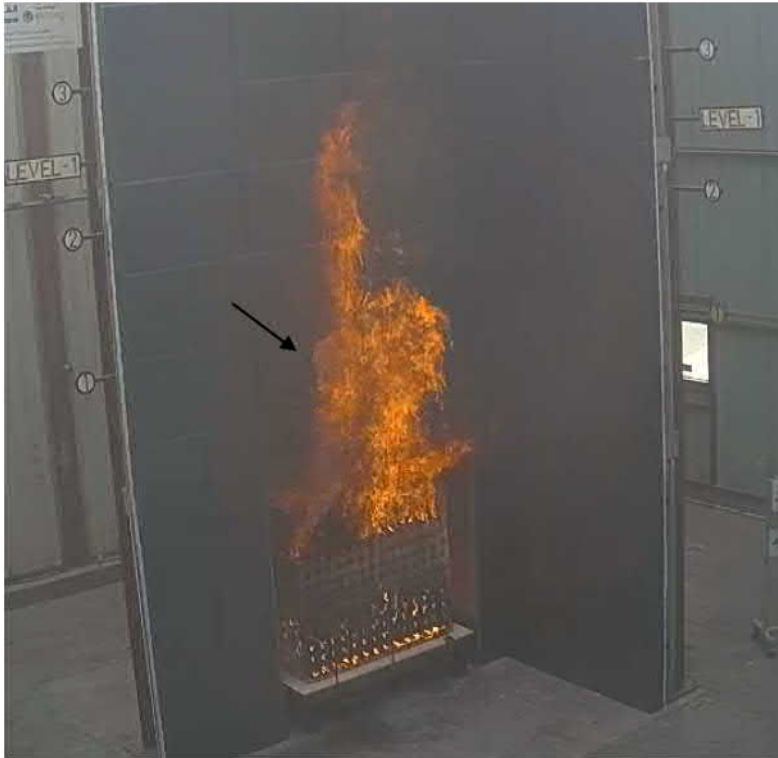
| Time from ignition | | Observation |
|---|---|---|
| 03 | 51 | Coating of mid-panels up to 1 m above the combustion chamber was observed to be peeling off. Refer to photo 18 in Appendix C. |

Photo 18 Coating of mid-panels up to 1 m above the combustion chamber started to peel off

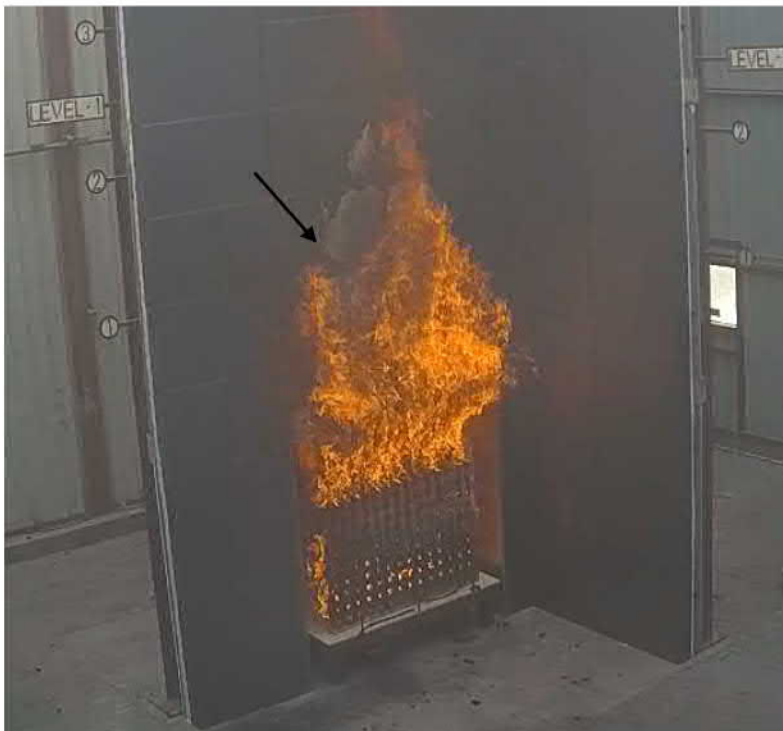
| Time from ignition | | Observation |
|---|---|---|
| 04 | 16 | Coating of panels up to 2 m above the combustion chamber was observed to be peeling off. Refer to photo 19 in Appendix C. |

Photo 19 Coating of panels up to 2 m above the combustion chamber started to peel off

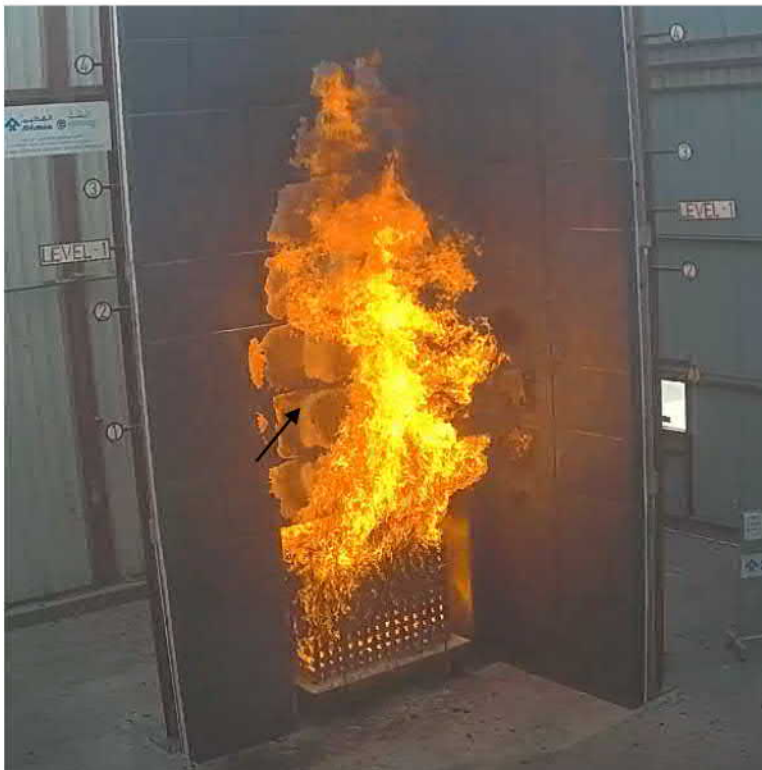
**Photo 21** Mid-panels at 1 m above the combustion chamber were partially consumed and insulation was exposed

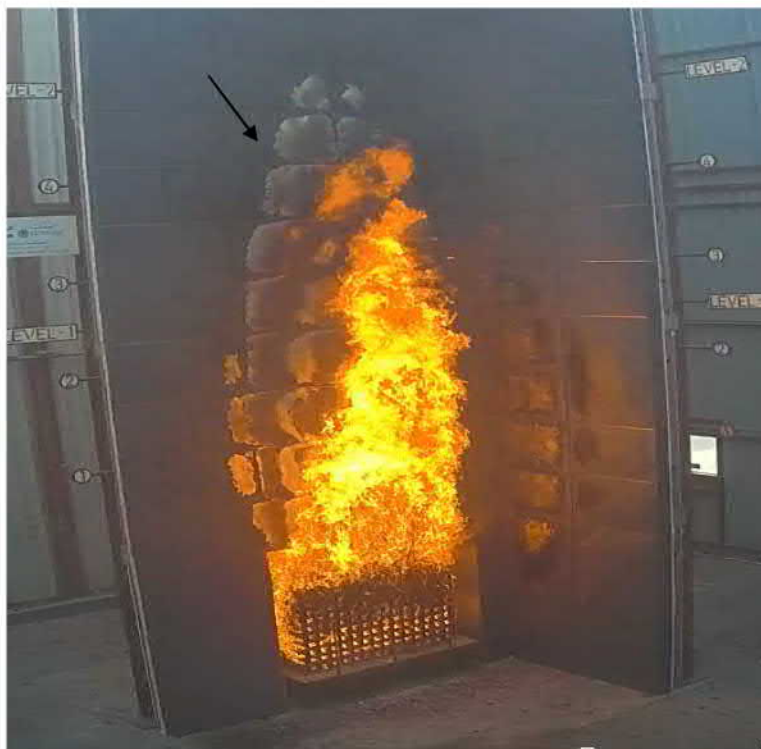
| Time from ignition | | Observation |
|---|---|---|
| 14 | 41 | Coating of mid-panels at 5 m above the combustion chamber was observed to be peeling off. Refer to photo 23 in Appendix C. |

**Photo 23** Coating of mid-panels at 5 m above the combustion chamber started to peel off

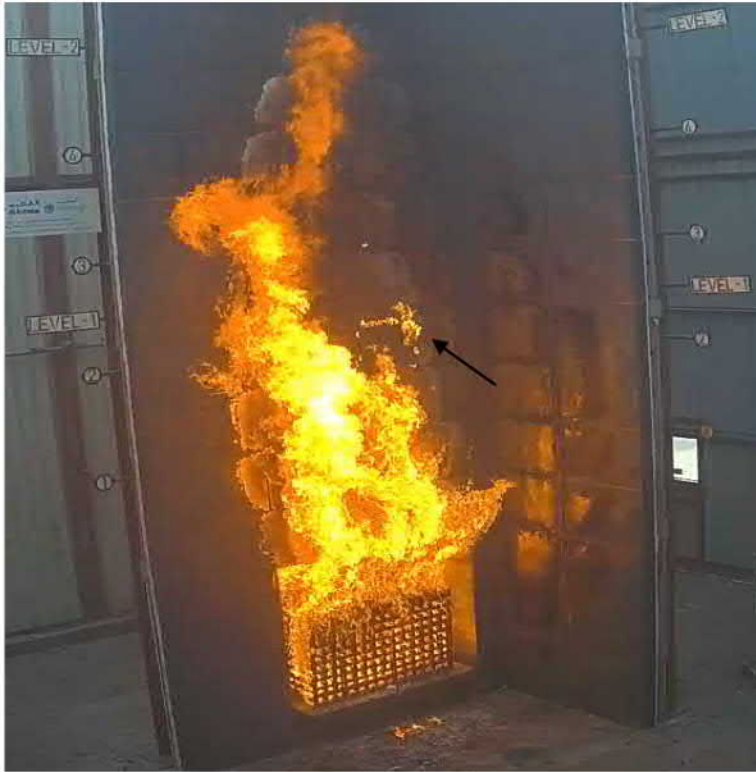
Photo 26 Self-sustained flames on mid-panel at level 1

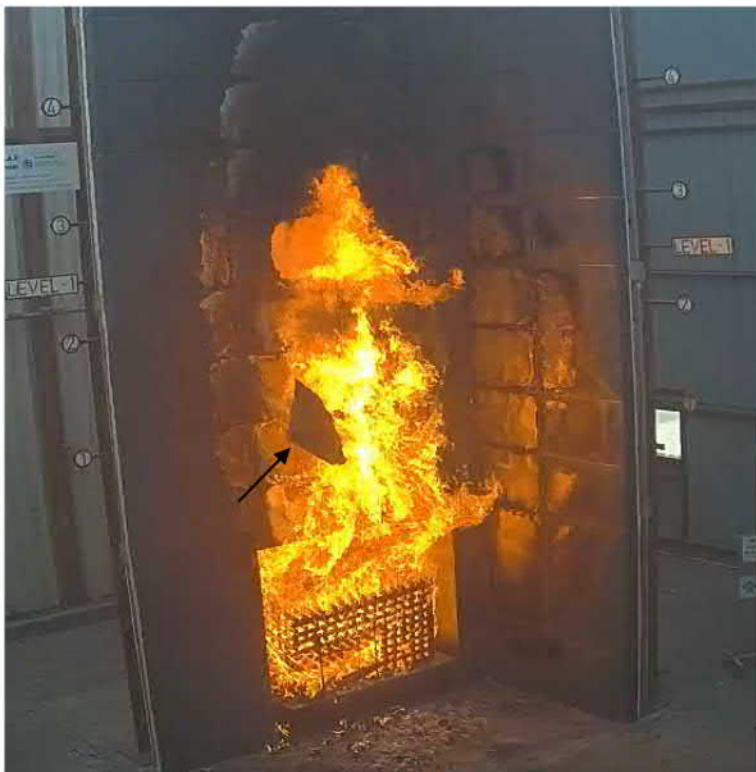
Photo 27 Debris of mid-panel at 3 m above the combustion chamber fell off

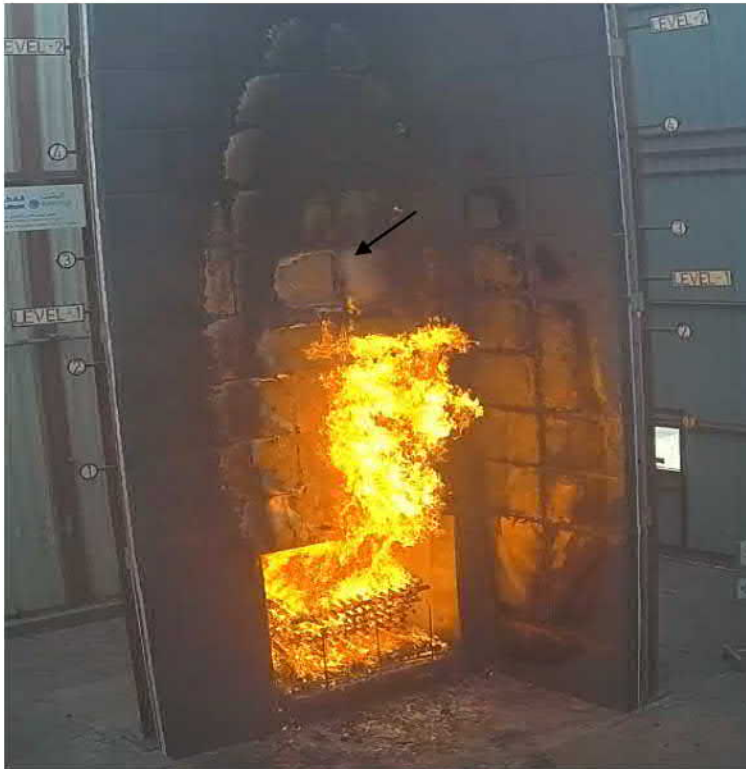
**Photo 28** Mid-panels at 3 m above the combustion chamber were partially consumed and insulation exposed

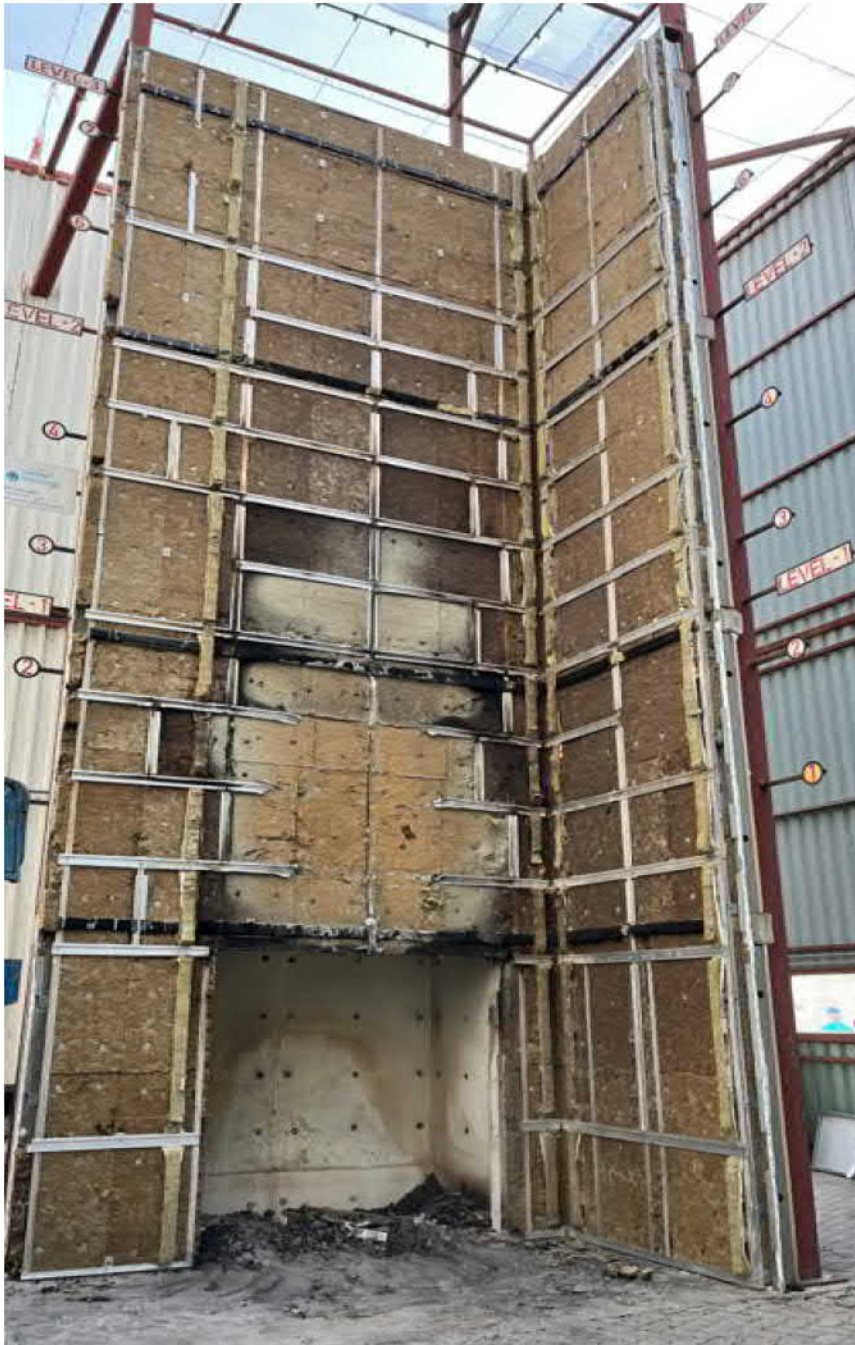
Photo 30    Siderise cavity barrier, Knauf Rocksilk insulation, Alubond RFS panel  
 attachment clip and runners

| Component | Observations |
|---|---|
| Siderise cavity barriers | <p><b>Horizontal intumescent cavity barrier:</b></p> <p>Main wall:</p> <p>The 1<sup>st</sup> horizontal cavity barrier at 140 mm above the combustion chamber was activated. Intumescent layer was partially present on the activated section of the cavity barrier. Minor material loss observed.</p> <p>The 2<sup>nd</sup> horizontal cavity barrier at 2,240 mm above the combustion chamber was activated. Intumescent layer was partially present on the activated sections of the cavity barrier. Material loss of mineral wool insulation of the cavity barrier was observed.</p> <p>The 3<sup>rd</sup> horizontal cavity barrier at 4,805 mm above the combustion chamber was activated. Expanded intumescent layer was present on the activated sections of the cavity barrier. Cavity barrier was intact, and no material loss of mineral wool insulation of the cavity barrier was observed.</p> <p>The 4<sup>th</sup> horizontal cavity barrier at 7,300 mm above the combustion chamber was not activated. Cavity barrier was intact, and no material loss of mineral wool insulation of the cavity barrier was observed.</p> <p>Wing wall:</p> <p>The 1<sup>st</sup> horizontal cavity barrier at 2,140 mm above the ground floor level combustion chamber was activated. Expanded intumescent layer was present on the activated sections of the cavity barrier. Cavity barrier was intact, and no material loss of mineral wool insulation of the cavity barrier was observed.</p> <p>The 2<sup>nd</sup> horizontal cavity barrier at 4,240 mm above the ground level was activated. Expanded intumescent layer was present on the activated section of the cavity barrier. Cavity barrier was intact, and no material loss of mineral wool insulation of the cavity barrier was observed.</p> <p>The 3<sup>rd</sup> horizontal cavity barrier at 6805 mm above the ground level was not activated. Cavity barrier was intact, and no material loss of mineral wool insulation of the cavity barrier was observed.</p> <p>The 4<sup>th</sup> horizontal cavity barrier at 9300 mm above the ground level was not activated. Cavity barrier was intact, and no material loss of mineral wool insulation of the cavity barrier was observed.</p> <p>Refer to photos 30, 34 to 36 in Appendix C.</p> <p><b>Vertical cavity barrier:</b></p> <p>Discolouration and distortion were observed on the on the vertical cavity barriers provided on the main wall and wing wall.</p> <p>Refer to photos 30, 34 to 36 in Appendix C.</p> |
| Knauf Rocksilk rainscreen slab insulation | <p>Main wall:</p> <p>Knauf rainscreen slab insulation located behind mid-panels up to 4 m above the combustion chamber were discoloured.</p> <p>All other insulation on the main wall was intact and no significant changes were observed.</p> <p>Wing wall:</p> <p>No significant changes were observed.</p> <p>Refer to photos 30, 34 &amp; 35 in Appendix C.</p> |

| Component | Observations |
|---|---|
| Alubond RFS<br>Railings and panel attachment clips | <p>Main wall:</p> <p>Railings and panel attachment clips located behind the mid-panels up to level 1 were melted.</p> <p>Railings and panel attachment clips located behind the mid-panels between level 1 and level 2 were discoloured.</p> <p>All other railings and panel attachment clips on the main wall were intact and no damage was observed.</p> <p>Wing wall:</p> <p>All railings and panel attachment clips on the wing wall were intact and no significant changes were observed.</p> <p>Refer to photos 30, 34 to 36 in Appendix C.</p> |
