## Fire Performance Test Report

Test standard: BS 8414-2:2020

Products: Alubond (FR-A2 ACP) Rain Screen Facade System

Report number: DLR2139

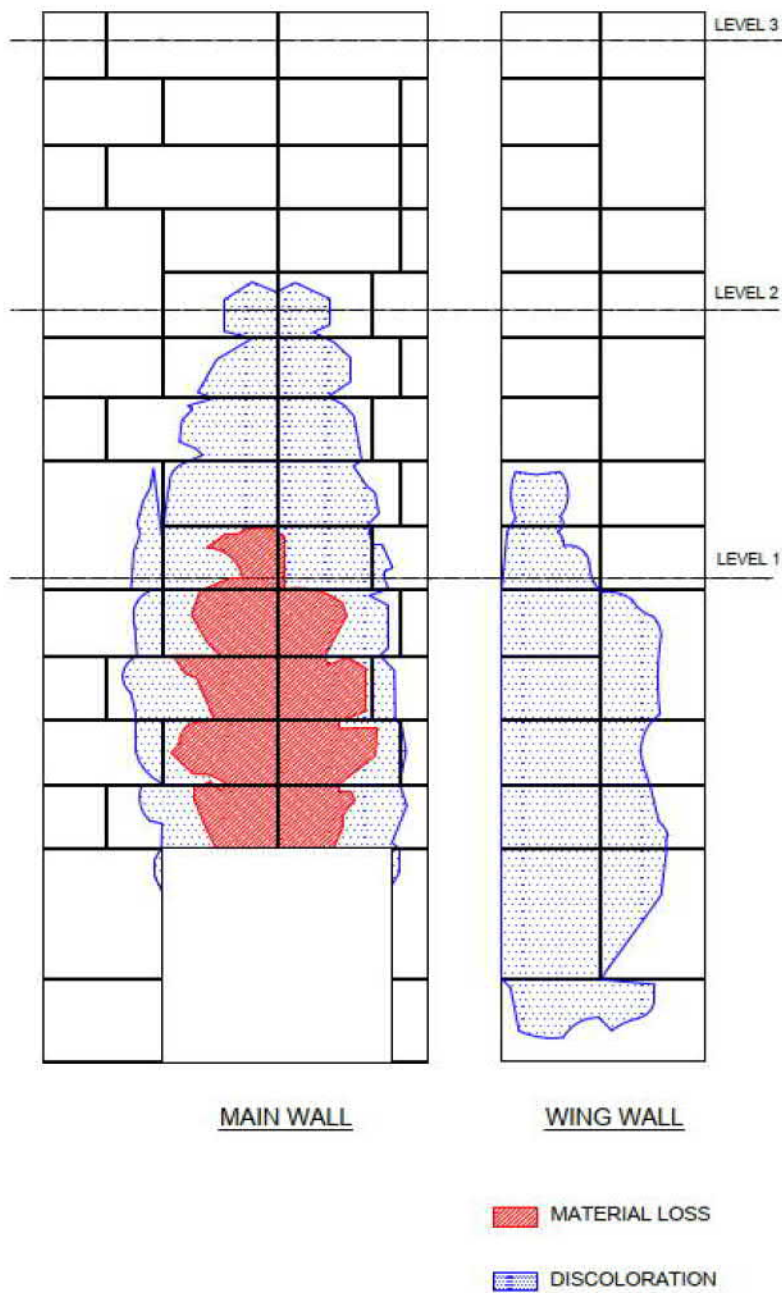
Figure 2 Area map showing the condition of the Alubond FR-A2 ACP cladding panels after the test

Approximately 12 m<sup>2</sup> of the external visible area was discoloured.

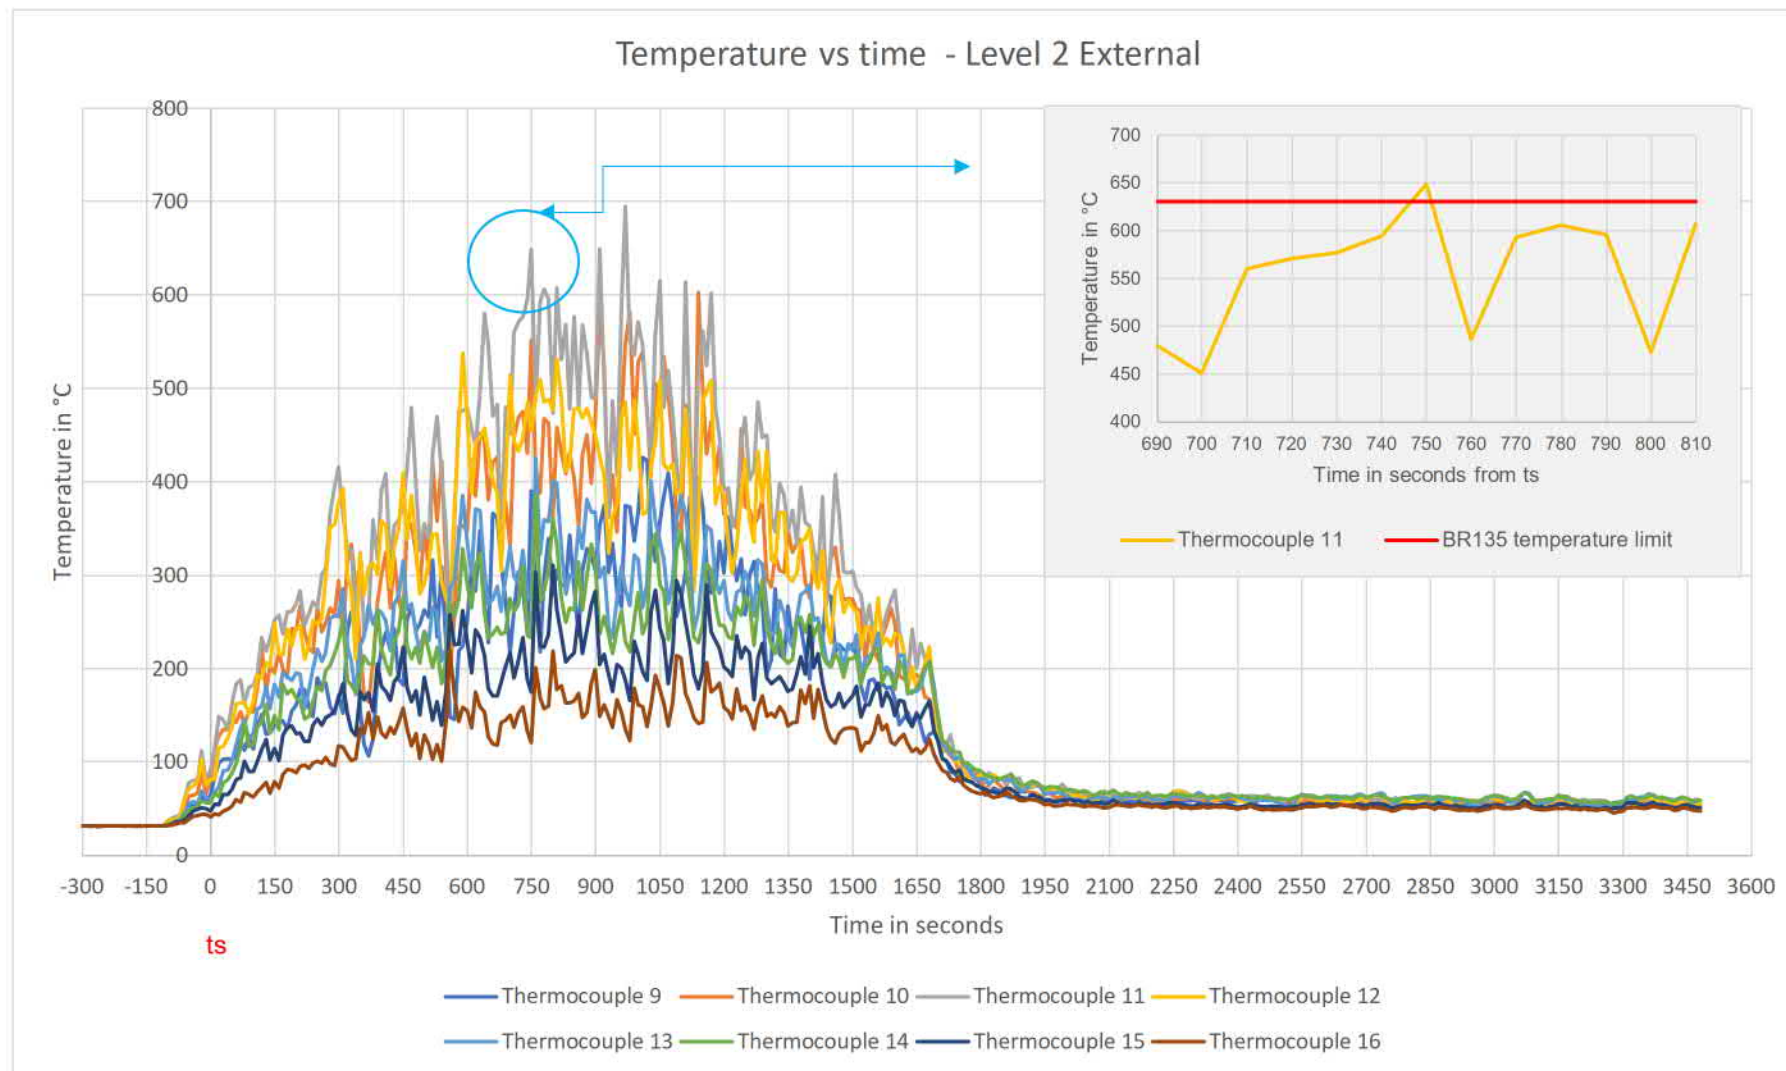
**Figure 6   Level 2, external – temperature vs time**

Note: Within 15 minutes of the start time (ts), thermocouple 11 recorded a temperature of 600°C above Ts (631 °C), sustained for a period of less than 10 seconds.

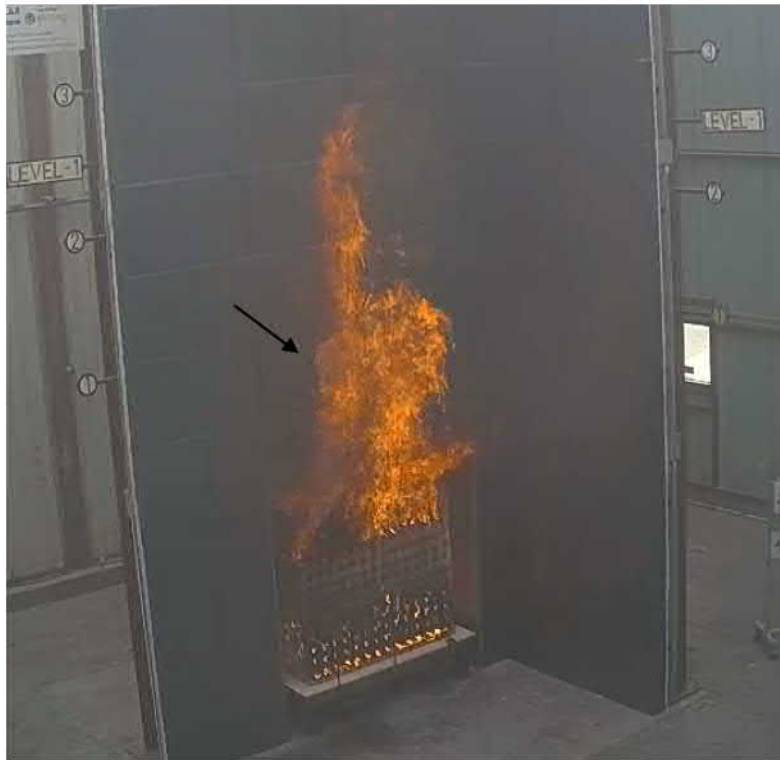
| Time from ignition | | Observation |
|---|---|---|
| 03 | 51 | Coating of mid-panels up to 1 m above the combustion chamber was observed to be peeling off. Refer to photo 18 in Appendix C. |

Photo 18 Coating of mid-panels up to 1 m above the combustion chamber started to peel off

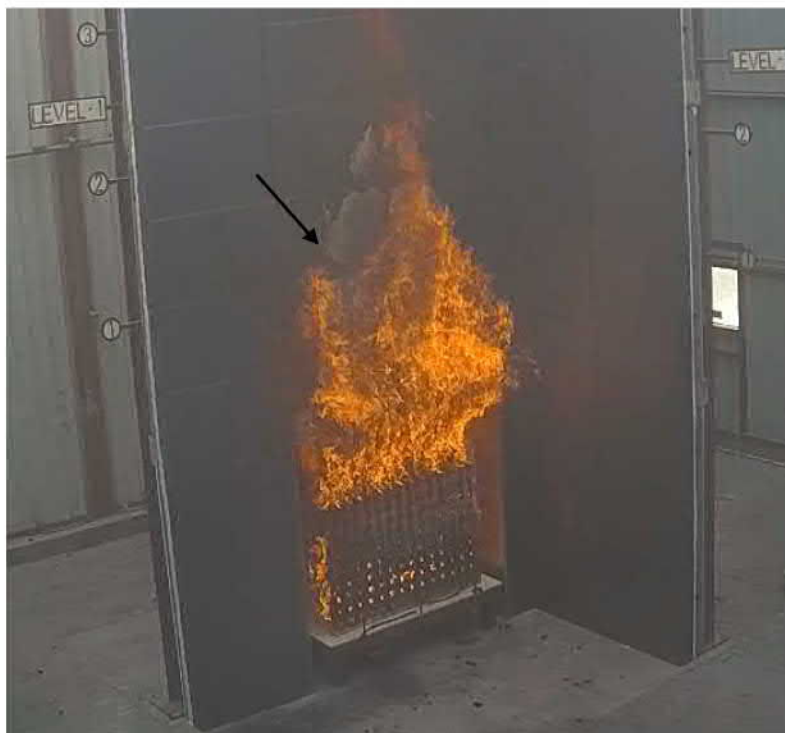
| Time from ignition | | Observation |
|---|---|---|
| 04 | 16 | Coating of panels up to 2 m above the combustion chamber was observed to be peeling off. Refer to photo 19 in Appendix C. |

Photo 19 Coating of panels up to 2 m above the combustion chamber started to peel off

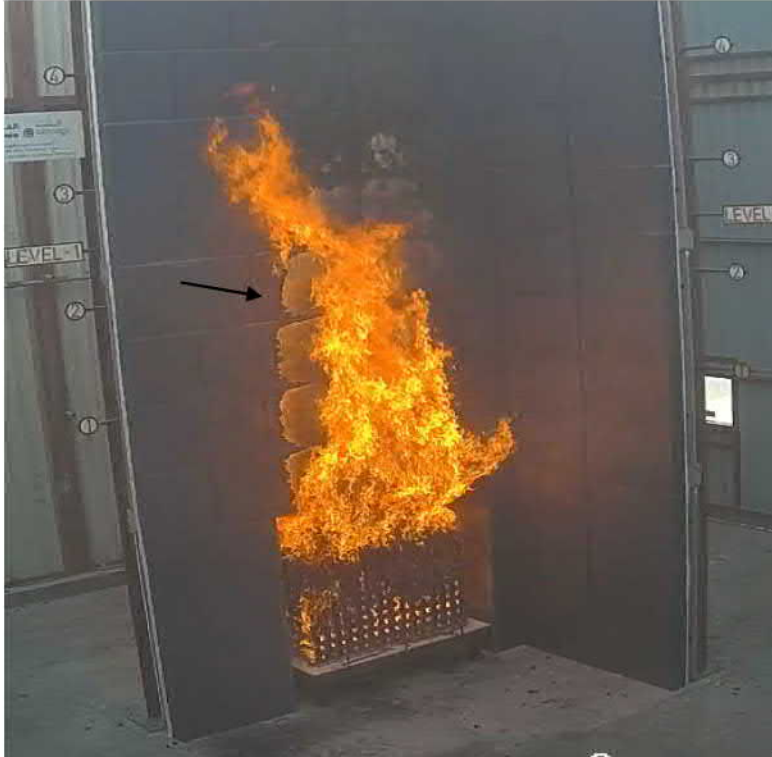
| Time from ignition | | Observation |
|---|---|---|
| 08 | 26 | Coating of mid-panels at 3 m above the combustion chamber was observed to be peeling off. Refer to photo 20 in Appendix C. |

**Photo 20** Coating of mid-panels at 3 m above the combustion chamber started to peel off

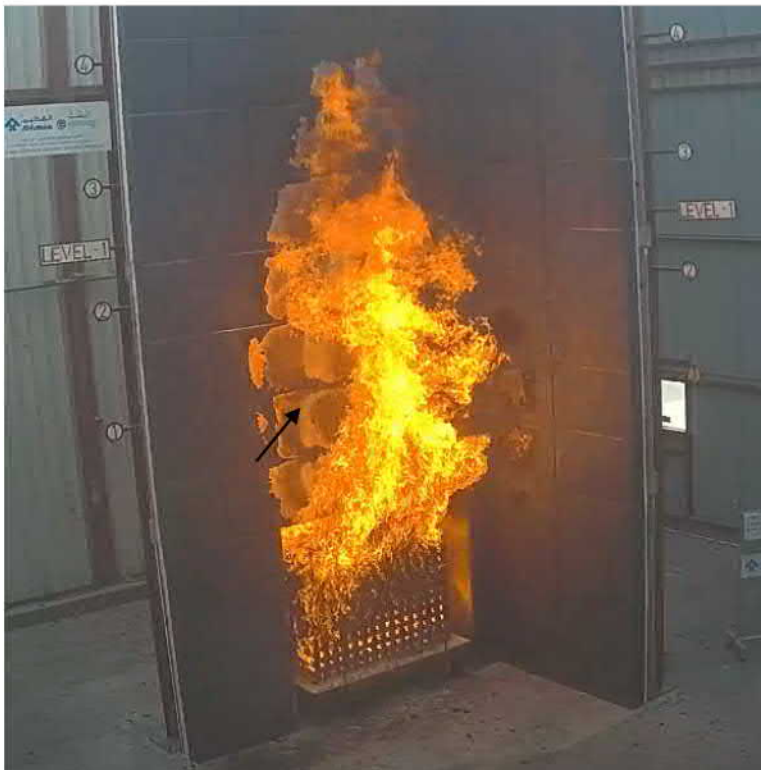
**Photo 21** Mid-panels at 1 m above the combustion chamber were partially consumed and insulation was exposed

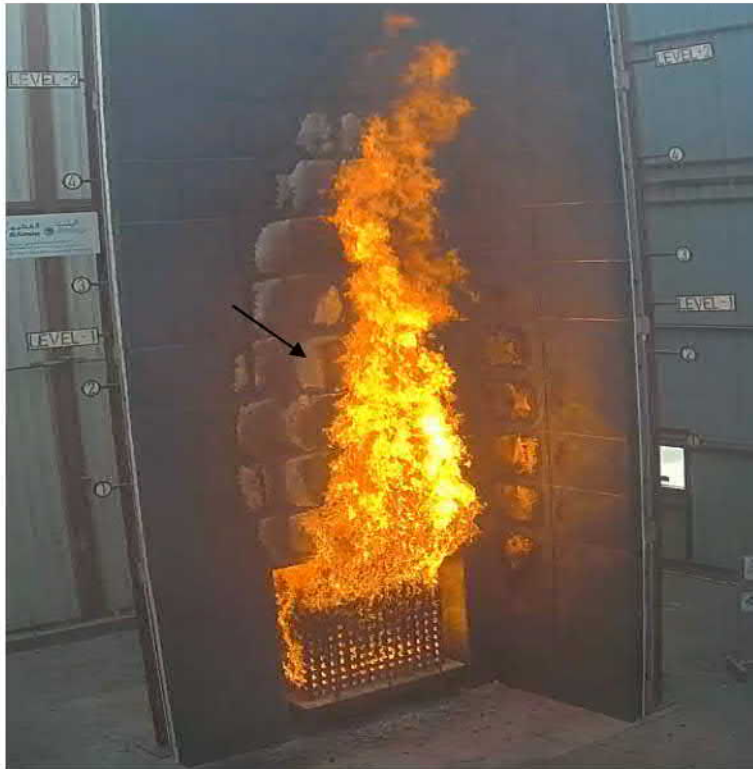
**Photo 22** Mid-panels between 1 to 2 m above the combustion chamber were partially consumed and insulation exposed

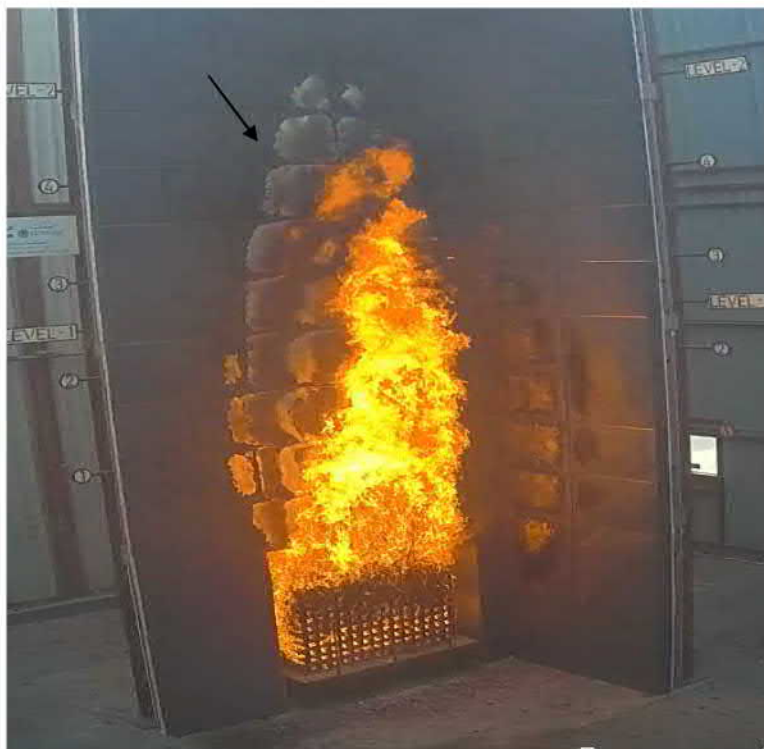
| Time from ignition | | Observation |
|---|---|---|
| 14 | 41 | Coating of mid-panels at 5 m above the combustion chamber was observed to be peeling off. Refer to photo 23 in Appendix C. |

**Photo 23** Coating of mid-panels at 5 m above the combustion chamber started to peel off

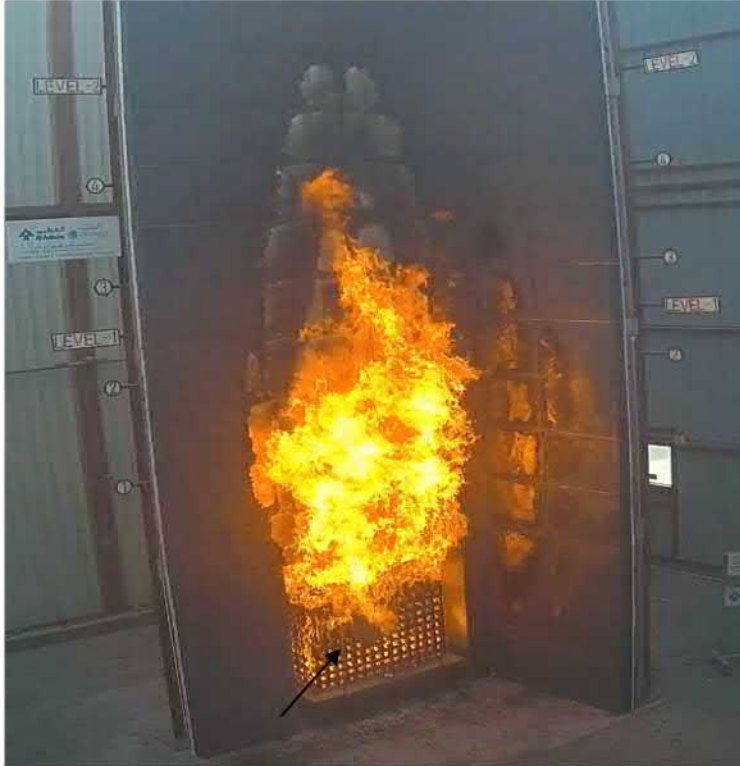
**Photo 24** Flaming debris from mid panel at 1 m above the combustion chamber fell off

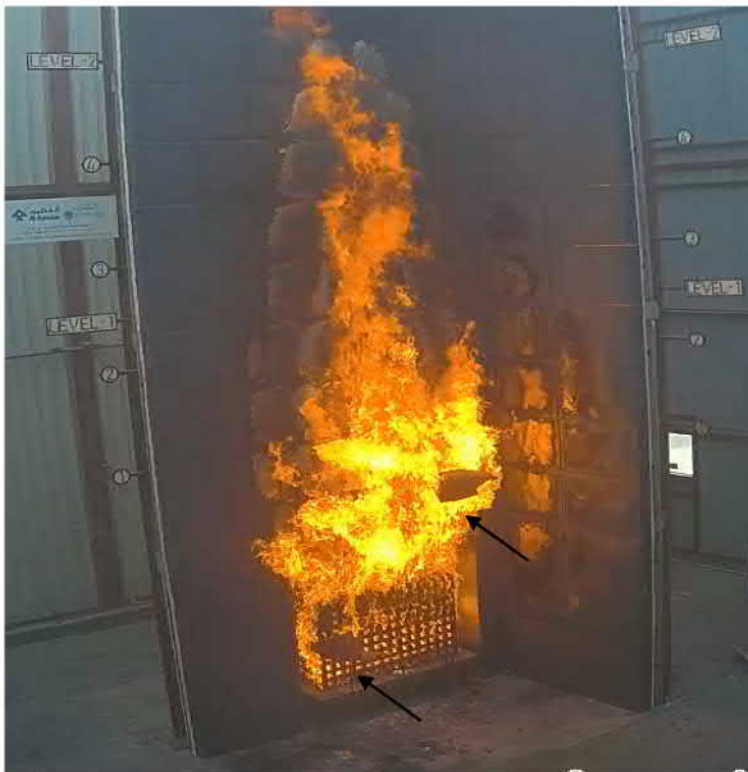
**Photo 25** Debris of core from mid panels between 1 to 2 m above the combustion chamber fell off

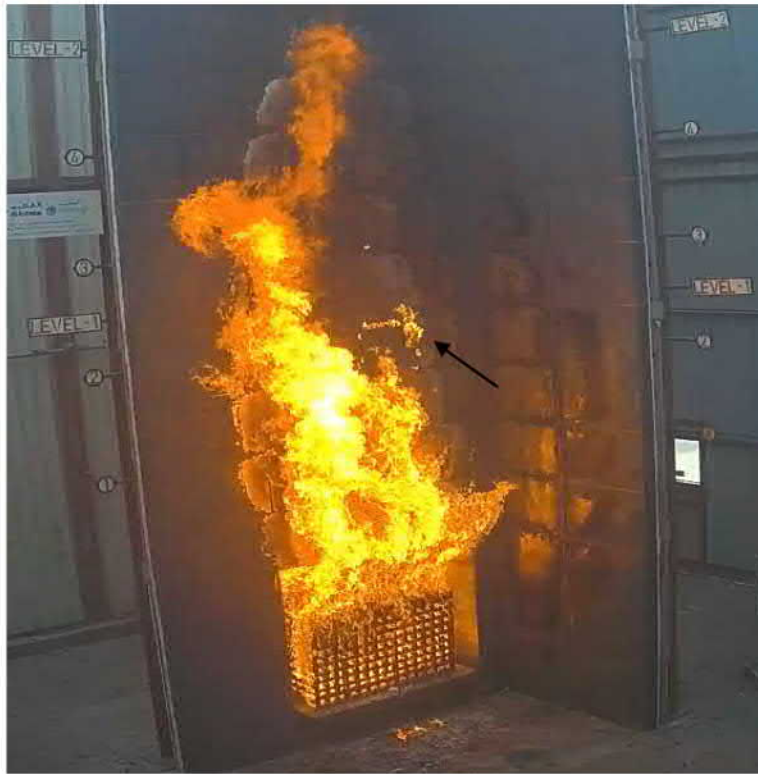
Photo 26 Self-sustained flames on mid-panel at level 1

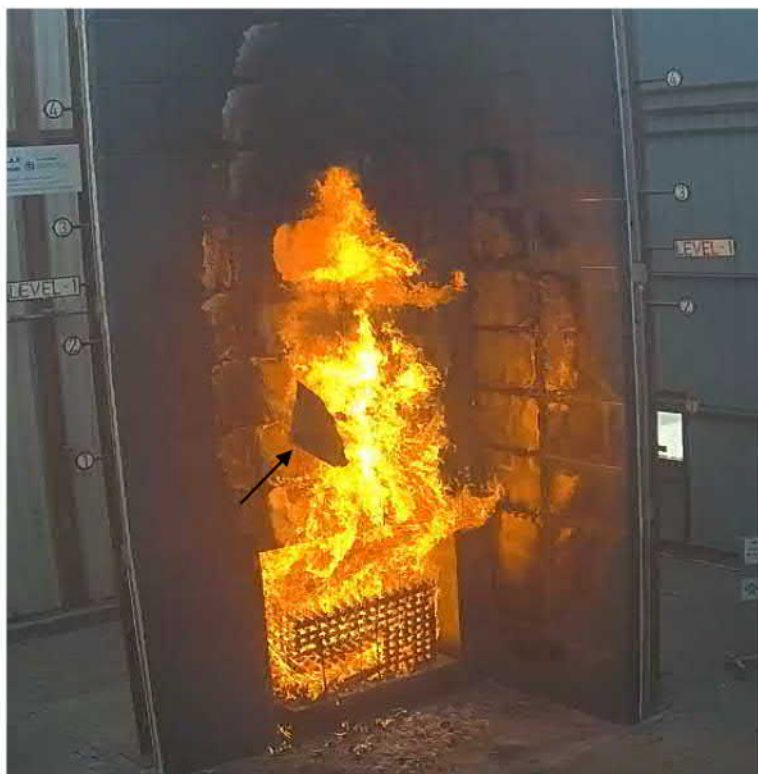
Photo 27 Debris of mid-panel at 3 m above the combustion chamber fell off

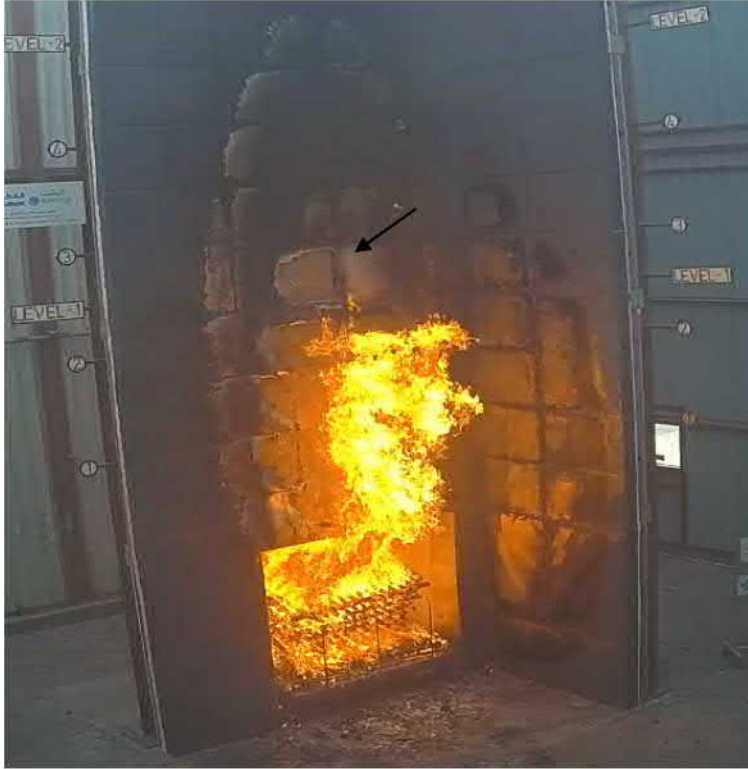
**Photo 28** Mid-panels at 3 m above the combustion chamber were partially consumed and insulation exposed

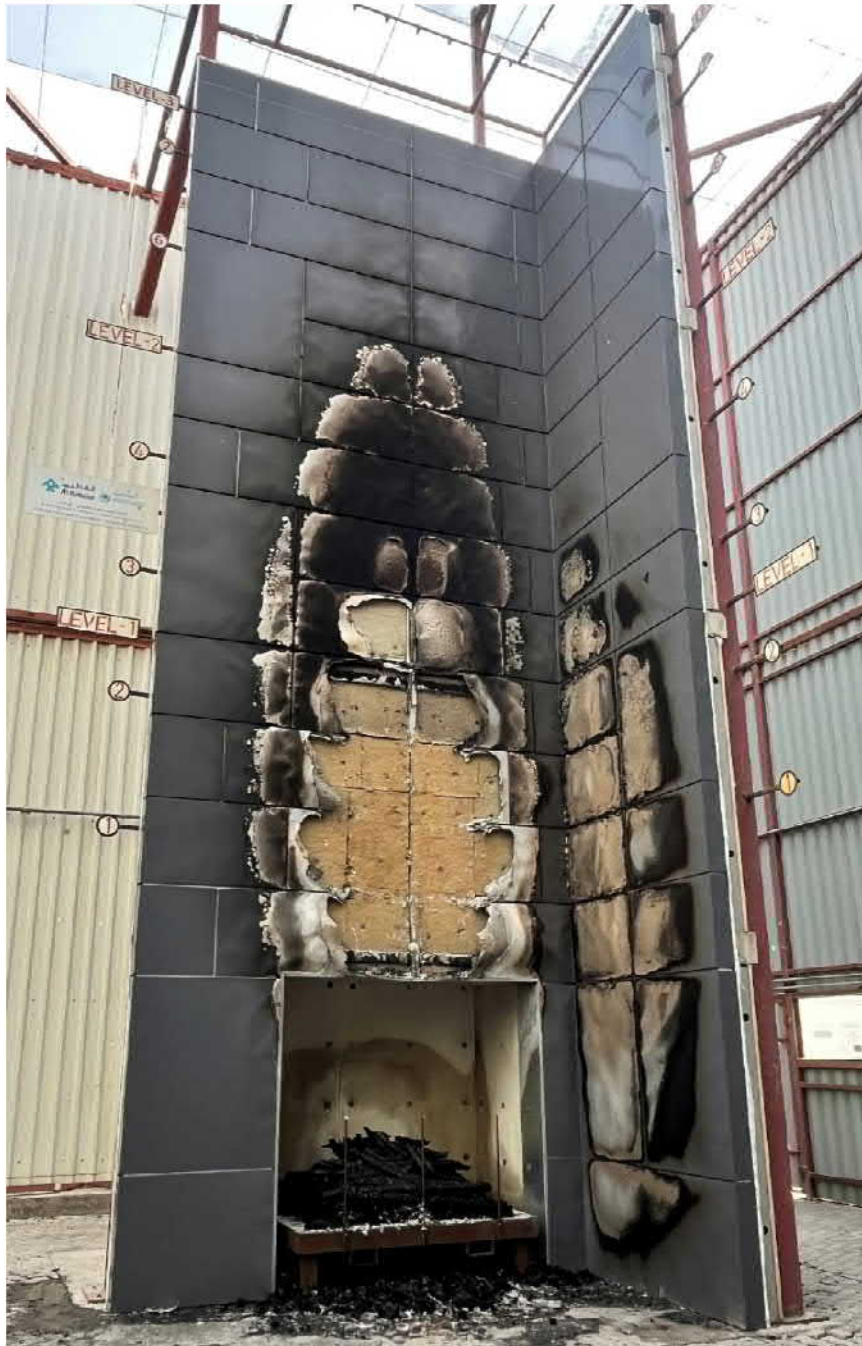
Photo 29 Alubond FR-A2 ACP cladding on completion of the test

| Component | Observations |
|---|---|
| Alubond FR-A2 ACP | <p>Main wall:</p> <p>Mid-panels up to level 1 were partially consumed and remaining areas were discoloured and distorted.</p> <p>Mid-panels between level 1 to level 2 were discoloured</p> <p>No significant changes on the remaining panels on the main wall.</p> <p>Wing wall:</p> <p>Wing wall panels up to level 1 were discoloured.</p> <p>No significant changes on the remaining panels on the wing wall.</p> <p>Refer to photo 29 in Appendix C.</p> |

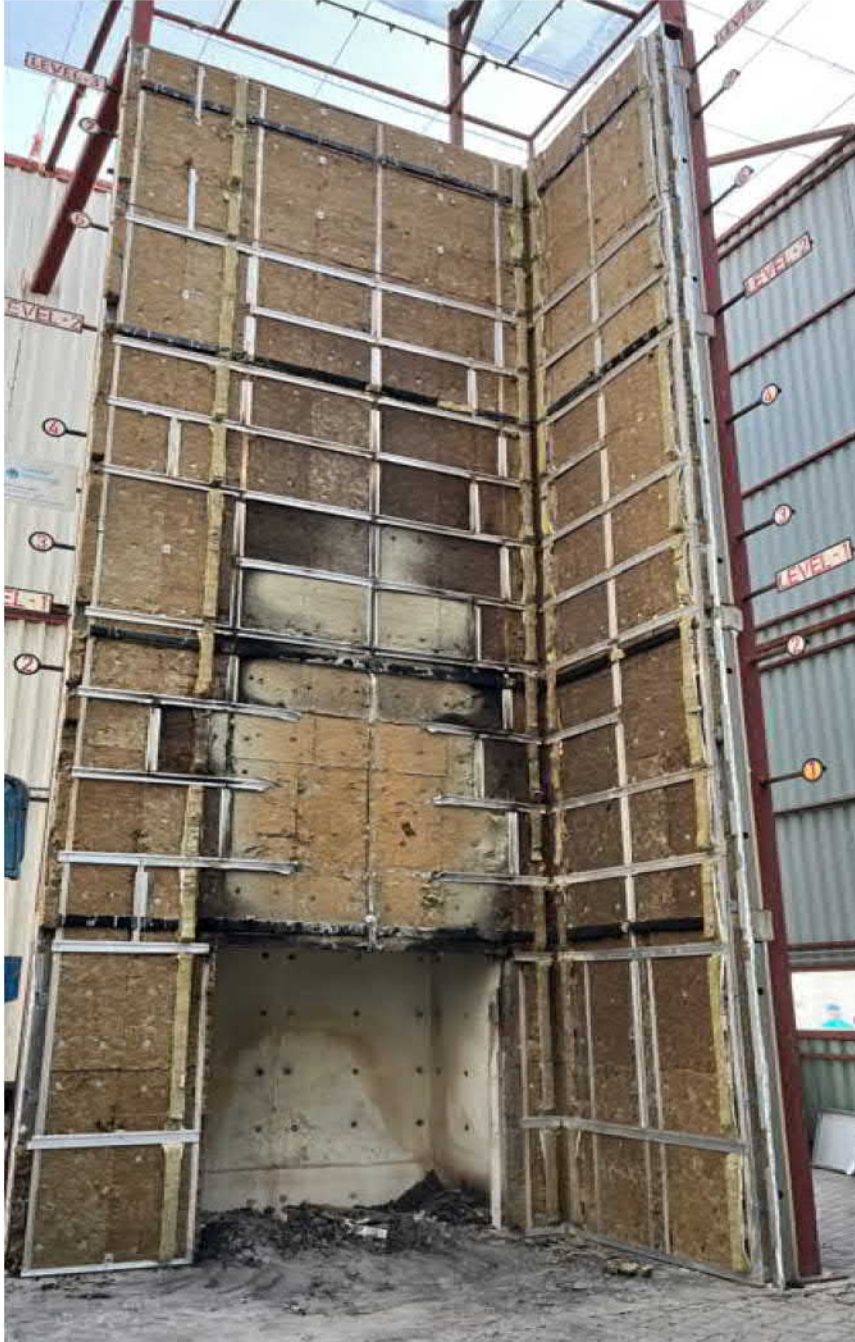
Photo 30    Siderise cavity barrier, Knauf Rocksilk insulation, Alubond RFS panel  
 attachment clip and runners

| Component | Observations |
|---|---|
| Siderise cavity barriers | <p><b>Horizontal intumescent cavity barrier:</b></p> <p>Main wall:</p> <p>The 1<sup>st</sup> horizontal cavity barrier at 140 mm above the combustion chamber was activated. Intumescent layer was partially present on the activated section of the cavity barrier. Minor material loss observed.</p> <p>The 2<sup>nd</sup> horizontal cavity barrier at 2,240 mm above the combustion chamber was activated. Intumescent layer was partially present on the activated sections of the cavity barrier. Material loss of mineral wool insulation of the cavity barrier was observed.</p> <p>The 3<sup>rd</sup> horizontal cavity barrier at 4,805 mm above the combustion chamber was activated. Expanded intumescent layer was present on the activated sections of the cavity barrier. Cavity barrier was intact, and no material loss of mineral wool insulation of the cavity barrier was observed.</p> <p>The 4<sup>th</sup> horizontal cavity barrier at 7,300 mm above the combustion chamber was not activated. Cavity barrier was intact, and no material loss of mineral wool insulation of the cavity barrier was observed.</p> <p>Wing wall:</p> <p>The 1<sup>st</sup> horizontal cavity barrier at 2,140 mm above the ground floor level combustion chamber was activated. Expanded intumescent layer was present on the activated sections of the cavity barrier. Cavity barrier was intact, and no material loss of mineral wool insulation of the cavity barrier was observed.</p> <p>The 2<sup>nd</sup> horizontal cavity barrier at 4,240 mm above the ground level was activated. Expanded intumescent layer was present on the activated section of the cavity barrier. Cavity barrier was intact, and no material loss of mineral wool insulation of the cavity barrier was observed.</p> <p>The 3<sup>rd</sup> horizontal cavity barrier at 6805 mm above the ground level was not activated. Cavity barrier was intact, and no material loss of mineral wool insulation of the cavity barrier was observed.</p> <p>The 4<sup>th</sup> horizontal cavity barrier at 9300 mm above the ground level was not activated. Cavity barrier was intact, and no material loss of mineral wool insulation of the cavity barrier was observed.</p> <p>Refer to photos 30, 34 to 36 in Appendix C.</p> <p><b>Vertical cavity barrier:</b></p> <p>Discolouration and distortion were observed on the on the vertical cavity barriers provided on the main wall and wing wall.</p> <p>Refer to photos 30, 34 to 36 in Appendix C.</p> |
| Knauf Rocksilk rainscreen slab insulation | <p>Main wall:</p> <p>Knauf rainscreen slab insulation located behind mid-panels up to 4 m above the combustion chamber were discoloured.</p> <p>All other insulation on the main wall was intact and no significant changes were observed.</p> <p>Wing wall:</p> <p>No significant changes were observed.</p> <p>Refer to photos 30, 34 &amp; 35 in Appendix C.</p> |

| Component | Observations |
|---|---|
| Alubond RFS<br>Railings and panel attachment clips | <p>Main wall:</p> <p>Railings and panel attachment clips located behind the mid-panels up to level 1 were melted.</p> <p>Railings and panel attachment clips located behind the mid-panels between level 1 and level 2 were discoloured.</p> <p>All other railings and panel attachment clips on the main wall were intact and no damage was observed.</p> <p>Wing wall:</p> <p>All railings and panel attachment clips on the wing wall were intact and no significant changes were observed.</p> <p>Refer to photos 30, 34 to 36 in Appendix C.</p> |

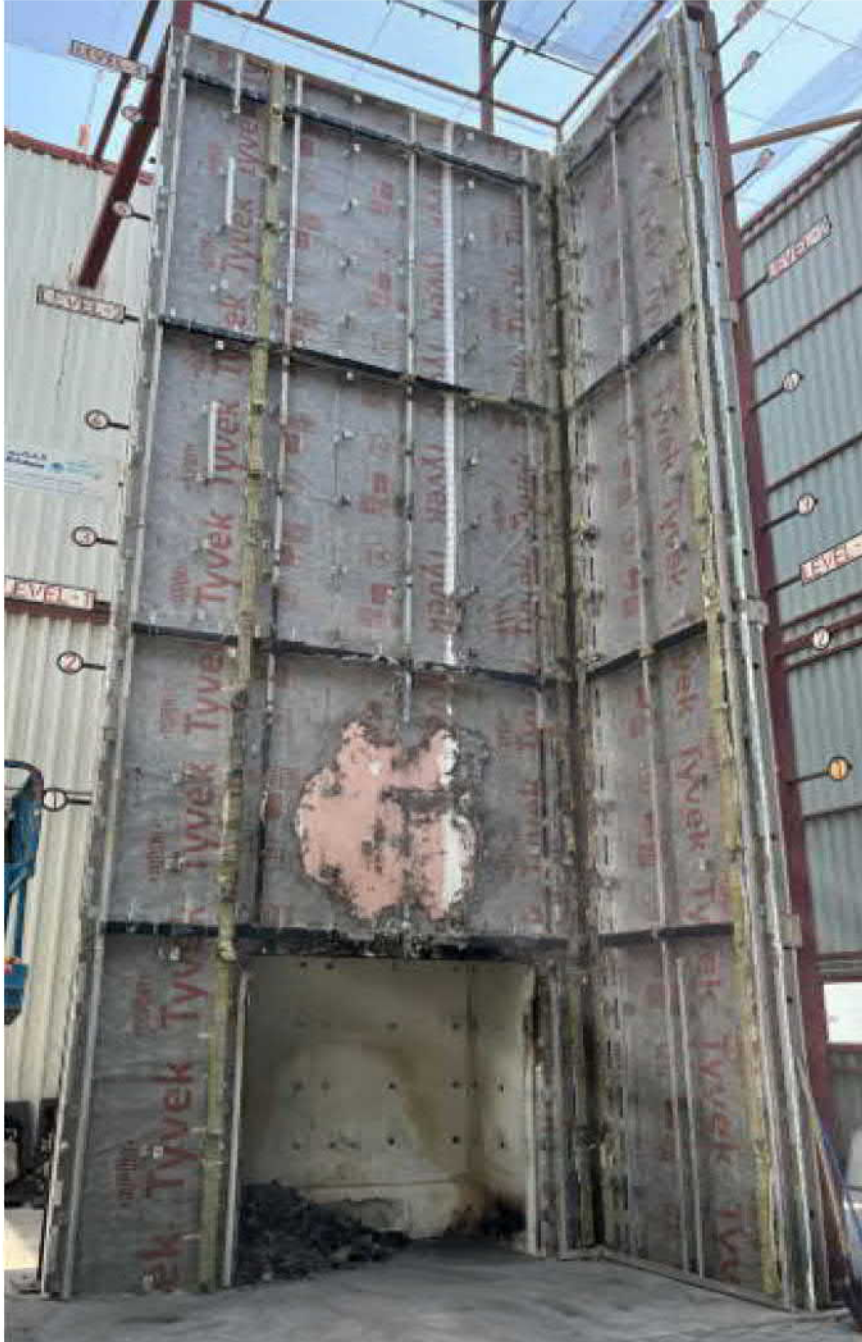
Photo 31 Dupont Tyvek Supro membrane and Alubond RFS brackets

| Component | Observations |
|---|---|
| Alubond RFS brackets | <p>Galvanized steel brackets</p> <p>All galvanized brackets on the main wall and wing wall were intact and no significant changes were observed.</p> <p>Aluminium horizontal support brackets:</p> <p>Minor discoloration was observed on the aluminium brackets located behind mid panels up to level 1.</p> <p>All other aluminium brackets on the main wall and wing wall were intact and no significant changes were observed.</p> <p>Refer to photo 31 in Appendix C.</p> |
| Dupont Tyvek Supro membrane | <p>Material loss and discoloration were observed on Tyvek membrane located behind the mid-panels up to 2 m above the combustion chamber.</p> <p>Remaining Tyvek membrane on the main wall and wing wall were intact and no significant changes were observed.</p> <p>Refer to photo 31 in Appendix C.</p> |

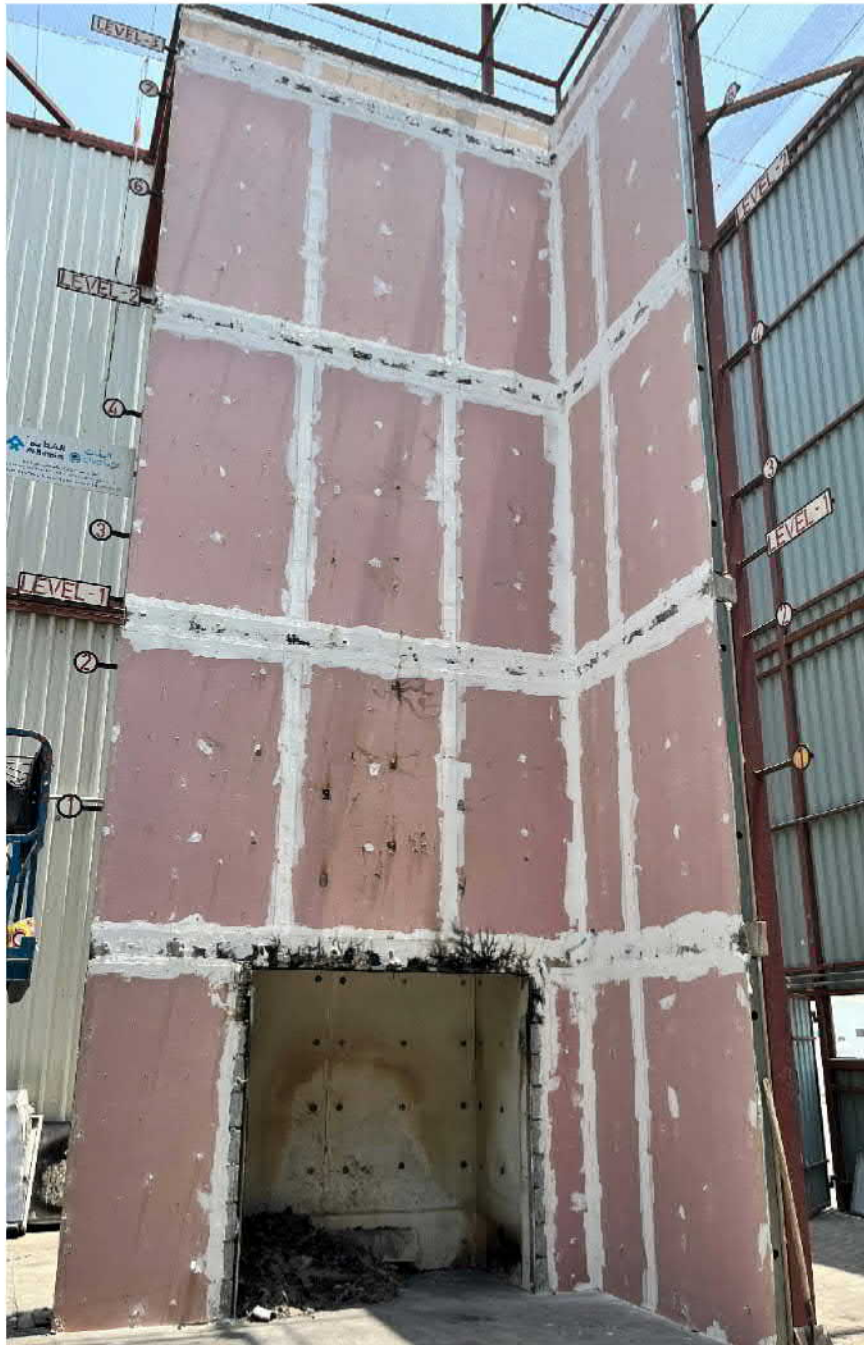
Photo 32 Knauf Type X gypsum board (front)

| Component | Observations |
|---|---|
| Knauf type X Gypsum board and SFS | <p>No significant changes were observed.</p> <p>Refer to photos 32 &amp; 33 in Appendix C.</p> |

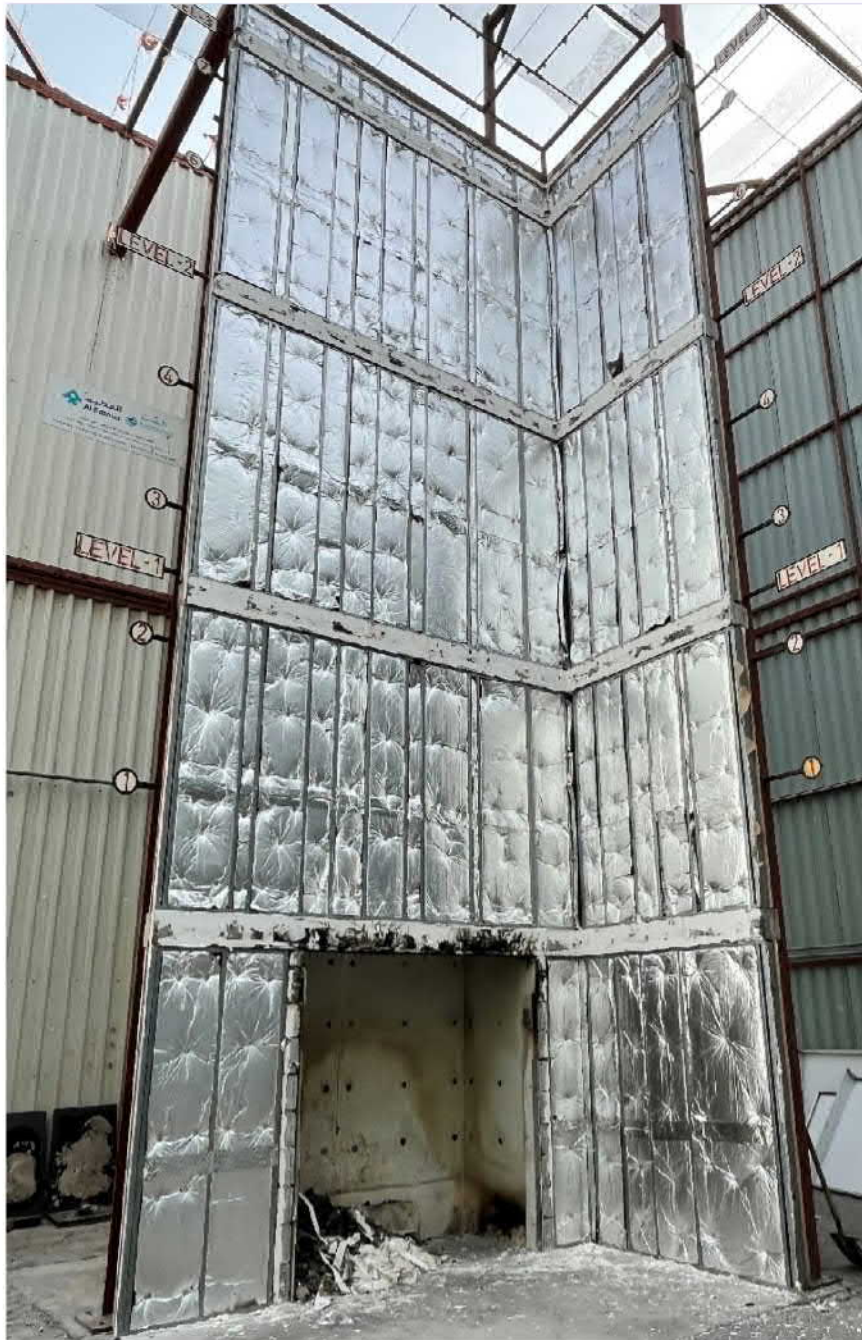
Photo 33 Knauf glasswool FS-Slab

| Component | Observations |
|---|---|
| Knauf glass wool FS-Slab | <p>No significant changes were observed</p> <p>Refer to photo 33 in Appendix C.</p> |
