Flood Investigation Report

Greater Manchester

26 December 2015

*This report is written to comply with Section 19 of the
Flood and Water Management Act, 2010.*

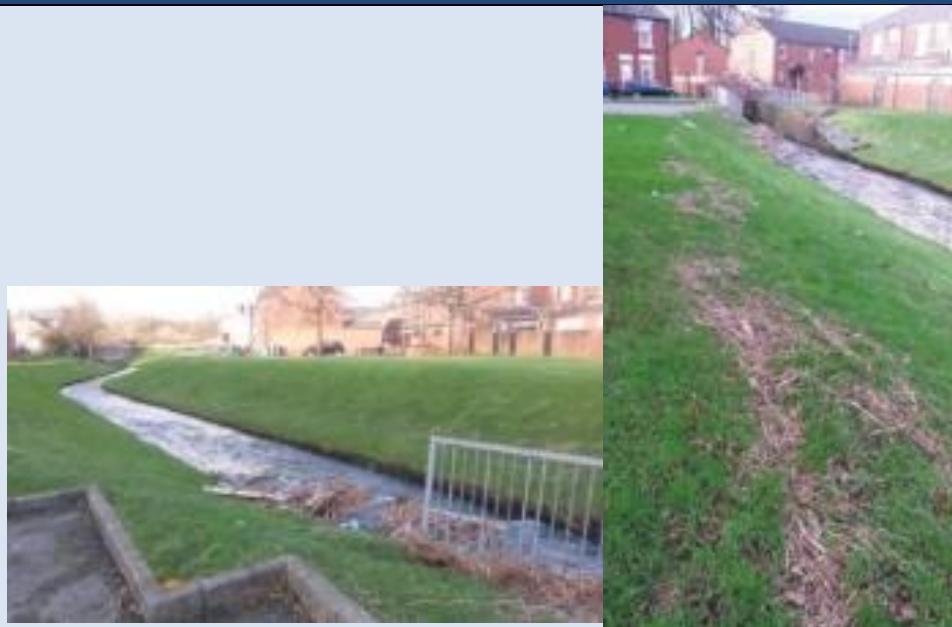
Picture 71 Hector Avenue, 2015

- The Environment Agency are leading investigations at this location as most flooding was from main river
- 36 flooded properties flooded:
 - 35 from main river (River Roch and Hey Brook/ Buckley Brook)
 - 1 from ordinary watercourse
- Properties close to R Roch flooded internally to a depth of up to 400mm
- A number of cellars close to Hey Brook and the River Roch flooded from surface water/groundwater when brook reached high level but did not overtop
- Culverts overtopped on Hey Brook upstream of Foxholes Rd/Red Lane allowing floodwater on to Buckley Rd and Park Lane (online video)
- Nearby sub-stations were flooded causing loss of power supply to properties
- Allotments on Kellet Street flooded (and in 2012)
- Cellars of 4 houses in Wardleworth flooded in 2012 due to backing up of a drain into the river

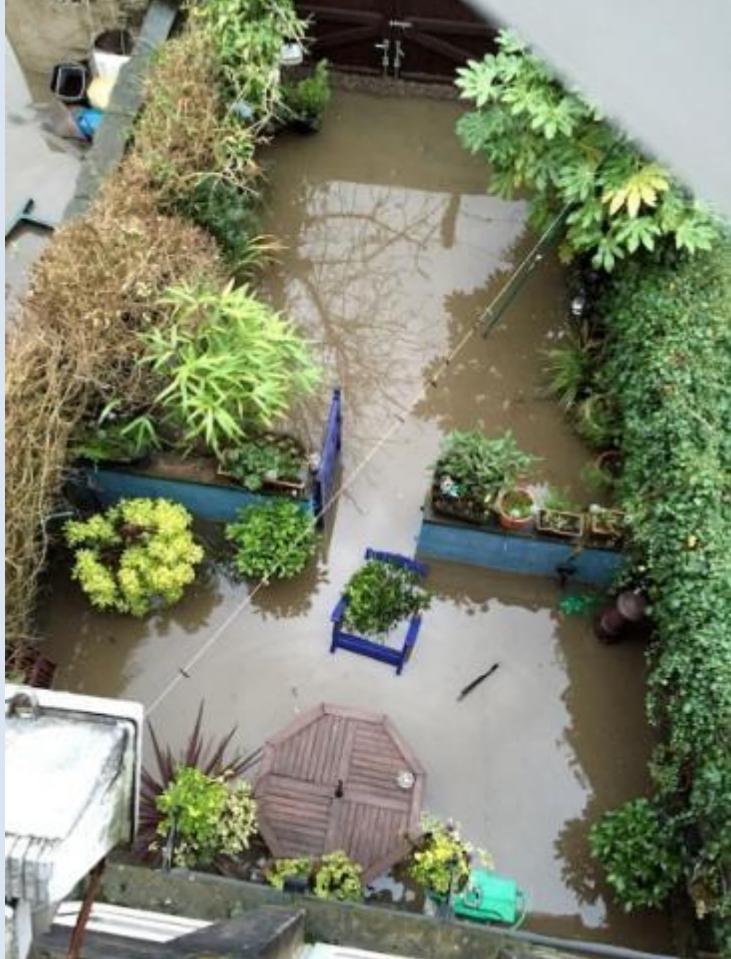
Description/Main Issues
<ul style="list-style-type: none"> The Environment Agency are leading investigations at this location as most flooding was from main river 10 properties flooded from River Roch Drains in rear yards of residential properties filled up, followed by flooding from the river that was gradual at first, then fast, muddy and polluted water flowed into properties to a depth of 600 to 900mm Riparian landowners cleared some debris from the river channel and a disused footbridge downstream of the weir following the flood and will consider possible bridge removal (3rd arch was blocked) Heap Bridge residents are keen to set up a residents group which would be useful for further discussions about flooding, resilience and potential measures
Photos

<p data-bbox="436 1724 1135 1785">Picture 74 Pictures taken by resident on Bury Road, Heap Bridge from first floor window</p>

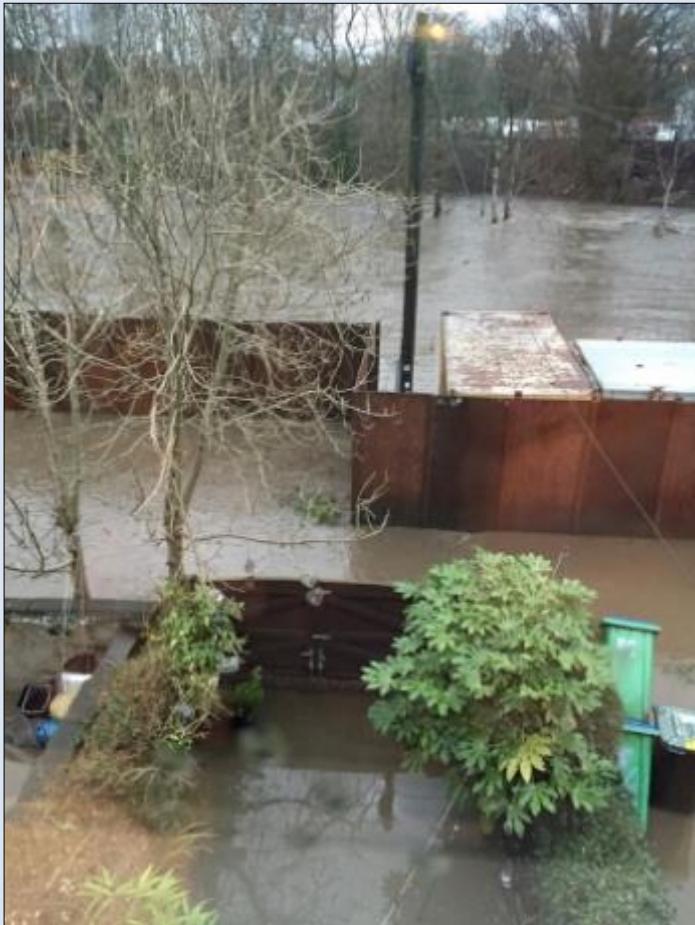
Picture 75 Pictures taken by resident on Bury Road, Heap Bridge from first floor window

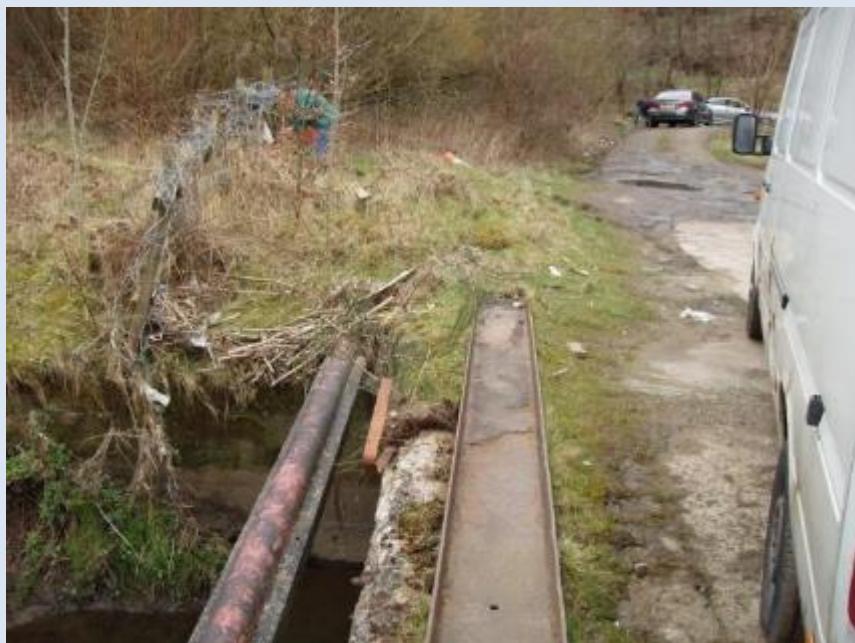
- The Environment Agency are leading investigations at this location as most flooding was from main river
- 10 industrial storage units flooded at Firgrove Business Park from the River Beal
- Channel and culvert capacity exceeded. Culvert has smaller section at inlet than at outlet
- Flows overtopped banks at inlet of culvert and flooded adjoining units and yard areas
- Previous flooding occurred in 1991, 1995, February and August 2002

Picture 76 Culvert inlet

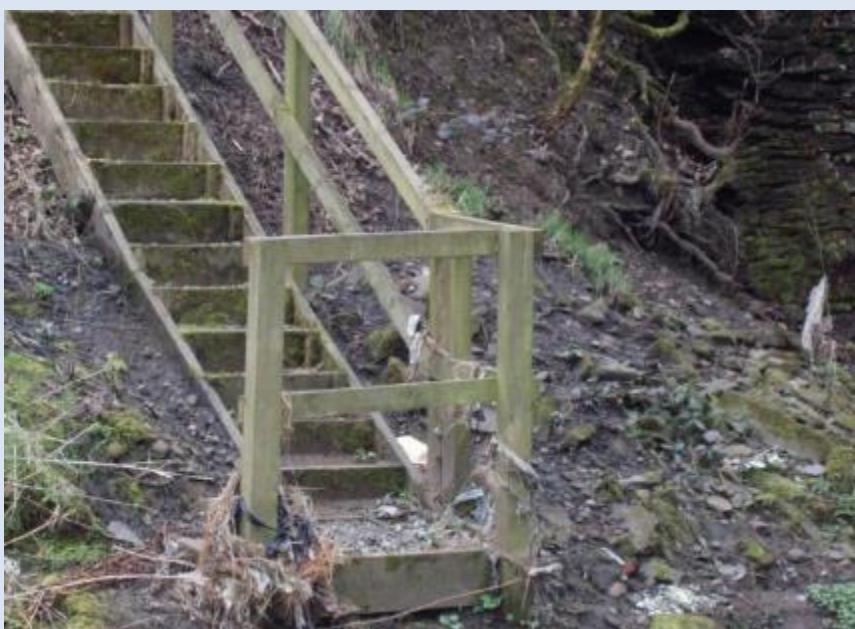
Picture 77 Debris downstream

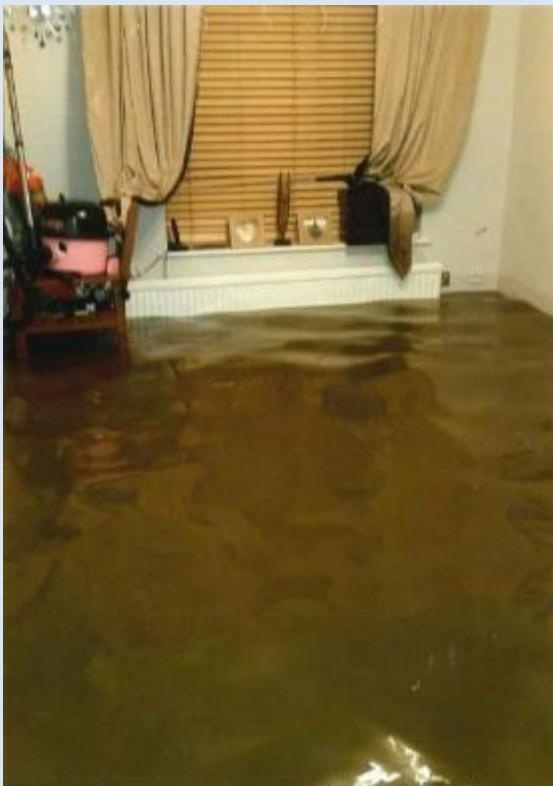
Picture 78 internal property flooding – Lower Broughton

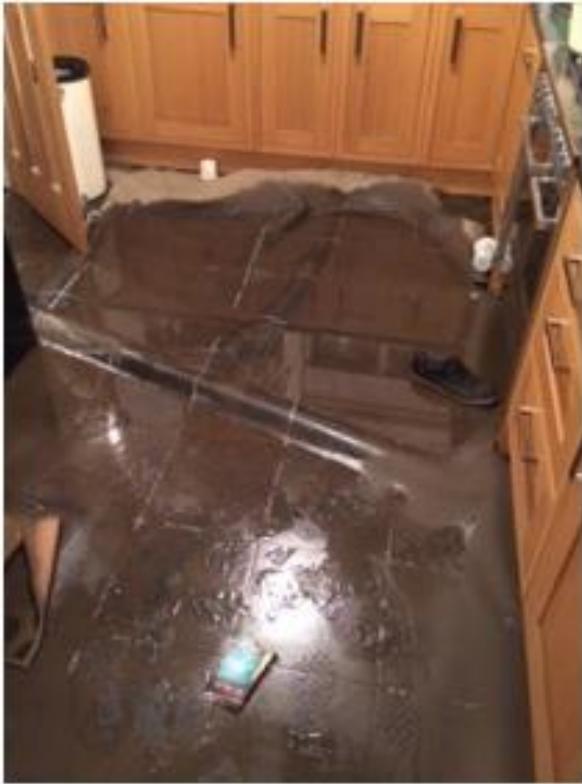
Picture 79 Silt as a result of internal property flooding – Lower Broughton

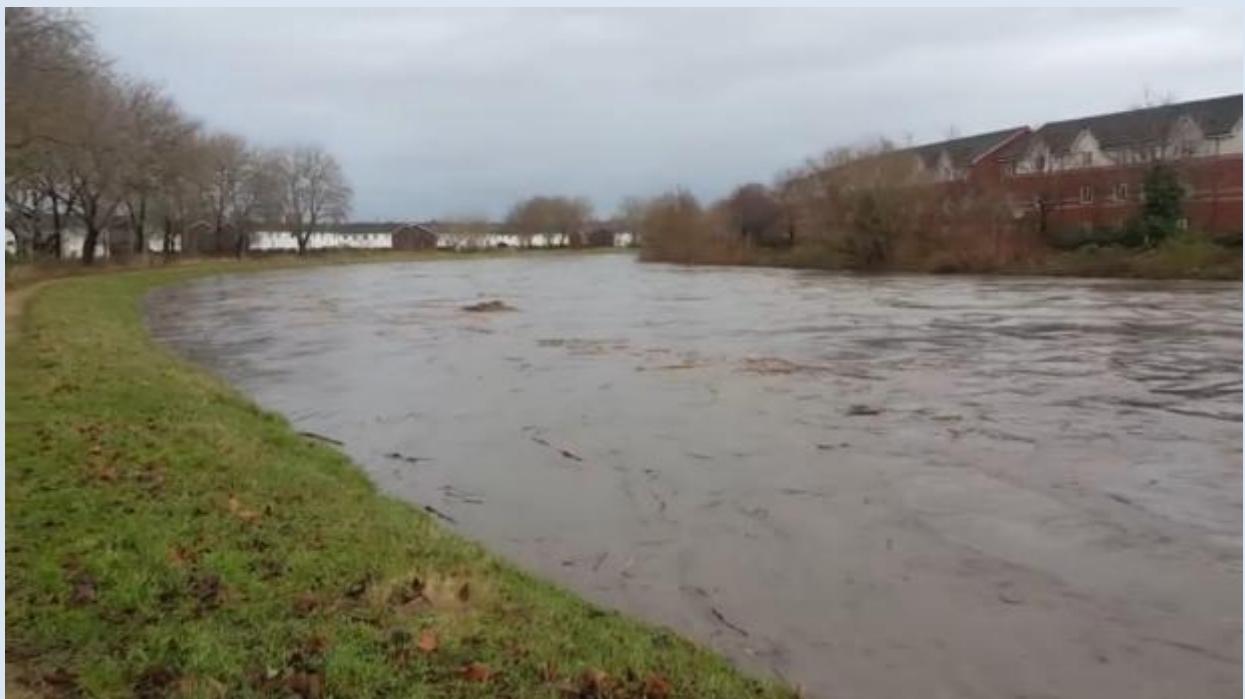
Picture 80 High water levels in the River Irwell

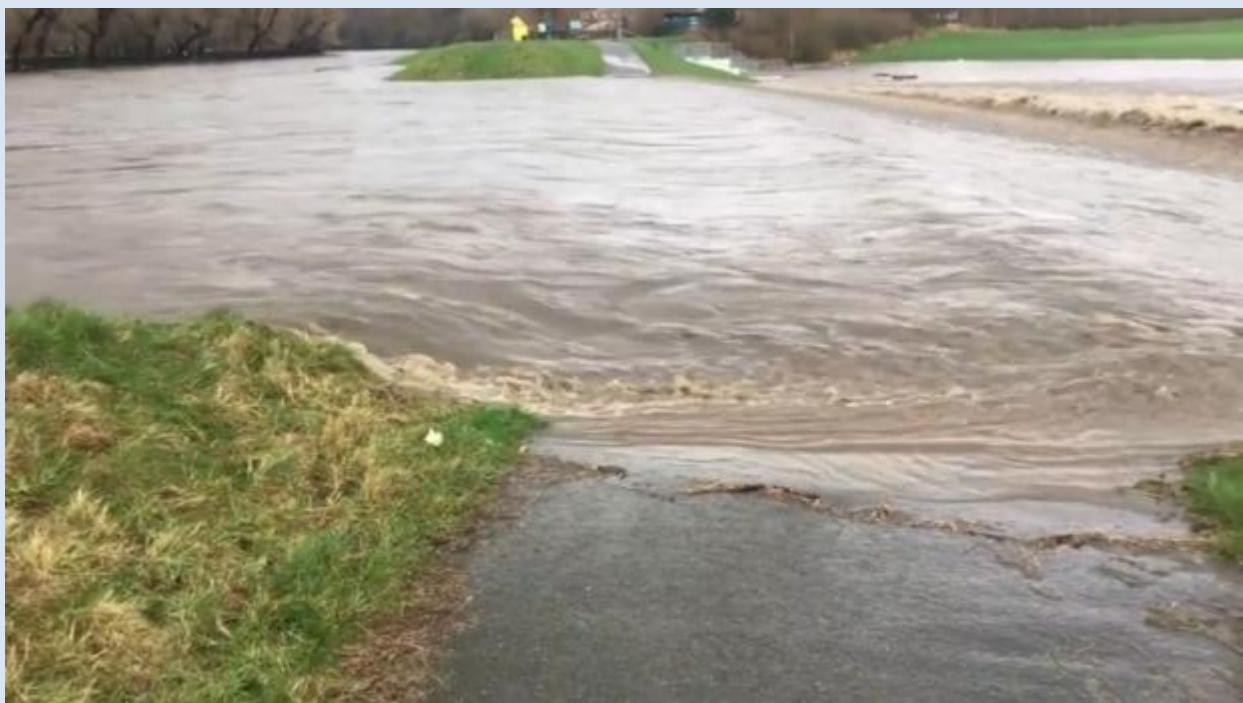
Picture 81 Inlet to Littleton Road flood storage basin, River Irwell

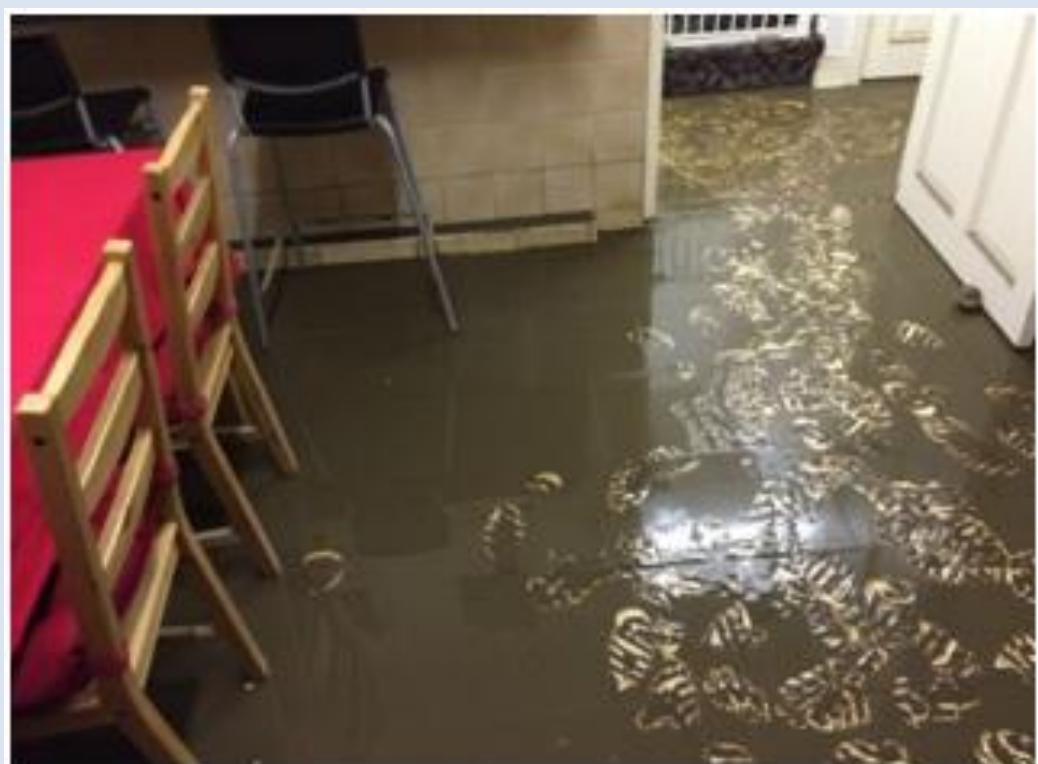
Picture 82 Silt as a result of internal property flooding – Lower Broughton

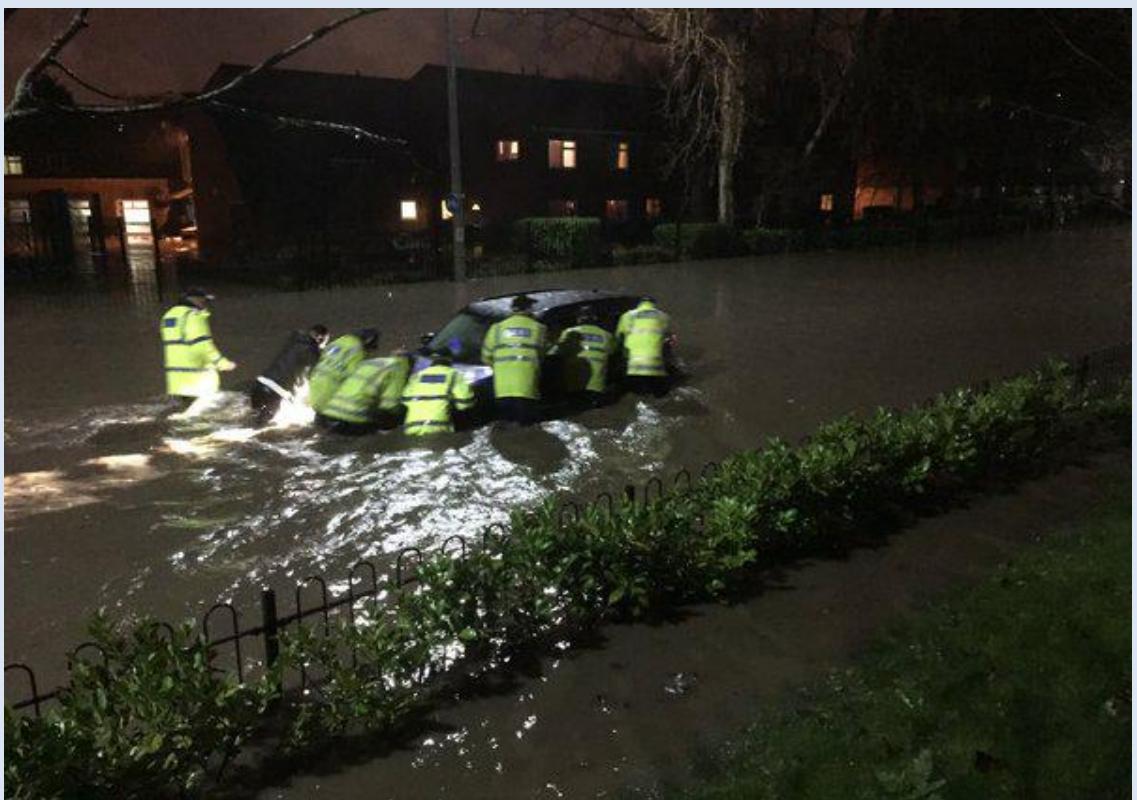
Picture 83 Vehicle stuck in flood waters – Lower Broughton

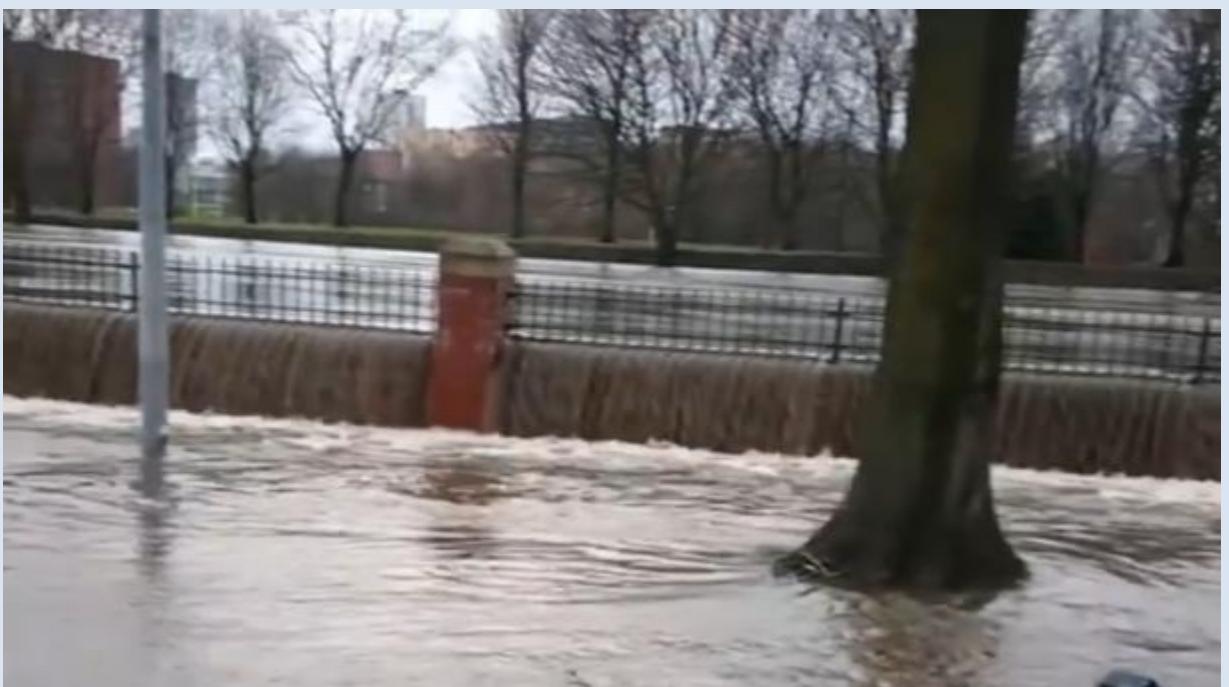
Picture 84 River Irwell overtopping at Heath Avenue

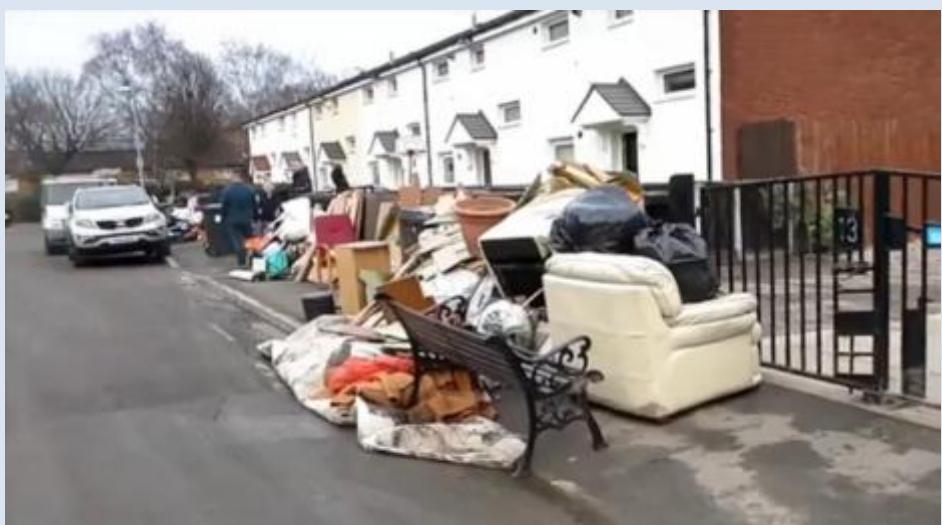
Picture 86 debris from flooded homes

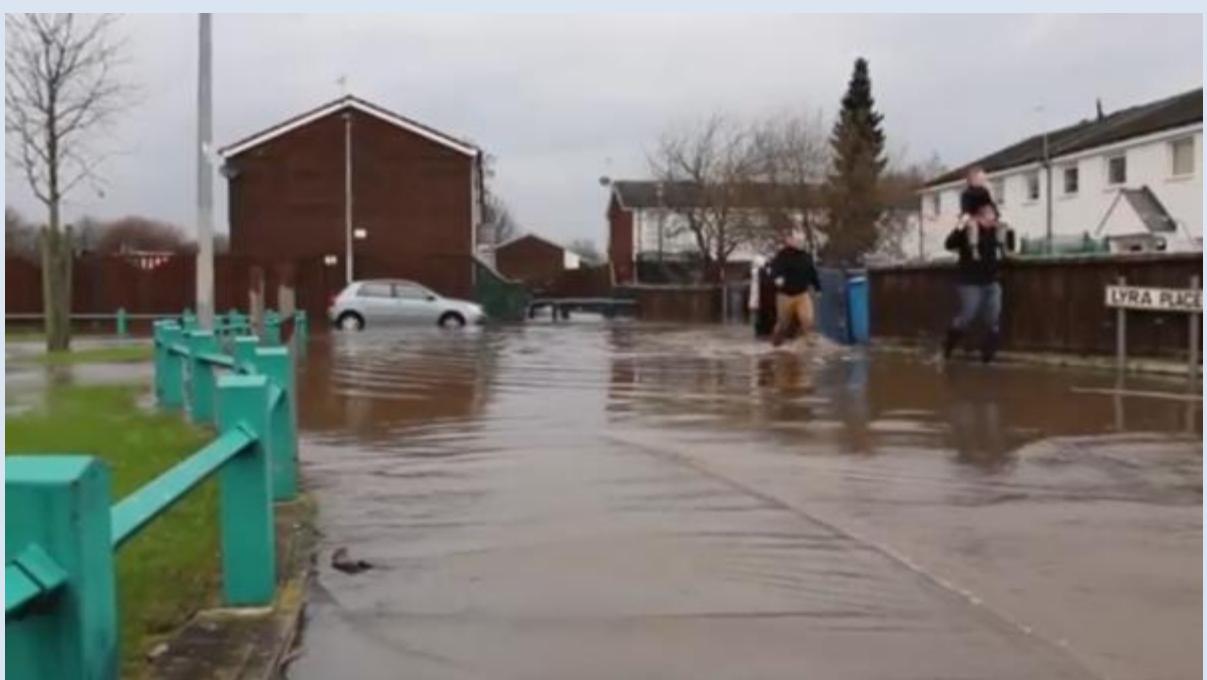
Picture 87 Flooding at Lyra Place – Lower Broughton

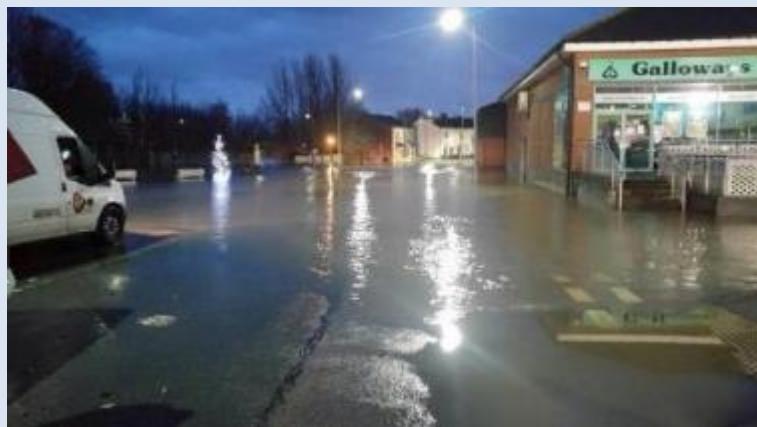
Picture 88 Flooding at Walthew Parade/Walthew Lane

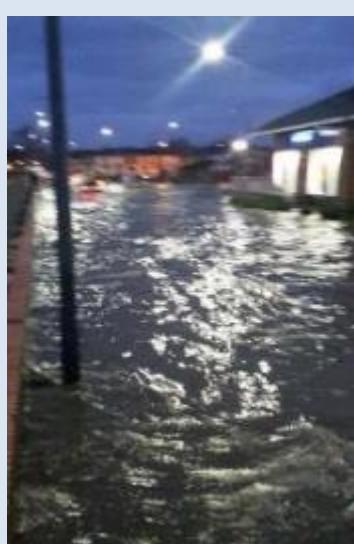
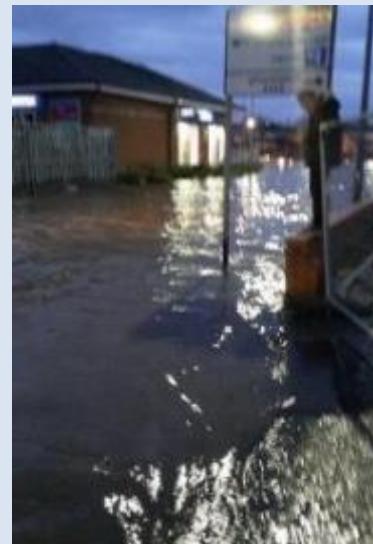
Picture 89 Flooding on Platt Lane (looking North)

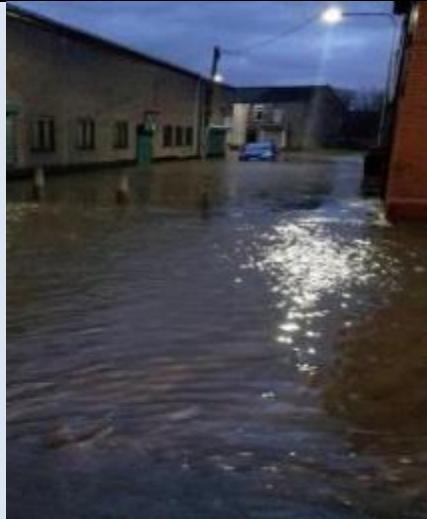
Picture 90 Flooding in Aspinall Street (looking east from junction with Platt Street)

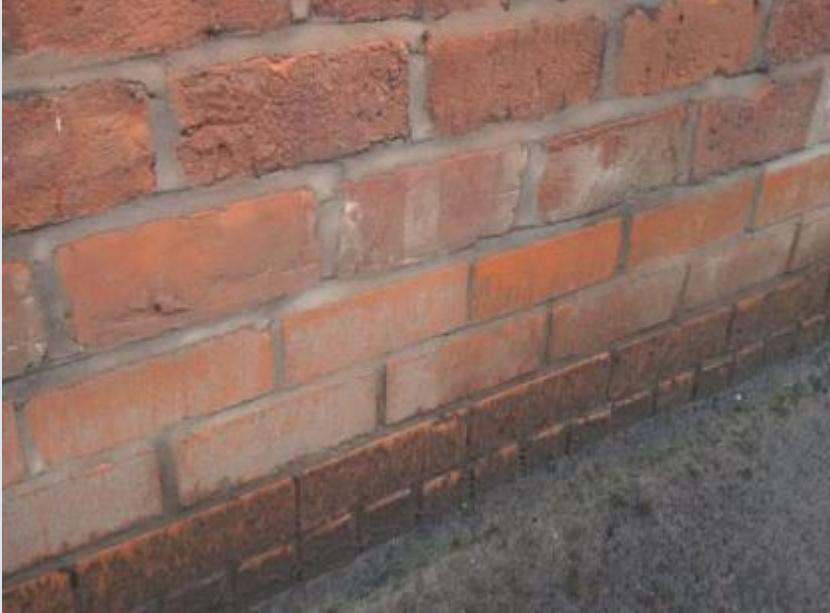
<p data-bbox="568 1349 922 1379">Picture 93 Water mark, Lord Street</p>

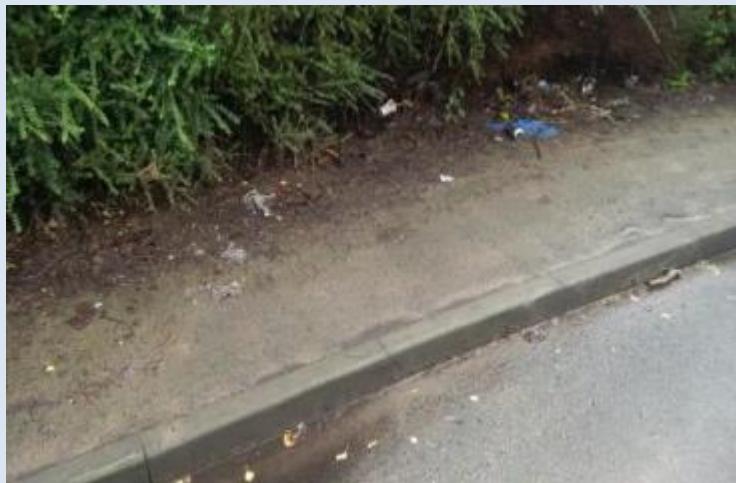
<p data-bbox="552 1911 938 1940">Picture 94 Silt deposit; Aughton Street</p>

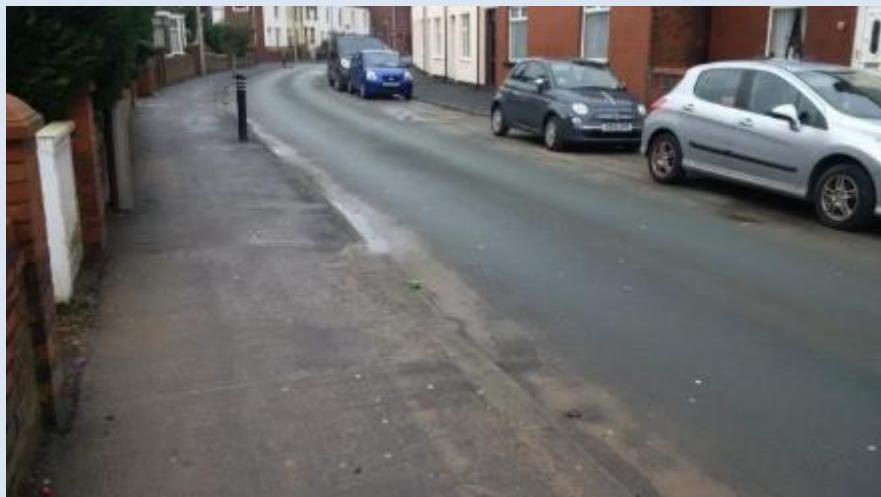
Picture 95 Silt deposit; Lord Street
