**Equipment : CWP 2 Unit 3**

**KKS : LJ30PAC10AP002-001**

**Technology : Vibrasi dan IR Thermography**

**Finding : Vibrasi CWP 2 Unit 3 Mulai Muncul Indikasi Kerusakan Bearing**

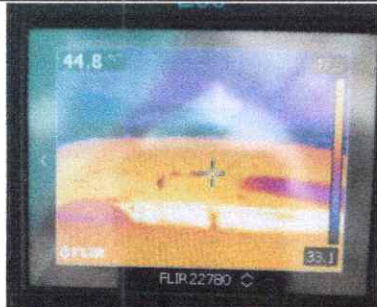
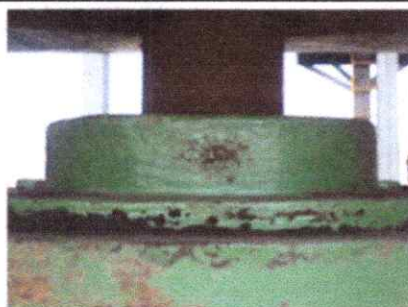
| CITRA IMAGING INFRARED THERMOGRAPHY | FOTO EQUIPMENT ACTUAL | KETERANGAN |
|---|---|---|
| | | Pada bearing 1 Motor Circulating Water Pump 2 Unit 3 tidak ada hotspot / kenaikan temperature yang berbahaya, temperature maksimal 44.8 deg cel. ✓ |

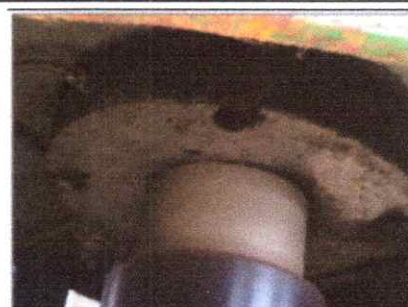
| CITRA IMAGING INFRARED THERMOGRAPHY | FOTO EQUIPMENT ACTUAL | KETERANGAN |
|---|---|---|
| | | Pada bearing 2 Motor Circulating Water Pump 2 Unit 3 tidak ada hotspot / kenaikan temperature yang berbahaya, temperature maksimal 55.2 deg cel. ✓ |

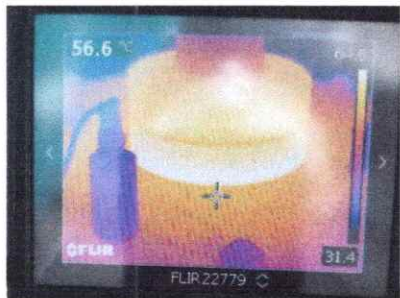
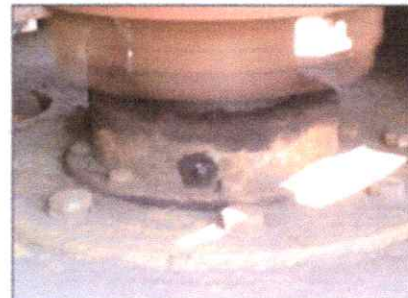
| CITRA IMAGING INFRARED THERMOGRAPHY | FOTO EQUIPMENT ACTUAL | KETERANGAN |
|---|---|---|
| | | Pada bearing 3 Pompa Circulating Water Pump 2 Unit 3 tidak ada kenaikan temperature, temperature maksimal 56.6 deg cel. ✓ |

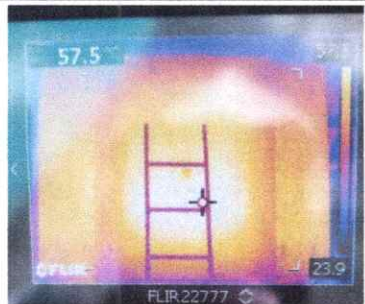
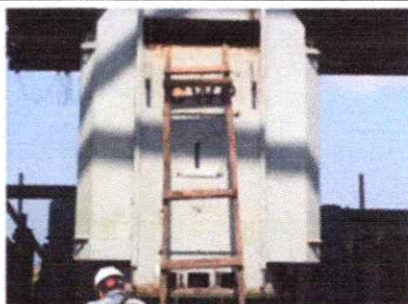
| CITRA IMAGING INFRARED THERMOGRAPHY | FOTO EQUIPMENT ACTUAL | KETERANGAN |
|---|---|---|
| | | Pada cover winding Motor Circulating Water Pump 2 Unit 3 tidak ada kenaikan temperature, temperature maksimal 57.5 deg cel. ✓ |
