Car Projects

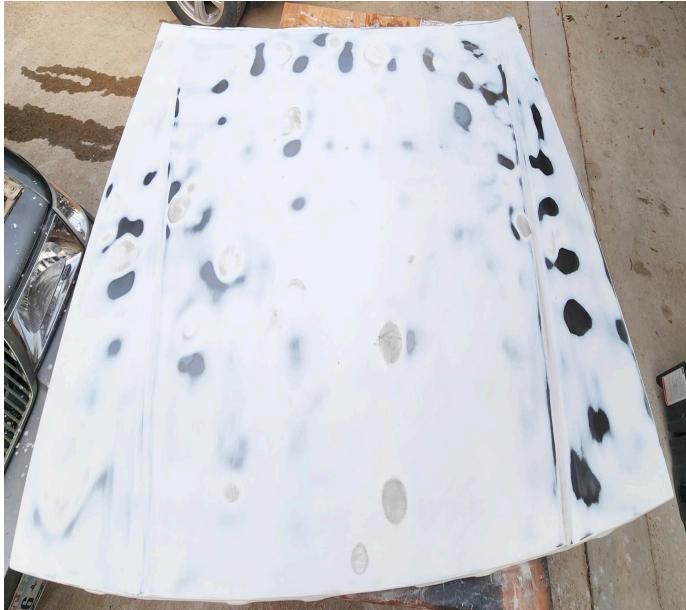
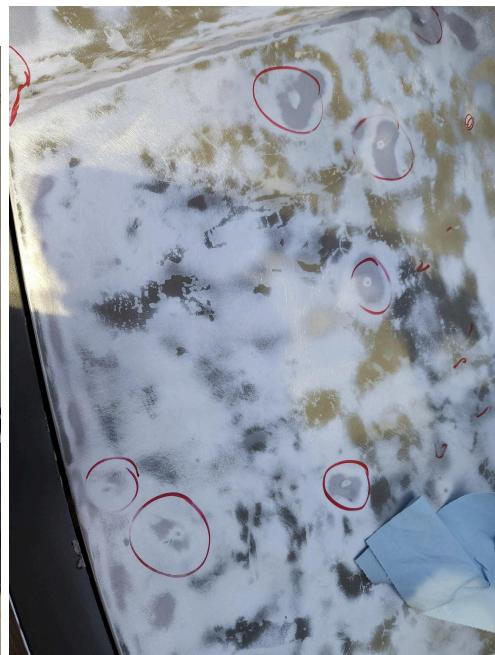
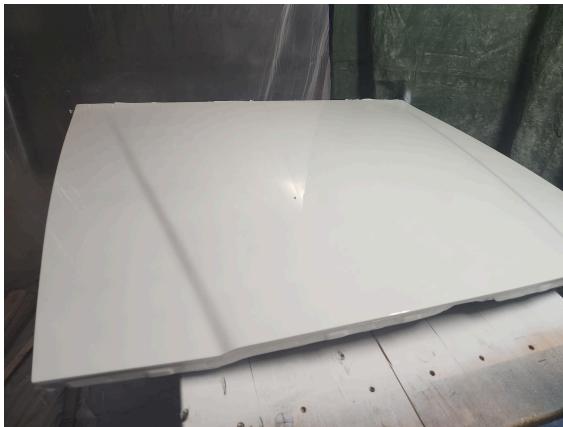
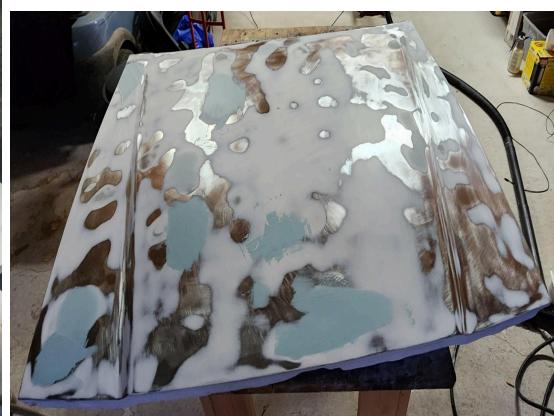
Paint

I painted my car. It took 4 months of working all day 3 days a week. It was much more difficult and took much more time than I expected.

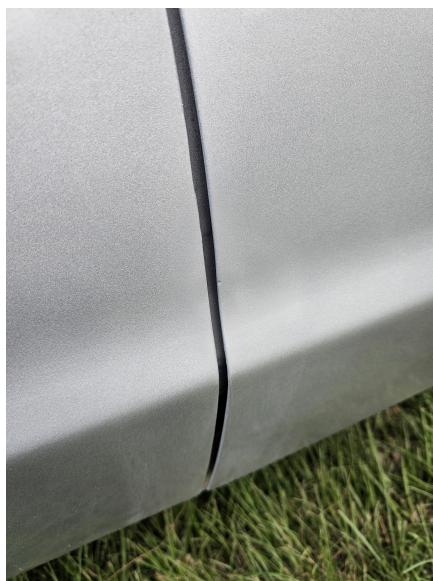
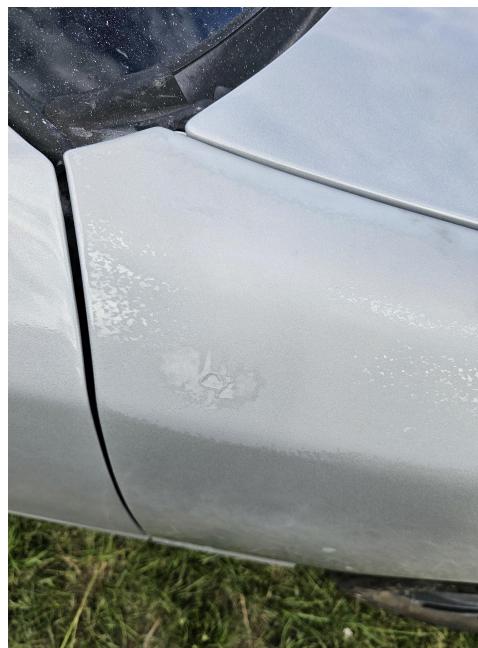
Flaws found in the final stretch to be fixed:

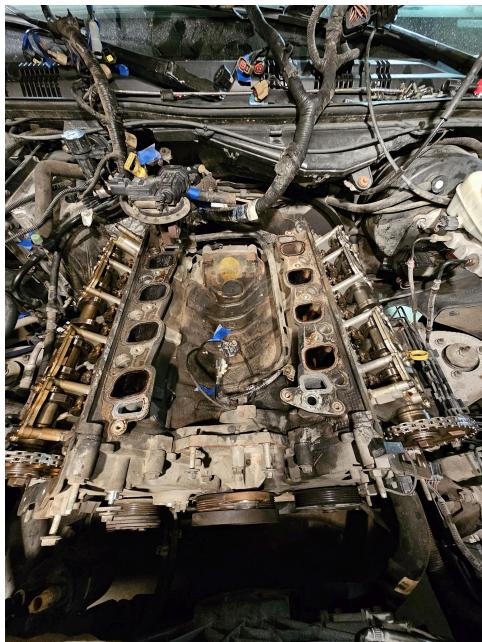
Head Gaskets

I had to replace the head gaskets on my car. I treated this like an opportunity to learn more about engine maintenance, it was a lot of work, a large time commitment, a lot to learn, and I thoroughly enjoyed it.

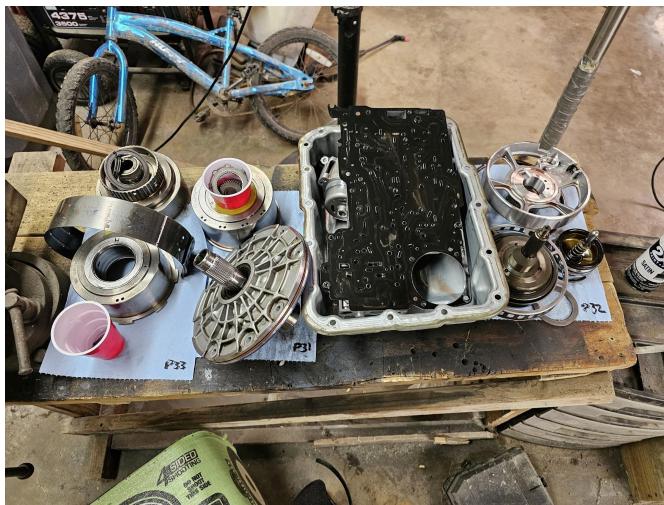
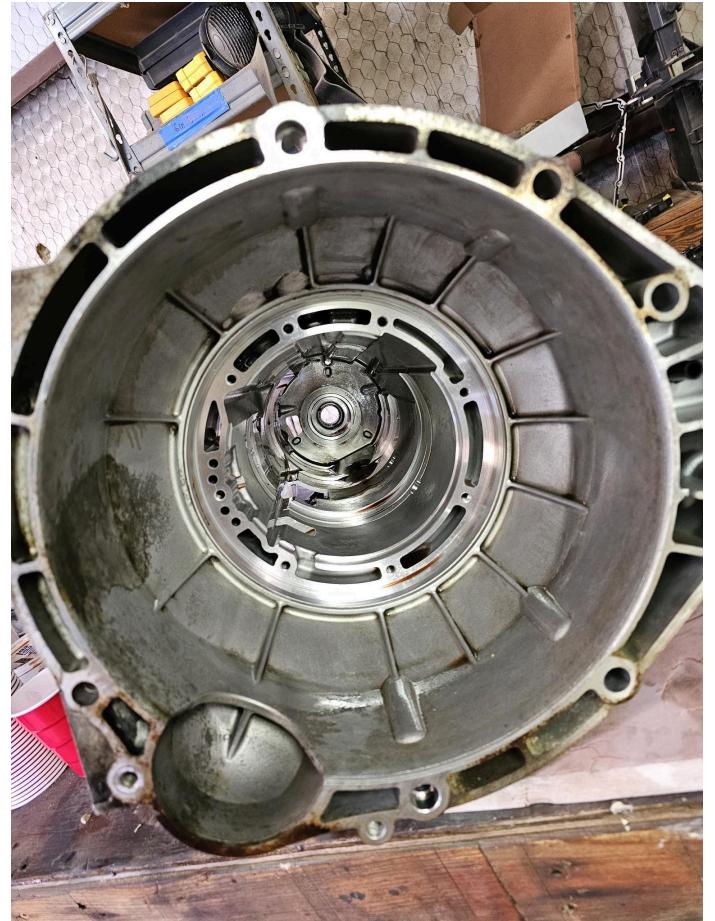
Transmission rebuild

I removed and rebuilt an automatic transmission which did not have reverse, I fixed the problem. I had never done this or anything similar before. It was very overwhelming at the start and I definitely thought I was in over my head, and was concerned I would not be able to recognize the root cause, but I did.

Root cause: Reverse band stretched, unable to constrict and fully constrain reverse drum.
