# Deployment of Aerial Robots after a major fire of an industrial hall with hazardous substances, a report

Abstract—This technical report is about the mission and the experience gained during the reconnaissance of an industrial hall with hazardous substances after a major fire in Berlin. During this operation, only UAVs and cameras were used to obtain information about the site and the building. First, a geo-referenced 3D model of the building was created in order to plan the entry into the hall. Subsequently, the UAVs were used to fly in the heavily damaged interior and take pictures from inside of the hall. A 360° camera mounted under the UAV was used to collect images of the surrounding area especially from sections that were difficult to fly into. Since the collected data set contained similar images as well as blurred images, it was cleaned from non-optimal images using visual SLAM, bundle adjustment and blur detection so that a 3D model and overviews could be calculated. It was shown that the emergency services were not able to extract the necessary information from the 3D model. Therefore, an interactive panorama viewer with links to other 360° images was implemented where

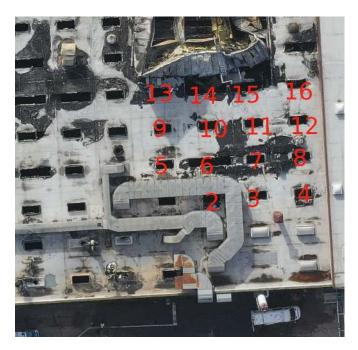
Fig. 6. Overview image after the initial meander mapping flight. The numbers indicate position of penetration points for the UAV (skylight windows) and therefore insight panorama 360 degree images. Bottom right is the position of the RobLW. The position of the operators were first at the RobLW and second at the neighbouring roof starting directly at the right sight of the image. The line at the right side is a wall which separates the halls. The part right from the line was not effected by the fire.

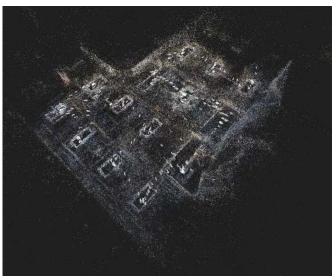
Fig. 8. Semi dense point cloud with localized image position calculated with structure from motion or visual SLAM.

With the blur detection the dataset was reduced to a little more than 200 images and processed with WebODM. WebODM uses OpenSfM [18] to create semi dense point clouds, as shown in Figure 8. This gives an abstract overview of the environment and also localizes the camera positions, which can be used in a 2D viewer. The dense point cloud was created using OpenMVS [19] and provides detailed representation of the environment (figure 9). This detailed representation could be used as an overview to get an overall impression of the situation.

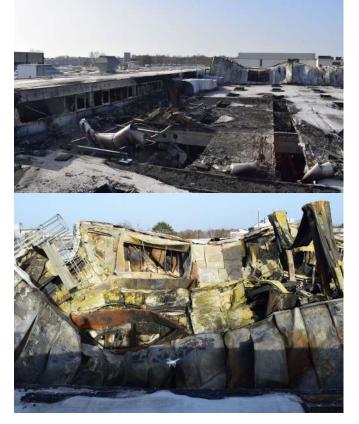
Fig. 11. Detail view of the roof of the industrial hall
