Repeater Technical Variance

Technical Variance No. 132217 Issue 5 Date 23 MAY 2013

Part Description LP TURBINE EXHAUST CASE (TAIL BEARING HOUSING)

TV Title MOUNT LUG FORGING LEADING EDGE INSPECTIONS

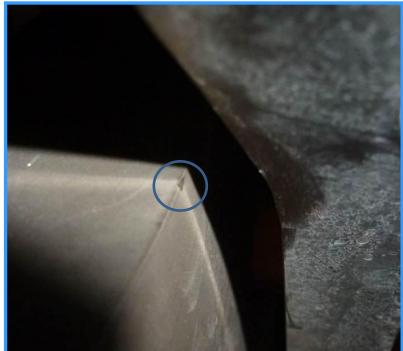
Figure 6 - On Wing - Fail Safe Catcher Damage

ASSESS FOR DAMAGE SIMILAR TO THAT IN FIG.6.

(ii) If Scored, galled, fretted or dented on the centre lug (fail safe lug) front surface:

(1) Not more than 8,00 mm in width and 1,00 mm in depth ACCEPT

(2) More than 2,60 mm in depth REJECT

(3) More than in (1) and less than in (2) REPAIR,

FRS3253 AMM TASK 70-42-11-300-801-A within 100 Flight Cycles
