## **Internship Project Report**

### **Analysis and Identification of Improvement Areas for Wheel Rim Scratches and Surface Damages**

**Name: ROHIT SINGH (23ME8113)**

Institute Name: National Institute of Technology, Durgapur

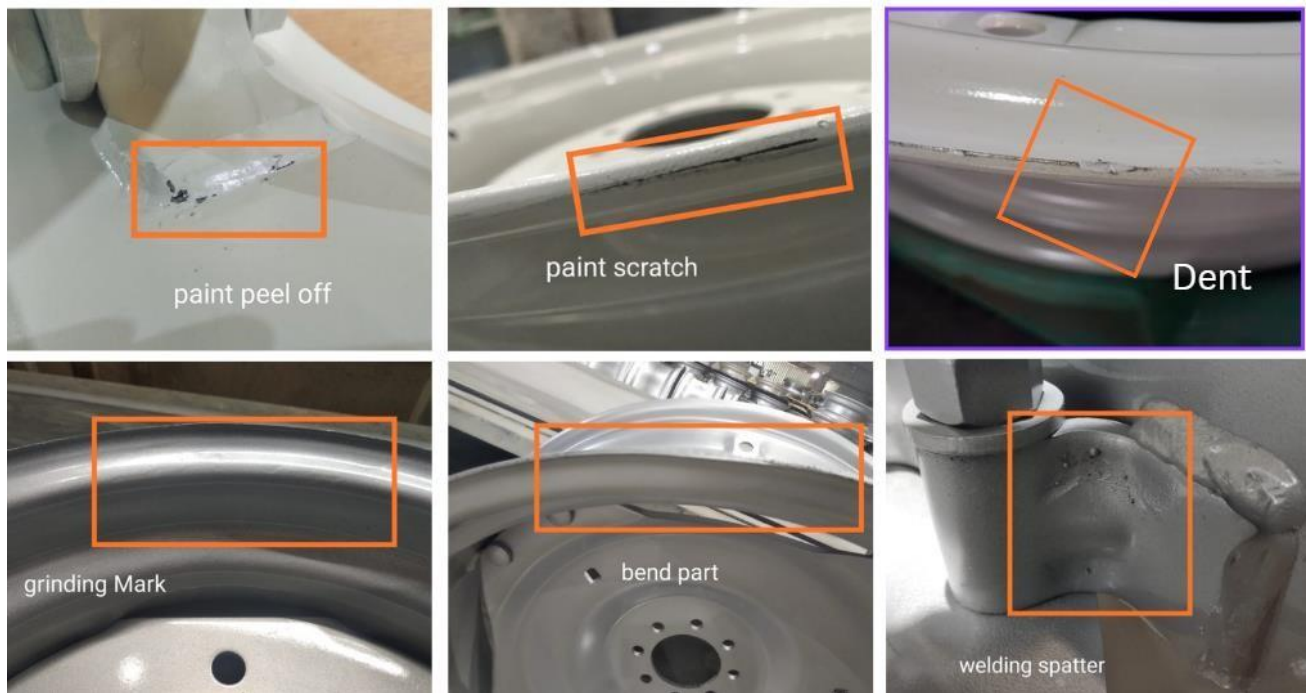
Based on observations during inspection, wheel rim scratches are commonly found at specific locations. These include the outer flange, bead seat area, and regions near the disc-to-rim interface. Scratches can be observed on both the outer and inner surfaces of the wheel rim, indicating exposure to damage at multiple stages of handling and assembly. Such defects are generally identified during final inspection and pre dispatch quality checks.

Since the wheel rim is a heavy component, it is more prone to scratches and damage due to multiple handling, stacking, and assembly operations. Contact with fixtures, tools, and adjacent components during these stages increases the possibility of surface damage, especially when protective measures are inadequate or misaligned. Repetitive manual handling further contributes to inconsistent contact and impact marks.

In addition to paint scratches, other wheel rim defects were also observed, such as welding spatter marks, paint dust, dents, and surface irregularities. Among these, dents were found to occur almost as frequently as paint scratches, indicating mechanical impact as a major contributor to defects. Therefore, this project focuses not only on wheel rim scratches but broadly on wheel rim surface damage and defects, with scratches being the primary defect under detailed analysis.

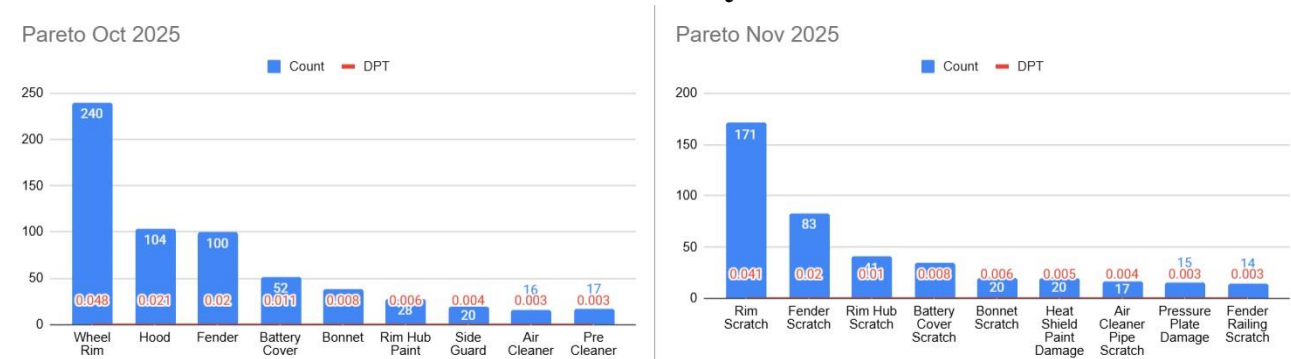
Pareto analysis of QCRI defect data highlights a highly skewed defect distribution, where a limited number of defect categories contribute to the majority of total defects. Statistical comparison shows that scratches and surface damage defects alone contribute the largest share of total DPT.

Component-level Pareto charts for Oct–Nov 2025 show that wheel rim scratches account for the highest defect count and DPT contribution, exceeding other components by a significant margin. In several months, wheel rim defects contribute more than 35–40% of total surface-related defects, clearly identifying them as the dominant issue.

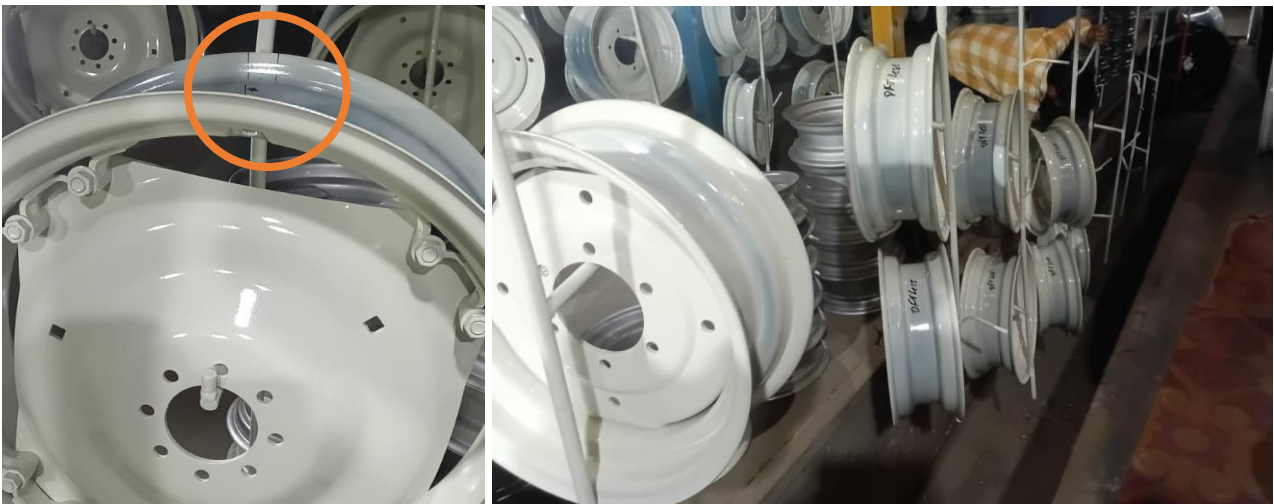
During observation of the paint shop process, it was noted that wheel rims are held using a metal rod inserted from the inner side (C-side) of the rim. While this method supports the rim during painting, it creates a contact zone where paint coverage is not achieved, leading to incomplete coating in that region. This exposed area becomes more vulnerable to scratches during subsequent handling.

Additionally, before the rims are cleared for transportation, they undergo multiple inspection stages where the rims are rotated for visual checking. Continuous rotation while the rim is in contact with hard supports can result in long, continuous scratch marks along the surface. These scratches are not impact-related but are caused by sliding contact during rotation.

It was also observed that after paint touch-up operations, hand impressions are sometimes found on the rim surface. This occurs due to a lack of awareness between consecutive operators, where freshly touched-up rims are handled without adequate curing time or visual indication. This indicates a gap in communication and handling discipline at the paint shop stage.

It is proposed that the paint shop holding method be redesigned so that the rim is supported from the portion where the tyre and tube are mounted. This surface remains completely covered after tyre fitment and is therefore not visible in the final assembled condition.

Although the current scratches occur on the inner (C-side) surface, they still affect perceived quality during inspection stages. Since wheel rim scratches are classified as visual defects rather than functional defects, shifting the holding contact to a nonvisible region can eliminate appearance-related rejections.

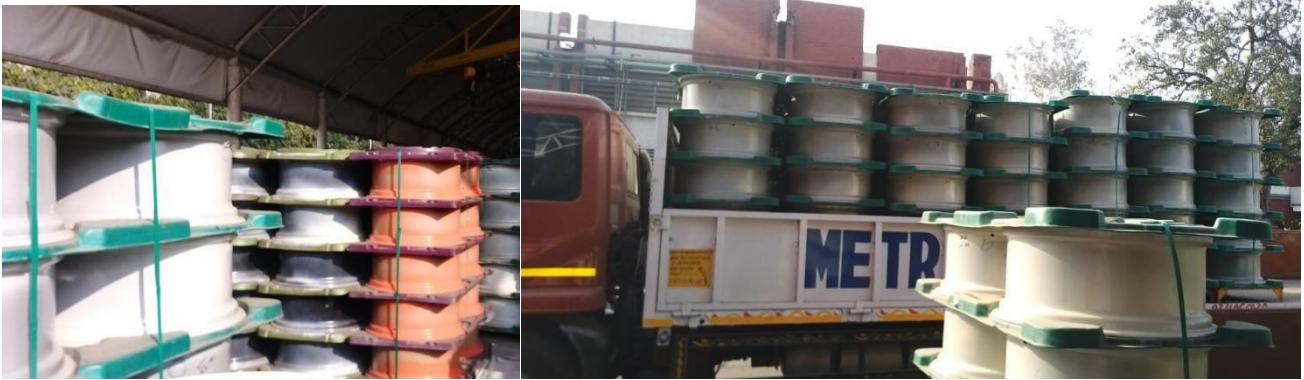
Wheel rims are transported over a distance of approximately 30–40 km, during which they are stacked horizontally one above another with separators placed between adjacent rims. While separators are intended to prevent direct metal-to-metal contact, relative movement during transit can lead to successive friction between the rim and separator surfaces.

Due to road vibrations and dynamic loading, rims experience micro-sliding and intermittent impacts, which can cause both scratches and minor dents. Rims positioned at the bottom of the stack are subjected to higher compressive loads from the upper rims, making them more susceptible to deformation and dent formation.

Additional damage risk is introduced during loading and unloading operations, where impact forces may act on the rim edges. These combined factors make transportation a critical stage for surface damage generation, especially for rims already vulnerable due to partial paint coverage.

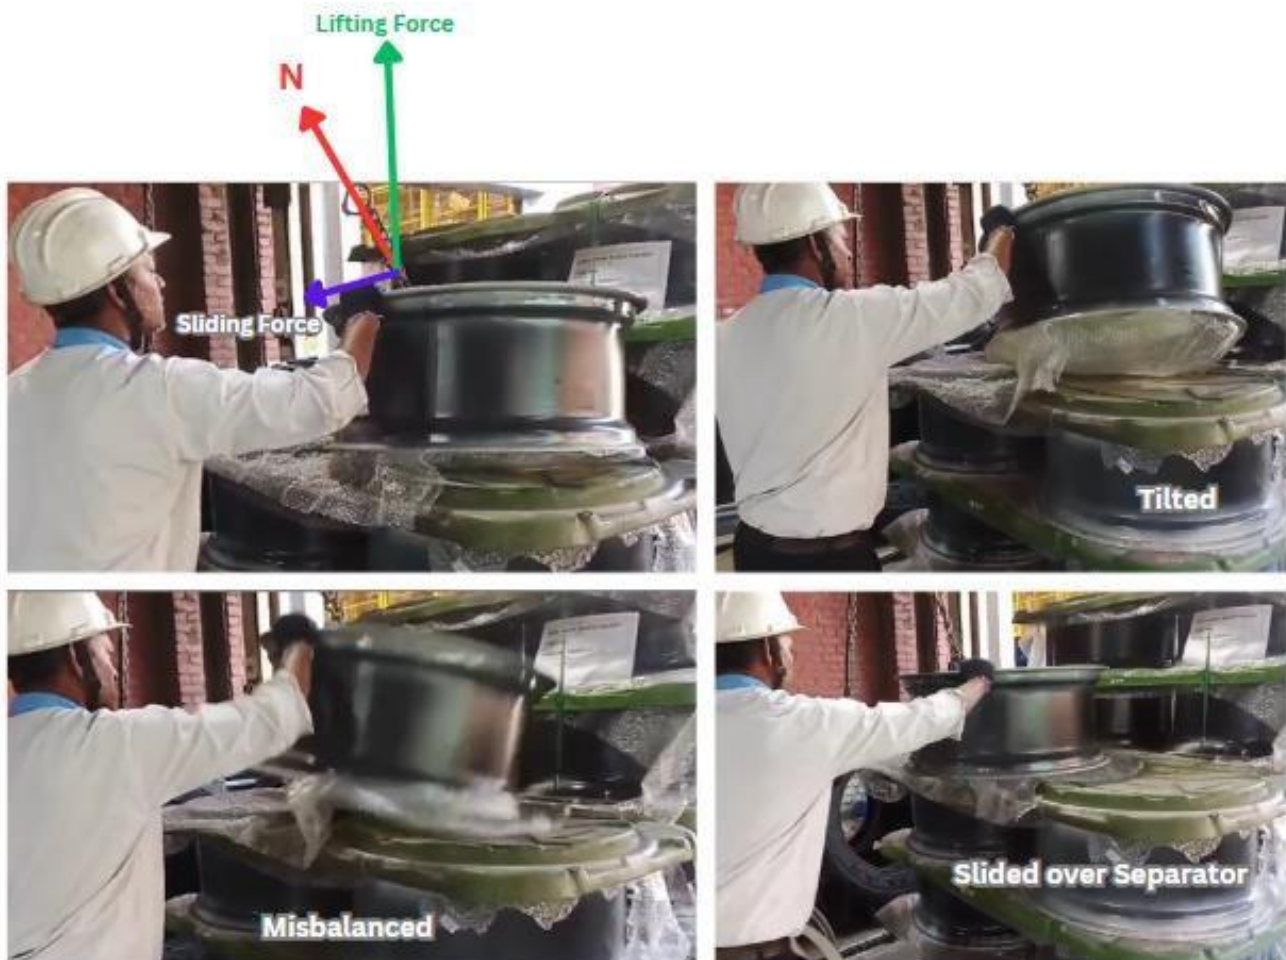
At the tyre fitment sub-assembly stage, it was observed that even rims received in good condition from the supplier and QCRI inspection develop scratches and dents due to improper handling methods. Rims are handled using a small crane, lifting two rims placed side-by-side from a stacked arrangement.

The lifting configuration results in a net unbalanced reaction force acting parallel to the sub-assembly direction. Due to this imbalance, the rim tends to shift laterally during

It was also noted that handling precision at this stage is inconsistent, and rims are not always guided carefully during lifting and placement. This increases the likelihood of accidental contact and damage, making this stage highly prone to scratch and dent formation.

After stable lifting, the rim can then be safely transferred to the wheel assembly area, reducing scratch generation at one of the most critical defect-prone stages.

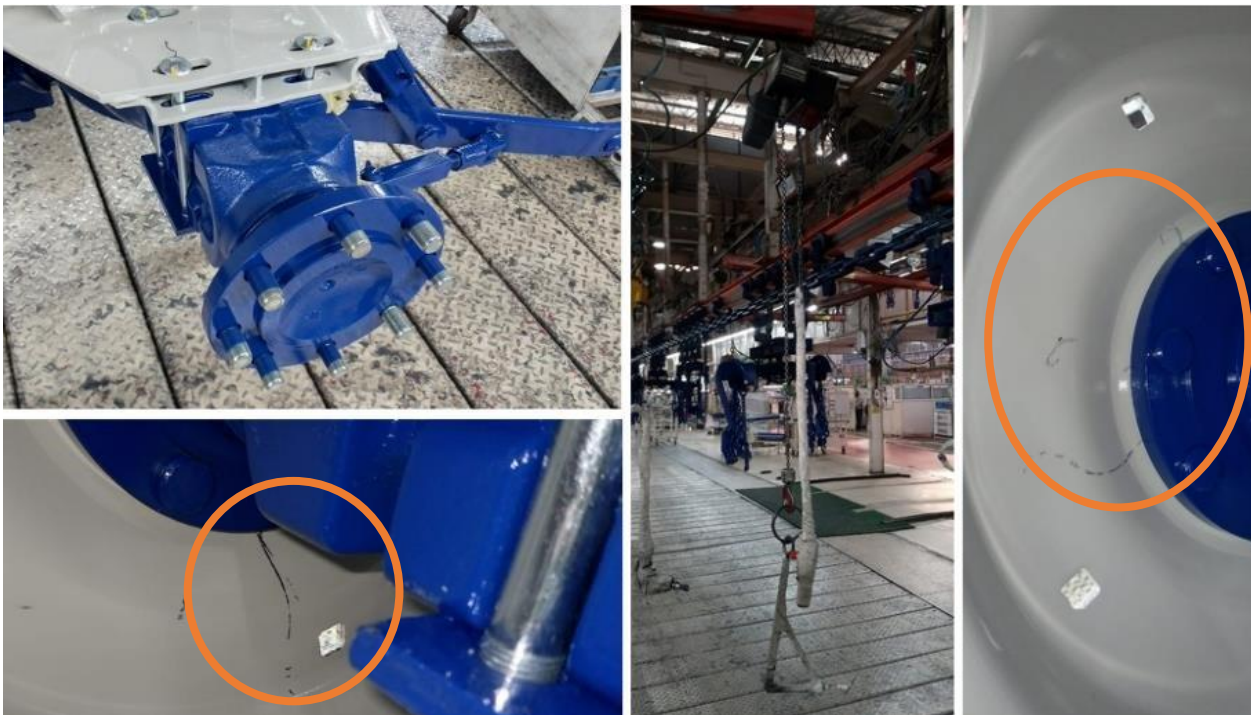
As the tilted rim is brought closer to the hub, the inner surface of the rim comes into contact with hub bolts or studs. This unintended contact leads to scratches on the inner side of the wheel, which are difficult to detect at early stages and are often identified only during later inspections.

This issue is primarily caused by lack of alignment control during crane-assisted positioning and absence of guiding mechanisms to prevent tilt. As a result, this stage contributes significantly to inner-surface scratches despite the rim being in acceptable condition prior to assembly.

In this approach, the wheel can be rolled from storage onto a small hand-drawn lifter. The wheel is then oriented parallel to the hub face and lifted vertically using a jack mechanism. This controlled motion minimizes tilt and prevents contact between the rim inner surface and hub bolts.

Although the initial investment for such equipment may be higher, the approach offers long-term benefits through substantial reduction in rim scratches, dents, rework, and DPT, making it a high-impact quality improvement opportunity.
