# SolarSight AI

## Official Maintenance & Inspection Report

Inspection ID: 573dab34...af01

Date: May 09, 2026 - 06:09:24

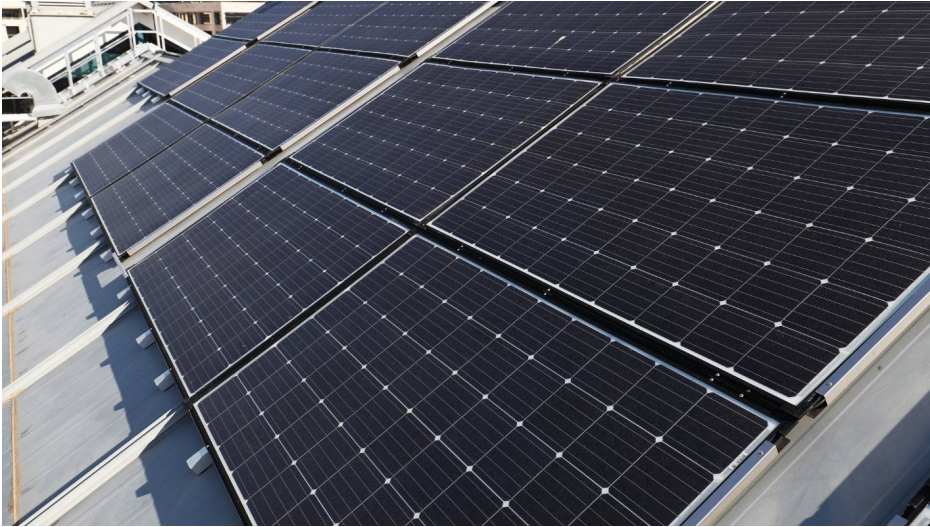
- Hotspot (96% confidence) at Unknown Panel Location
- Micro-crack (44% confidence) at Unknown Panel Location
- Micro-crack (68% confidence) at Unknown Panel Location
