# ROOFSCAN UK

Drone Roof Inspection Report

12 Ocean Drive, Brighton, BN1 4ZZ

Report ref: RS-2026-0142 - Inspection date: 14 June 2026 - Delivered: 16 June 2026

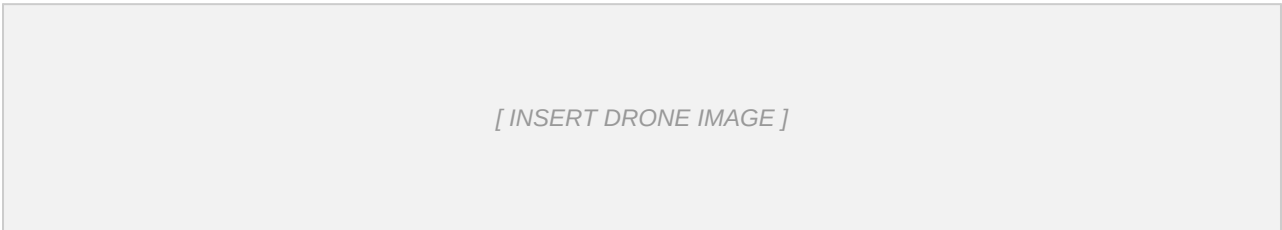
### 2.1 Ridge and hip tiles

**Observation:** Ridge line secure, no displaced or missing tiles observed.

**Priority:** Satisfactory

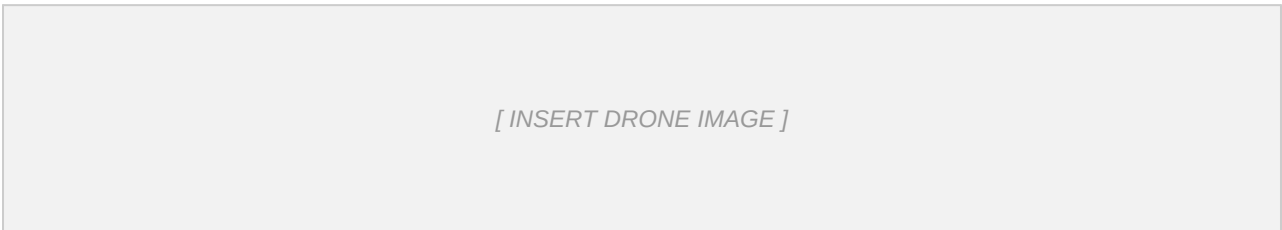
### 2.2 Main tile field

REPAIR  
REQUIRED

**Observation:** Approximately 6 cracked tiles on the rear (north-facing) slope, likely storm damage. Recommend replacement before winter.

**Priority:** Repair required

| Priority | Item | Recommendation |
|---|---|---|
| High | 2.2 Main tile field | Replace ~6 cracked tiles on rear slope before winter. |

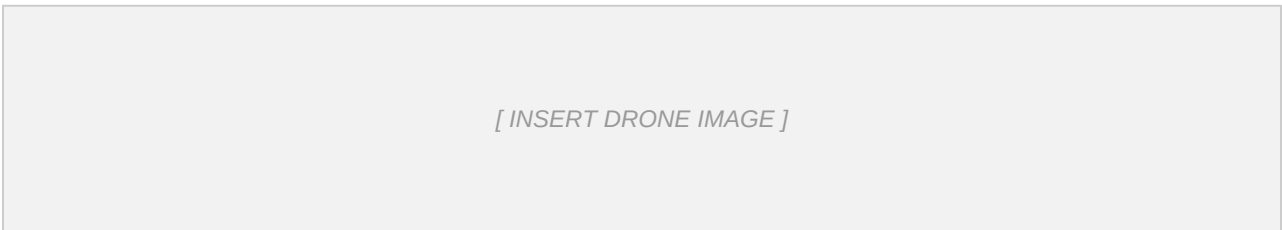
### 2.3 Valleys

**Observation:** Valley gutters clear and correctly laid.

**Priority:** Satisfactory

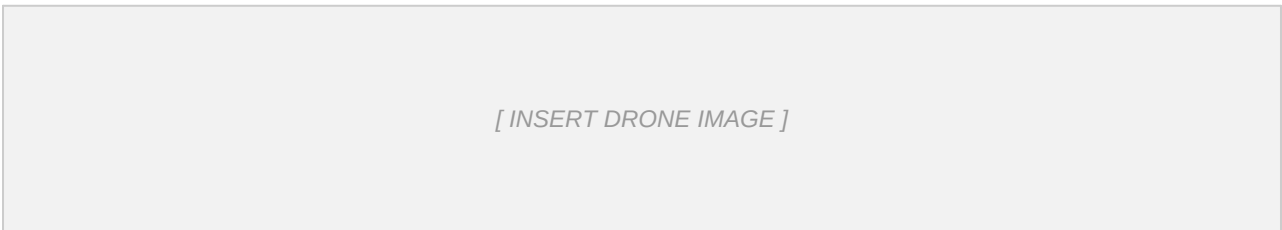
### 3.1 Gutters

MONITOR

**Observation:** Slight sagging to the rear gutter run, likely a loose bracket. Recommend a trade follow-up.

**Priority:** Monitor

| Priority | Item | Recommendation |
|---|---|---|
| Medium | 3.1 Rear gutter run | Secure loose bracket causing slight sag. |

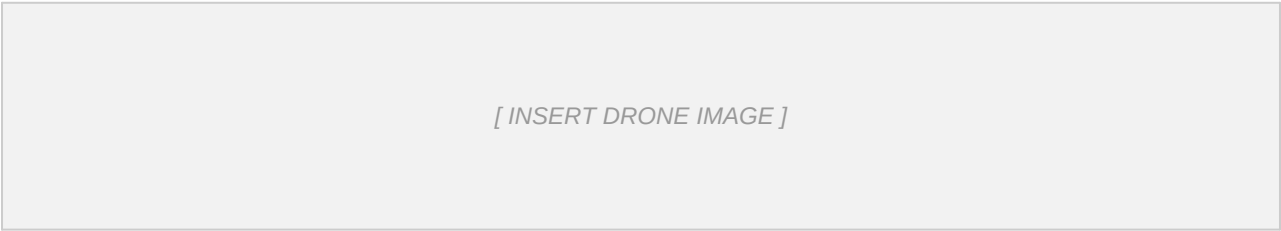
3.2 Downpipes

**Observation:** All downpipes secure and draining correctly.  
**Priority:** Satisfactory

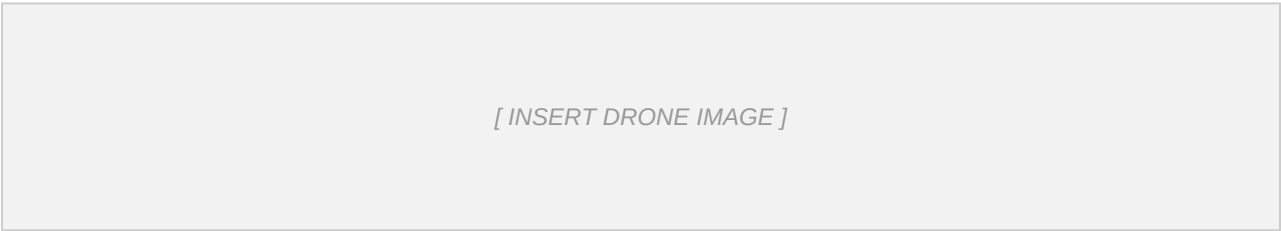
4.2 Aerials and fixtures

**Observation:** TV aerial mount is secure with no visible movement.  
**Priority:** Satisfactory
