The building/business chosen to be bought and taken over by CL is The Esslemont Bar & Restaurant, located at 38 Union Street, Aberdeen, AB10 1BD (1).

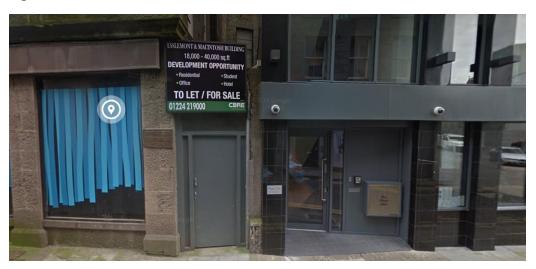
Figure 6: Northern wall back door

We can see that two of these doors have a lock. It is unclear what type of lock is on the backfire escape, however we can see the lock on the back door. It is a CodeLocks 155 Mortice Latch, an entry level mechanical push lock for "light duty entry control" (5).

This attack is going to exploit the back doors of the building to get into the restaurant. The lock is a CodeLocks 155 Mortice Latch, and with research, a video bypassing the locks has been found **(6)**. Restaurants require morning deliveries of fresh food every day meaning there is a high likelihood that a back door will be open to allow these deliveries to be made, which our penetration tester could exploit to gain access without having to bypass locks.

In terms of countermeasures, It would e recommended to change locks to more heavy duty, outdoor solution, the current locks installed are mainly meant for indoor purposes, that could easily be broken by someone with intent. Secondly, there does not appear to be any CTTV watching the doors, allowing attackers to have more confidence, installing CCTV would act as a deterrent to potential attackers.
