LEVEL 1

# Your survey report

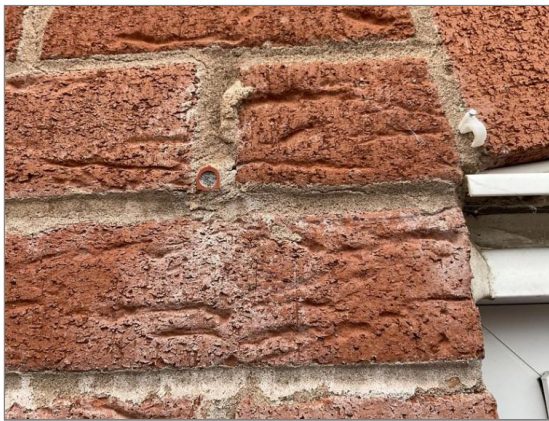
Condition Rating 2. The element has defects that need repairing or replacing, but are not considered to be either serious or urgent. This element must also be maintained in the normal way. You should follow the advice given in Section K - 'What to do now'.

*Photo - 2 Blocked weep holes*

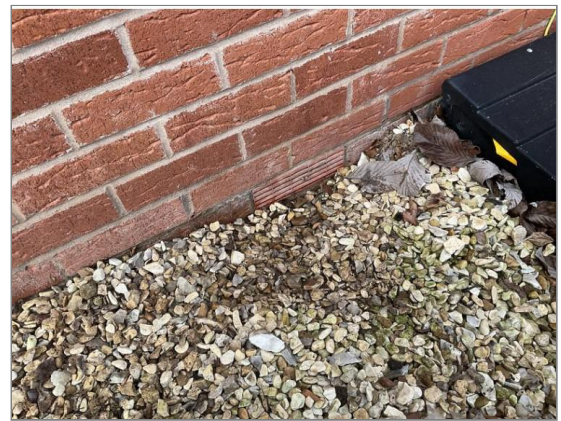
*Photo - 3 High ground levels and partially blocked air vents.*

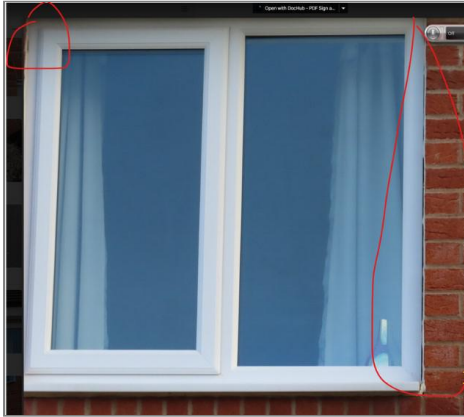
The seals around the outside of the frame on one of the rear windows is defective and peeling away from the brickwork.

Condition Rating 2. The element has defects that need repairing or replacing, but are not considered to be either serious or urgent. This element must also be maintained in the normal way. You should follow the advice given in Section K - 'What to do now'.

Photo - 4 Mastic sealant peeling from around the frame.

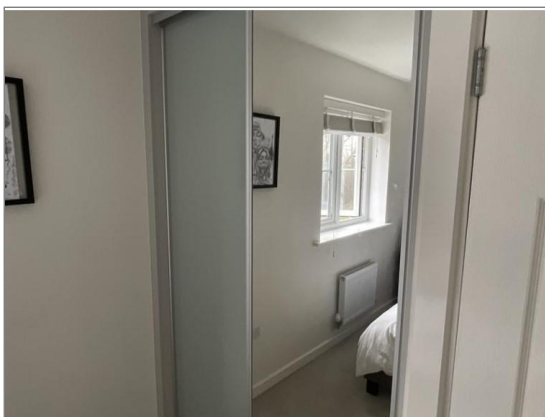
There are flimsy mirrored sliding doors to the wardrobes in the front bedroom. There are no visible safety markings to the glazed doors. This is a potential safety hazard to persons (See section I3).

Condition Rating 3. The element has defects that are serious and/or need to be repaired, replaced or investigated urgently. You should follow the advice given in Section K - 'What to do now'.

Photo - 5 No safety markings to glazed doors.

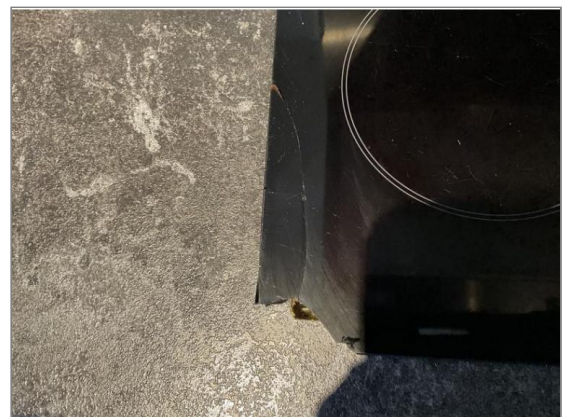
The cooker hob plate is damaged on one corner of the hob, which has exposed a part of the work surface underneath. The damaged hob is a safety risk to persons (See Section I3).

Photo - 6 Broken glass hob plate.

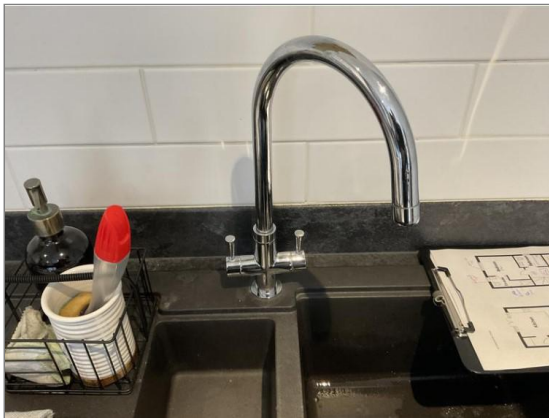
The mixer tap in the Kitchen was dripping during the inspection and the tap was loose from the sink.

*Photo - 7 Loose mixer tap*

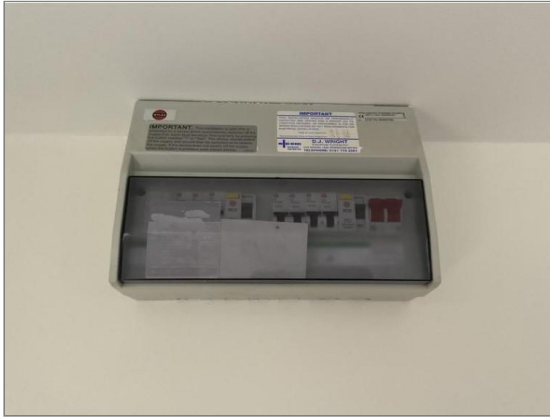
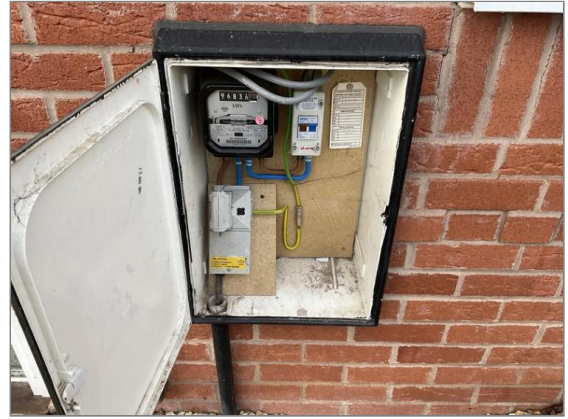
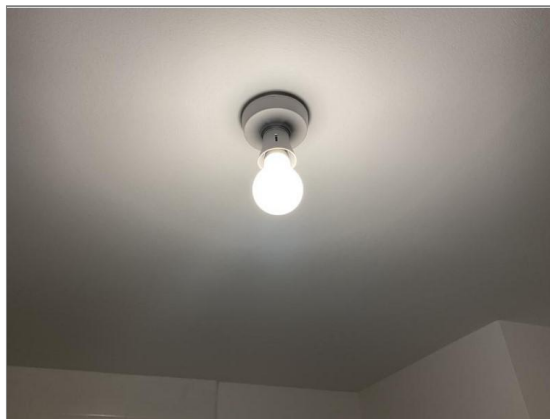
The electrical installation appears satisfactory with no obvious visual defects, but much is hidden from view. As such systems require specialist knowledge, I cannot comment on its serviceability or safety.

There is no recent (within the last 12 months) test certificate available for this electrical installation. This is a risk to the building and people and I refer you to my comments in section I. You should therefore obtain a precautionary circuit test from an NICEIC or similar registered electrician and follow their recommendations as to any upgrading/improvements required. Any works required should be carried out before use or occupation.

Condition Rating 3. The element has defects that are serious and/or need to be repaired, replaced or investigated urgently. You should follow the advice given in Section K - 'What to do now'.

Photo - 8 Consumer unit

Photo - 9 Meter

Photo - 10 Bathroom light fitting.

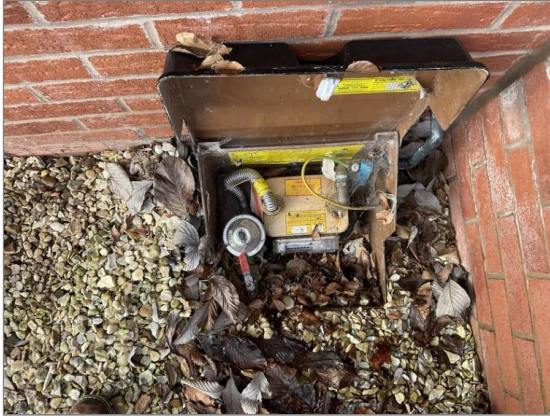
The gas meter cupboard has debris in it which includes leaves and gravel.

Condition Rating 3. The element has defects that are serious and/or need to be repaired, replaced or investigated urgently. You should follow the advice given in Section K - 'What to do now'.

Photo - 11 Gas meter
