Level 2

# Your survey report

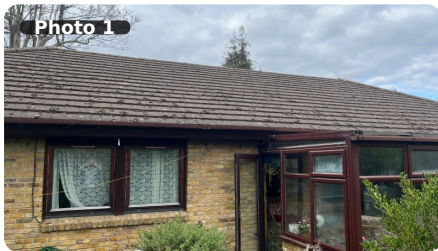
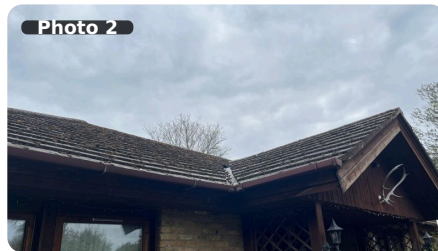
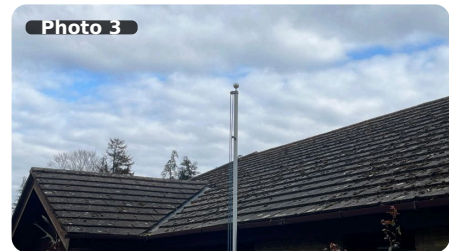
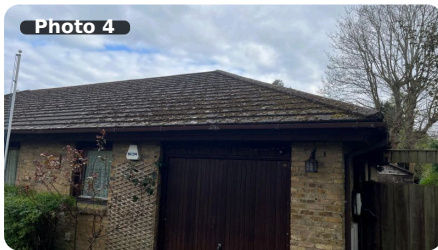
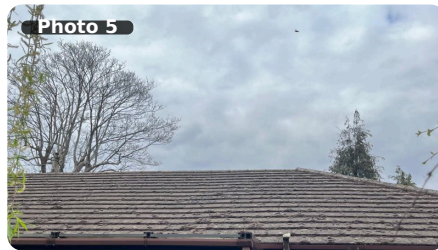
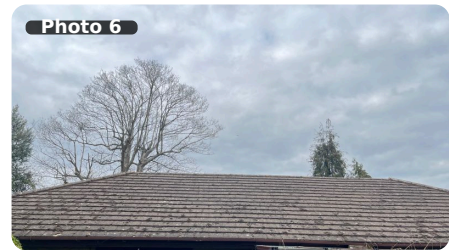
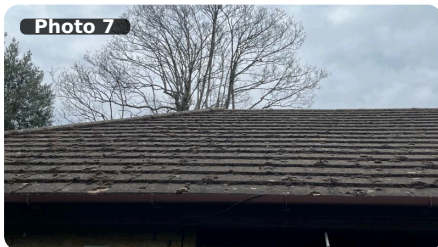
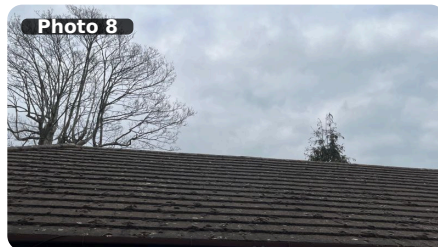
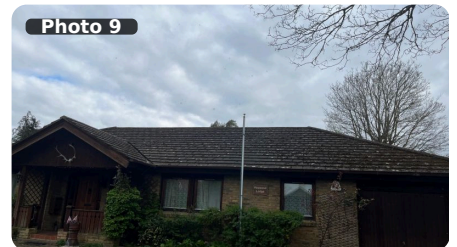
The property was observed to have uPVC rainwater gutters and downpipes serving the main pitched roof to the front, side and rear elevations, together with the gable porch roof and the conservatory roof. The visible rainwater goods appeared to be of conventional domestic form and were inspected from ground level only. Some downpipe bases were concealed below surface level and therefore the below ground gullies could not be inspected.

The rainwater goods showed signs of general weathering and exposure, with water staining visible at a number of gutter joints, together with localised debris, algae, lichen and vegetation growth, particularly around the porch area and at some downpipe penetrations. Limited access was available to the left hand front downpipe due to stored household items, and concealed terminations at ground level prevented confirmation of the condition of associated gullies. No active leakage was seen at the time of inspection, although no water test was undertaken and the visible staining indicates that some joints may have overflowed or discharged imperfectly at times.

The rainwater goods should be cleaned and maintained, with debris, moss and vegetation removed from gutters, outlets and surrounding penetrations, and joints monitored and repaired where necessary to prevent leakage or overflow. Any concealed gullies should be cleared and checked as part of routine maintenance. As the inspection was limited to a visual assessment from ground level only, and some areas were obstructed or below ground, hidden defects cannot be ruled out and further attention should be given if overflow, blockage or dampness becomes evident in use.

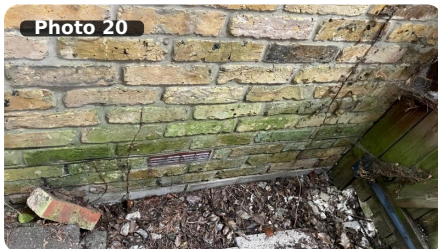
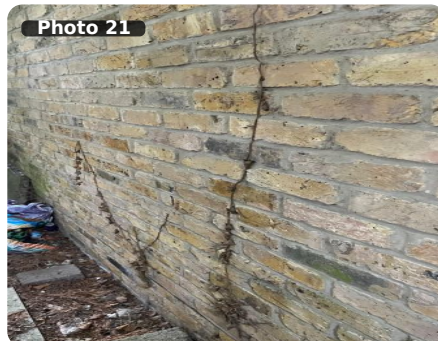
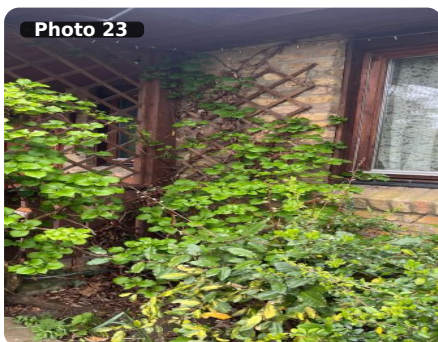
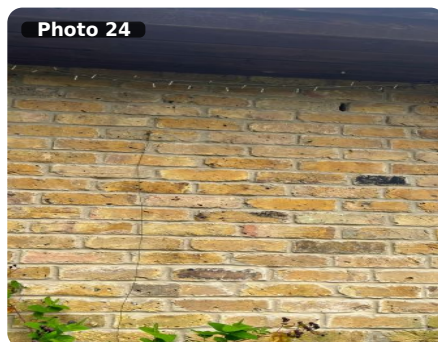
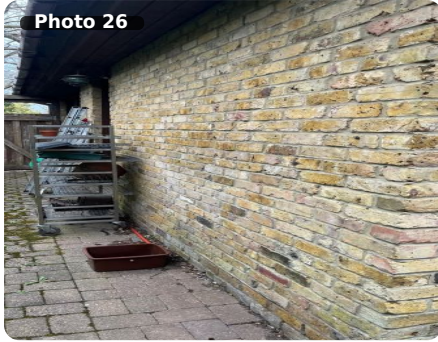
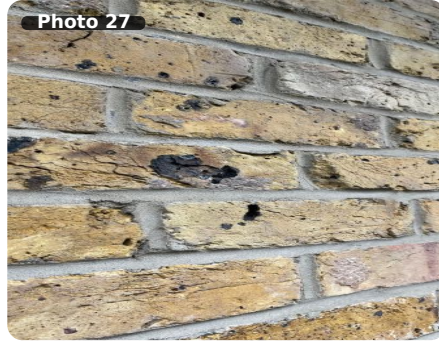
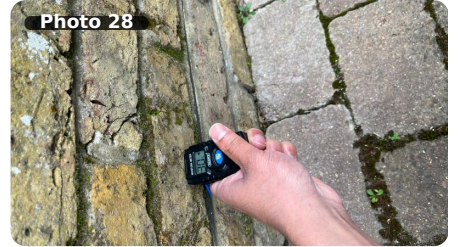
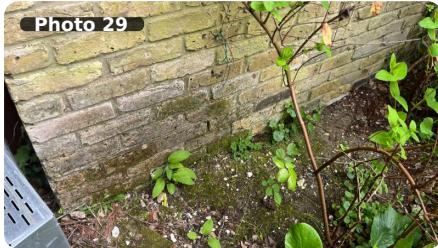
The windows were generally in fair condition overall, but a number of defects were noted. These included widespread mould growth around frame to glass junctions to the lounge and utility windows, with more localised mould growth to bedroom and bathroom windows. The front lounge glazing appeared faded, and several internal timber frames showed wear and tear, including powdery surface staining, minor decay and deterioration, particularly to the bathroom, bedroom 3 and utility room windows. Minor scratches to ironmongery were also noted. In the ensuite bathroom, an exposed gap was visible due to failed sealant at the window frame junction, and externally there were signs of weathering, dust, cobweb accumulation, peeling paint to the rear metal apron, and some opening at frame to wall junctions.

The property was observed to have timber framed double glazed windows of mainly awning style installed throughout. Inspection was limited, as a number of the windows were locked and some were partly obstructed by stored items, and therefore full comment cannot be made on operation or complete serviceability. Externally, the windows include metal aprons in places, and internal inspection was limited to the accessible areas only.

Repairs and maintenance are required, including removal of mould, renewal of defective sealant, overhaul and redecoration of weathered timber, and repair of any localised decay before deterioration progresses. External cleaning and routine maintenance should also be undertaken, and the faded lounge glazing may require replacement if performance or appearance is adversely affected. As many windows were locked or obstructed at the time of inspection, full operation could not be confirmed and concealed defects cannot be ruled out; the windows should therefore be checked fully and any defective components repaired as necessary.

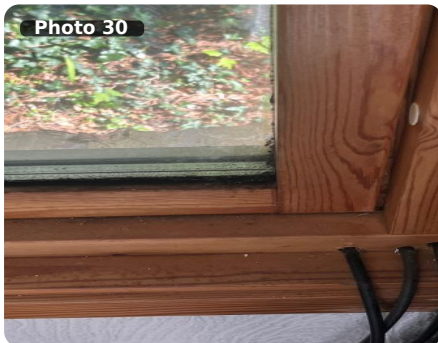
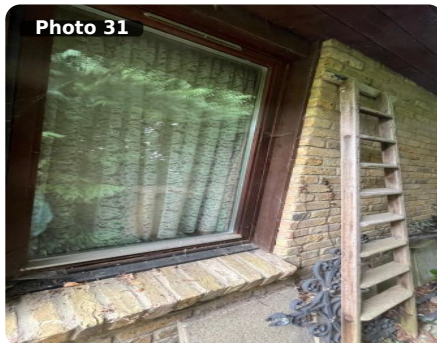
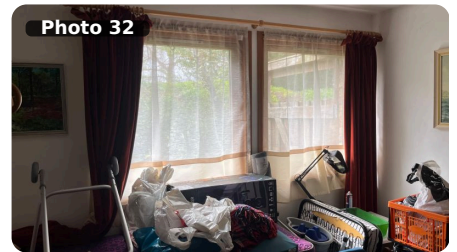
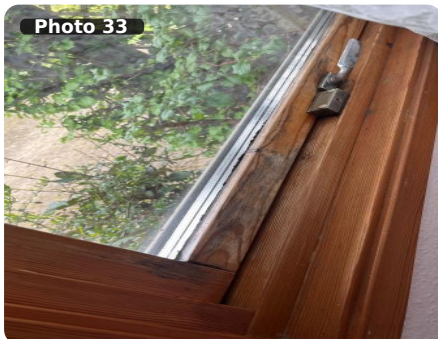
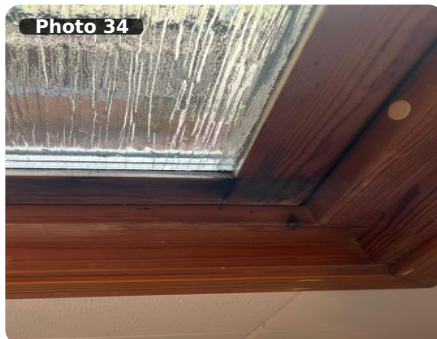
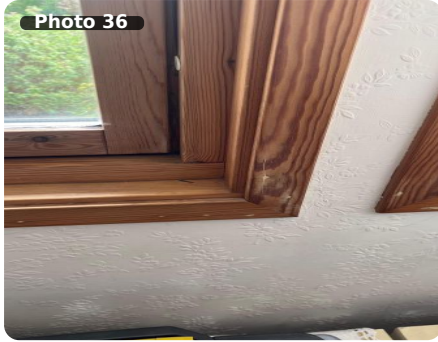
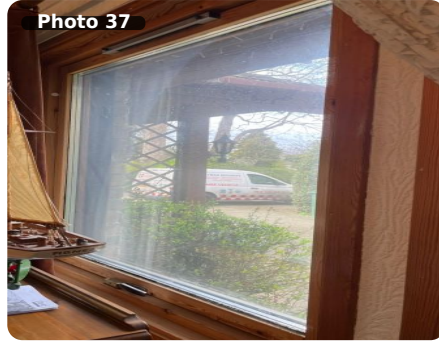
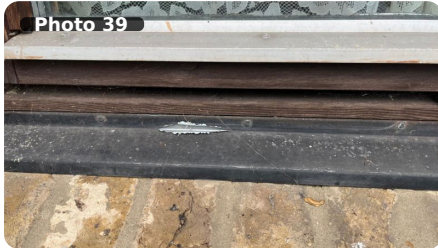
The property was observed to have timber external doors with associated ironmongery, including the main entrance door at the front elevation, timber access doors to the side alleyways, a timber door from bedroom 3 to the side passage, and a large timber-framed glazed sliding patio door providing access from the lounge to the rear garden. Inspection was limited in a number of areas, as some doors were locked and others had restricted access due to stored items.

The main entrance door was operational and capable of locking at the time of inspection, although the timber threshold and door frame at head level showed general weathering. The side access doors showed deterioration associated with exposure, including algae growth, weathered timber surfaces and rusting to ironmongery, and full comment on operation could not be made due to restricted access and locked positions. The sliding patio door and associated frame showed general wear and tear, with weathering to timber surfaces, peeling finish to the threshold metalwork, and an exposed gap at the frame-to-wall junction externally. The bedroom 3 external door also showed general weathering to the timber surfaces, peeling finish to the threshold metalwork and was locked.

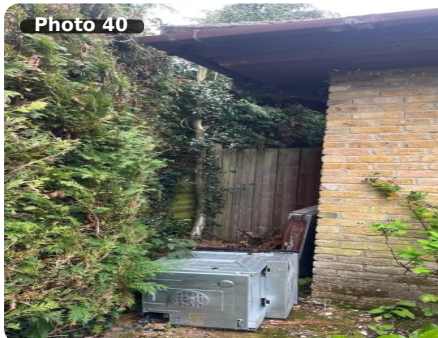
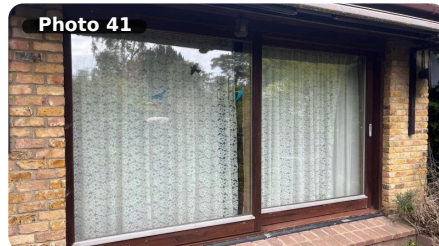
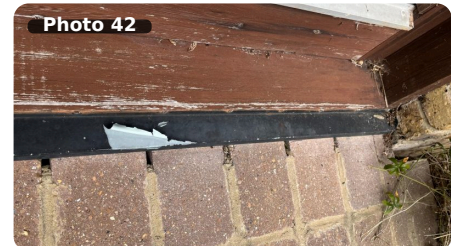
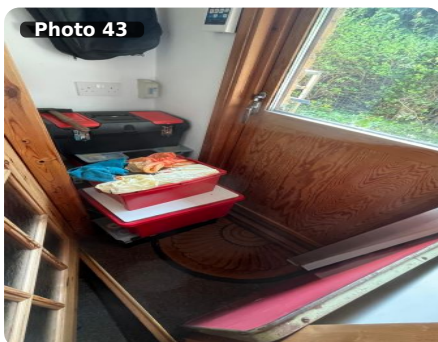
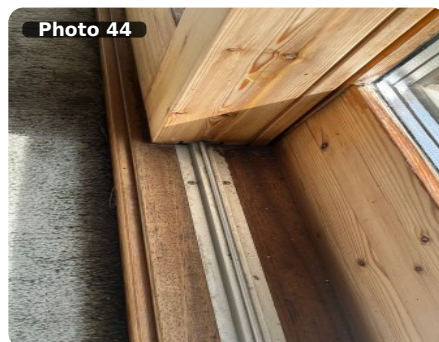
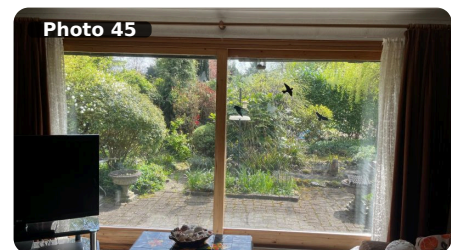
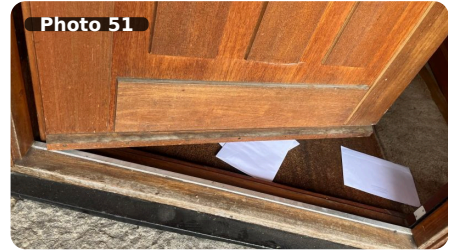
### Condition Rating 2.

Repairs and maintenance are required to the external doors, including cleaning, overhaul of ironmongery, repair and redecoration of weathered timber surfaces, renewal of defective sealant or open joints, and attention to deteriorated threshold finishes. The side access doors should be checked fully once access is available, and any defective components repaired or replaced as necessary. As several doors were locked or obstructed at the time of inspection, full operation and weather tightness could not be confirmed, and concealed defects cannot be ruled out.

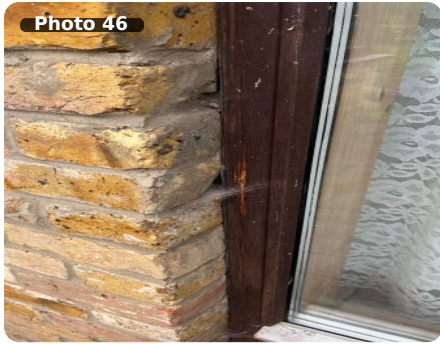
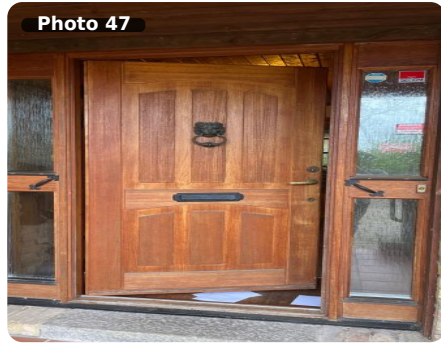
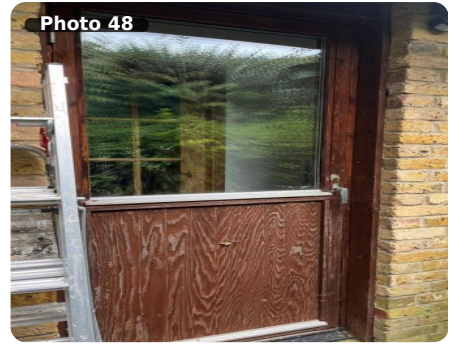
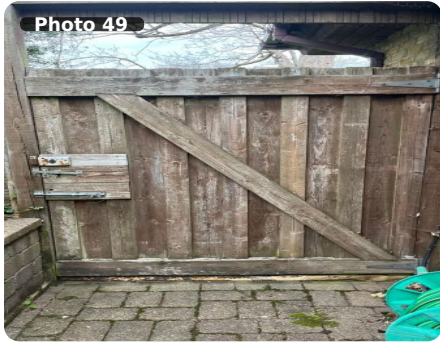
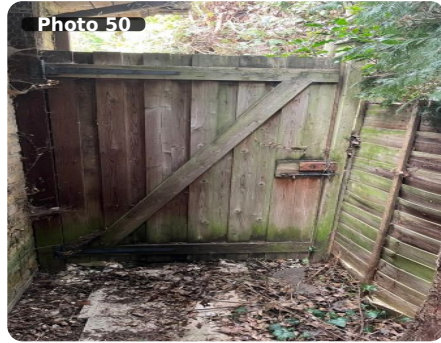
The property was observed to have a traditional front porch to the front elevation, formed in a combination of timber construction with low level brickwork, together with a rear conservatory accessed from the kitchen. The porch incorporates a gable form timber feature, timber ceiling, side supports and decorative timber detailing, with tiled floor finishes. The conservatory is of mixed construction comprising timber framed double glazed windows and doors over low level brick parapet walls, with a translucent glazed roof and a section of plastered solid ceiling continued from the kitchen, together with laminate floor finishes.

The porch and conservatory showed a number of defects and were in below average condition overall. The porch timberwork showed general weathering, staining, algae growth and poor surface finish, and the exposed electrical conduit was unevenly fixed beneath the timber ceiling. The associated brickwork showed cracking, efflorescence and localised mortar failure. Within the conservatory, the timber cills and internal timber trims showed deterioration and peeling finishes, and the door thresholds showed localised algae growth and accumulated debris. The glazed roof coverings showed moss growth, and the plastered ceiling section showed paint bubbling and slight hairline cracking. The low level conservatory brickwork showed cracking, efflorescence, failed mortar joints and a missing brick near the right hand door. Condensation was noted within sealed double glazed units, indicating failure of the glazing. No evidence of active water ingress was noted at the time of inspection; however, the condition of the roof coverings and internal finishes suggests the potential for moisture penetration over time.

Repairs are required without delay. These should include overhaul and repair of the porch and conservatory timber elements, renewal of defective trims and decayed sections, repointing and localised rebuilding to defective brickwork, replacement of failed double glazed units, and cleaning and treatment of moss and organic growth. The roof coverings and junctions should be inspected and maintained to reduce the risk of future water ingress. Internal finishes affected by deterioration should be repaired following completion of external works. A competent contractor should be instructed to undertake all necessary remedial works.

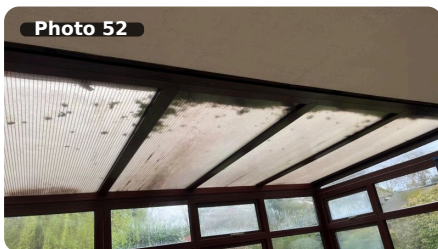
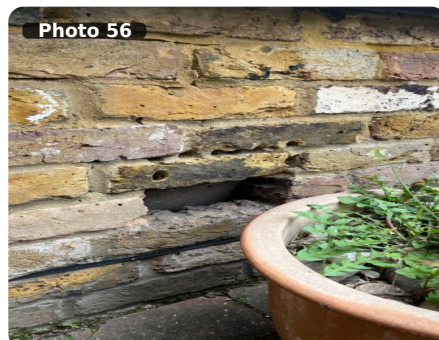
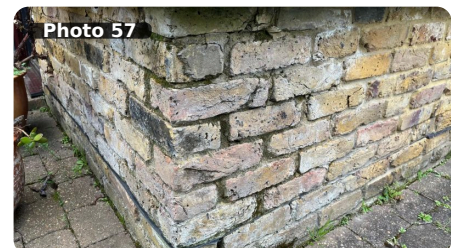
### Condition Rating 3.

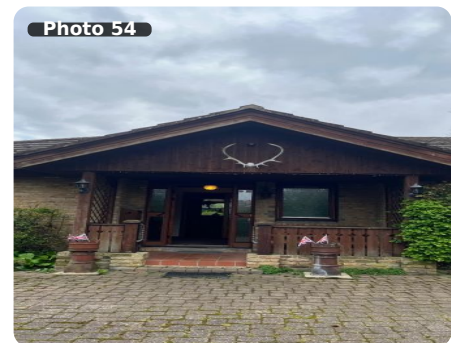
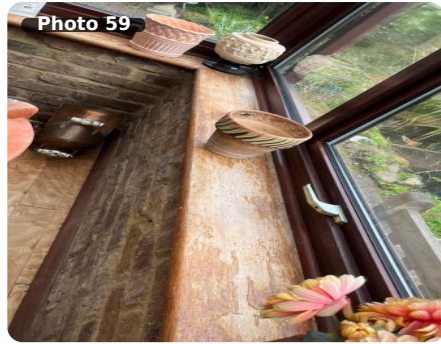
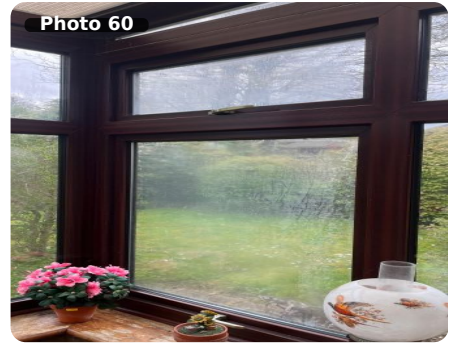
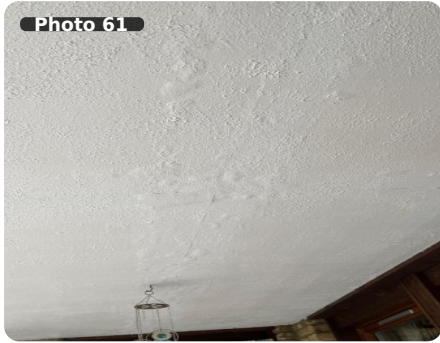
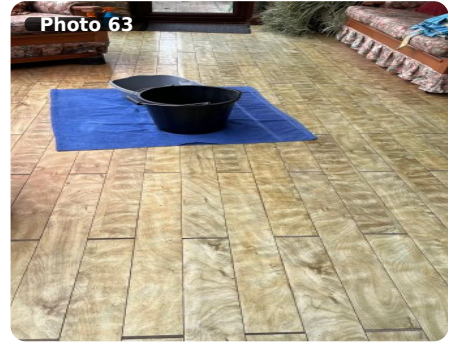
The property was observed to have timber fascia and soffit boards fitted throughout the main roof edges. These elements were inspected from ground level and from accessible surrounding areas only. A metal awning was also noted to the rear elevation at the external lounge area, fixed to the fascia line, although this was not tested and no comment can therefore be made on its operation or serviceability.

The fascia and soffit boards were generally in fair to reasonable condition overall, but showed a number of defects associated with age, weathering and exposure. These included surface staining, dirt accumulation, localised peeling finishes, open joints, exposed gaps, and deterioration to some timber support ends, particularly at rear elevation corners. A pipe penetration was also noted through the rear soffit. The rear awning showed weathering, with lichen growth to the surface and rusting evident to the metal support hinges and fixings.

Repairs and routine maintenance are required, including localised repair or replacement of deteriorated timber sections, sealing of open joints and gaps, and redecoration of exposed timber surfaces to protect against further weathering. The pipe penetration through the soffit should be properly sealed and checked. The rear awning and associated fixings should be inspected by a competent contractor and maintained as necessary, particularly where corrosion is evident. As inspection was visual only and no testing was undertaken, concealed defects cannot be ruled out.

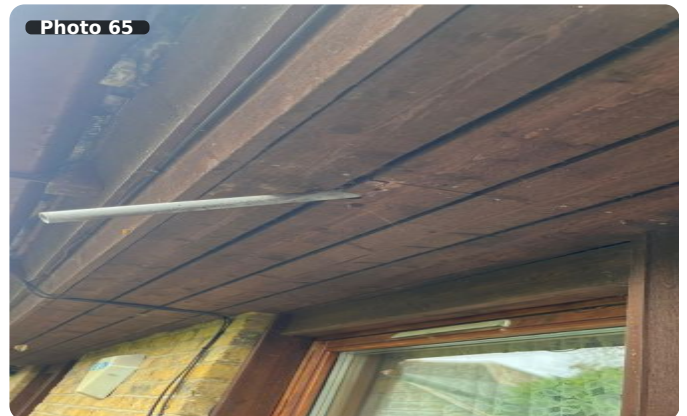
#### **Condition Rating 2.**

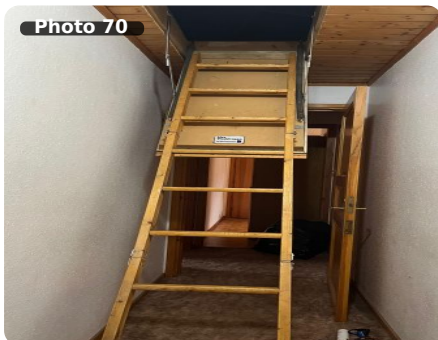
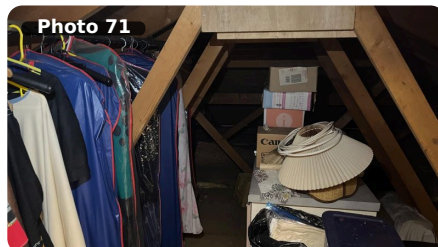
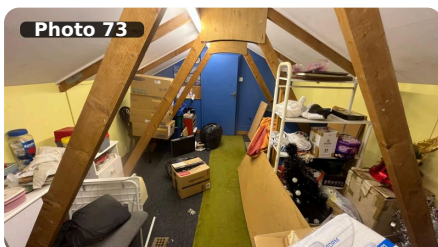
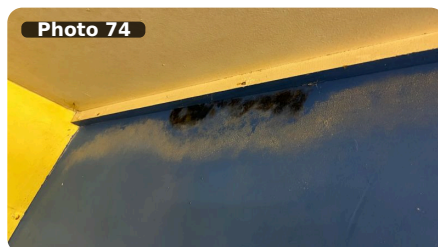
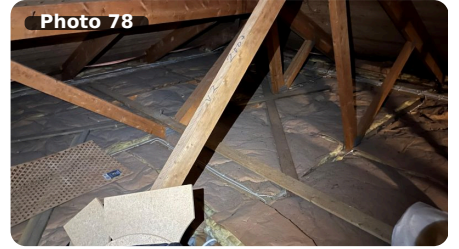
The property was observed to have loft access from the joinery section via a fitted timber loft ladder, which was operational at the time of inspection. A light fitting was present and functioning. The loft space was noted to be divided into three sections. The main landing area within the loft was finished with plasterboard lined ceilings and walls with painted surfaces, and the floor was covered in carpet. This section was being used for storage. Exposed rafters were visible in this area. Localised mould growth was noted at the ceiling to wall junction together with white staining to painted wall surfaces, which may be consistent with condensation, poor ventilation. Localised cracking was also noted to the plastered ceiling finish.

A second loft section was accessed from the main landing area through an internal door. This section had a timber boarded floor and was also being used for storage, which restricted inspection to the accessible areas only. A light fitting was present and operational. Exposed timber rafters and purlins were visible and appeared to be in generally reasonable condition where accessible. A third loft section was also accessed via a door from the main landing area. This section did not have a light fitting and contained limited stored items together with a water tank. Insulation was present throughout this area. Exposed rafters and purlins visible from accessible areas appeared to be in generally reasonable condition.

### Condition Rating 3.

The localised mould growth and staining within the main loft area should be investigated and addressed, with particular attention given to ventilation levels and any possible condensation related issues. Damaged and cracked internal finishes should be repaired as necessary. As inspection was restricted by stored belongings in parts of the loft, no comment can be made on concealed areas, and stored items should be moved if a more thorough inspection is required. Ongoing monitoring and routine maintenance of the loft space, insulation and ventilation arrangements is recommended.

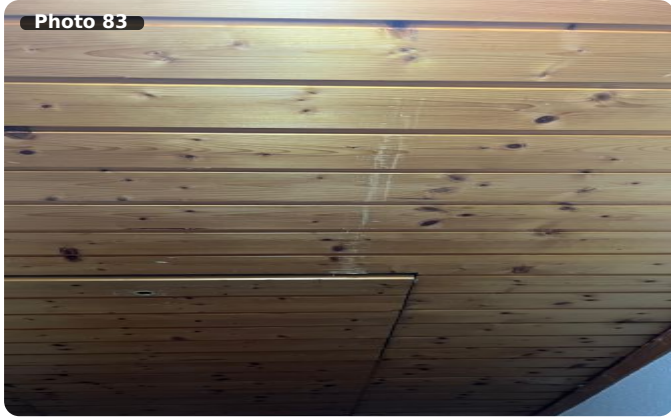
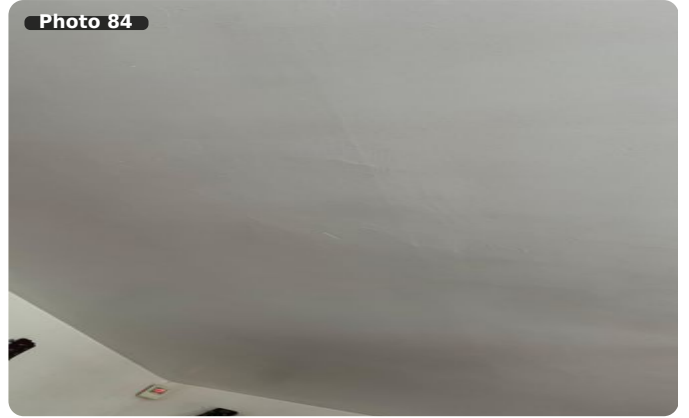
The internal walls appear to be of solid construction and are finished predominantly with painted surfaces and textured wallcoverings. Inspection was limited to the visible and readily accessible areas only, with some sections partially obscured by furniture and stored belongings, particularly within Bedroom 2, where full inspection of the wall surfaces was restricted.

The accessible wall surfaces were found to be in generally fair condition overall, with defects largely of a minor and cosmetic nature. In the lounge, the walls showed general decorative wear and tear consistent with age and use. Within the joinery section, slight hairline cracking was noted locally above radiator and near skirting level. In Bedroom 1, hairline cracking was noted above the curtain rail over the locked door to the conservatory, and localised darkened staining was visible above the radiator, consistent with heat-related marking. In the utility area, slight surface damage and deterioration were noted to a wall edge. No significant structural distortion was evident to the accessible internal wall surfaces at the time of inspection.

Localised making good and redecoration should be undertaken where required, including filling minor cracking, repairing damaged edges and addressing marked decorative finishes. The darkened area above the radiator should be cleaned and monitored, with redecoration as appropriate. Ongoing routine maintenance should be anticipated, and any cracking that becomes more pronounced or widespread should be reviewed further.

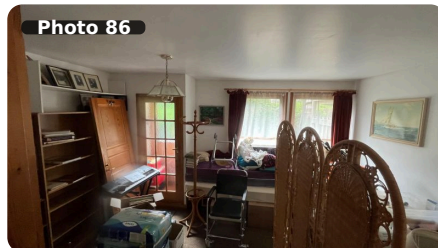
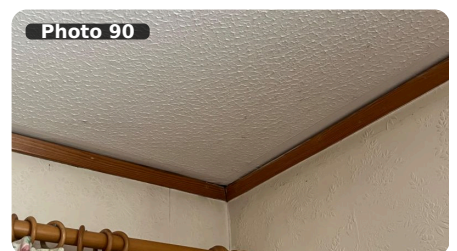
### Condition Rating 2.

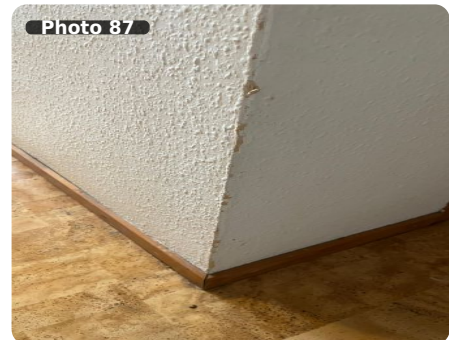
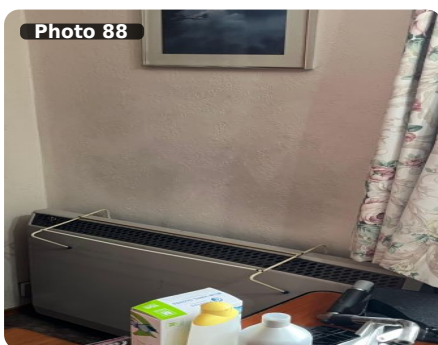
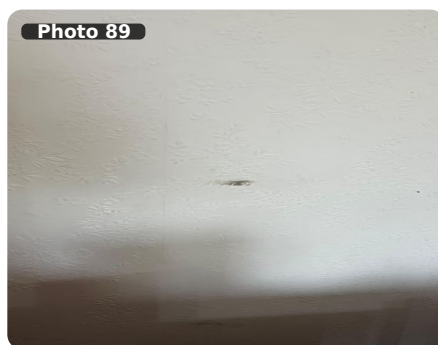
The internal floors are finished predominantly with fitted carpets to the lounge, joinery areas and bedrooms, with sheet floor coverings laid to the kitchen and utility areas. Inspection was limited to the visible and readily accessible areas at the time of survey, and some sections, particularly within Bedroom 2, were partly obscured by stored belongings and furniture.

The floor finishes were found to be generally serviceable but dated, with visible wear consistent with age and use. The carpets to the lounge showed localised staining, particularly near the window area, together with general flattening and wear. The carpet within the joinery areas showed signs of wear and local distortion, with some bunching and fraying affecting ease of door operation in places. The carpets within Bedrooms 1 and 3 also appeared worn and dated. The floor coverings to the kitchen and utility areas were likewise dated, with surface marking, scratching and dirt accumulation noted, particularly to corners and beneath fitted units where visible. No lifting of the finishes was noted to the main walked areas at the time of inspection, although concealed defects may exist beneath fixed coverings.

Allow for renewal or localised repair of worn floor finishes where required, particularly in areas affecting door clearance and where staining or wear is more advanced. The affected carpeted areas should be monitored and replaced in due course as part of routine modernisation. The kitchen and utility floor coverings should be cleaned and maintained, with replacement considered where appearance and wear no longer meet the client's expectations.

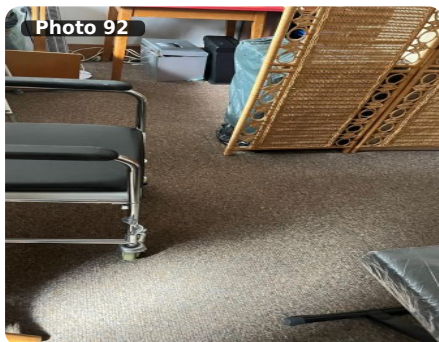
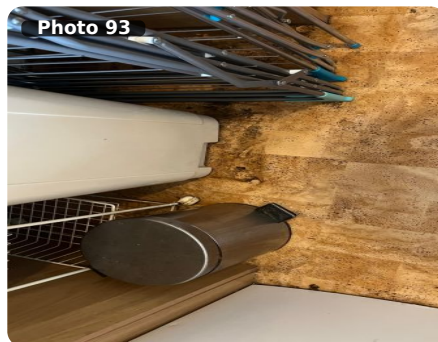
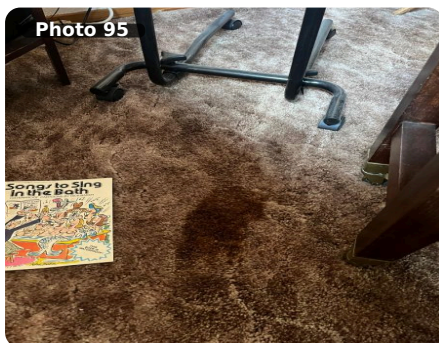
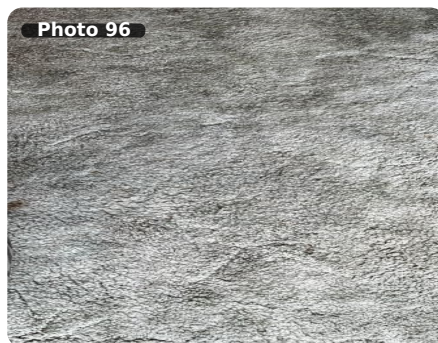
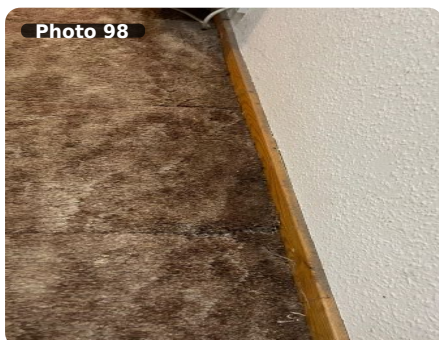
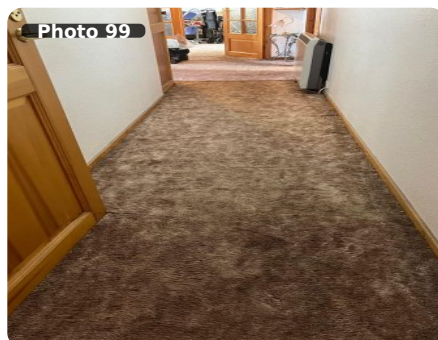
#### Condition Rating 2.

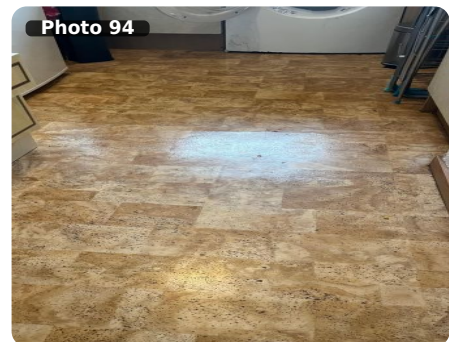
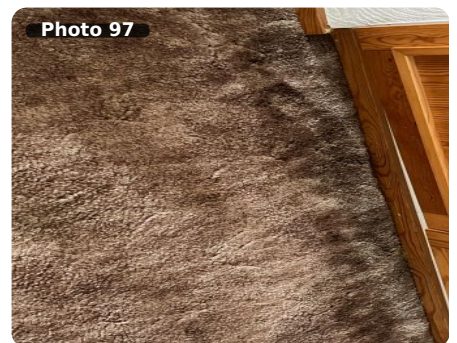
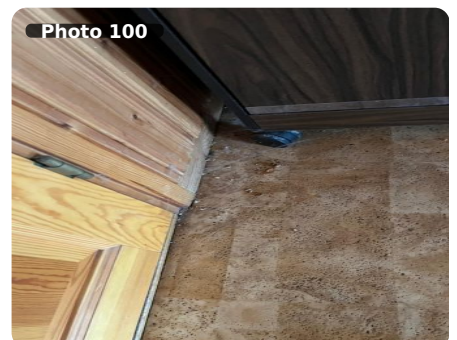
The lounge is fitted with an exposed brick chimney breast and fireplace with a tiled hearth and timber mantel. A freestanding electric stove style heater was positioned within the fireplace opening at the time of inspection. No chimney stack was evident externally and the fireplace appears to be retained principally as a decorative feature. Inspection was limited to the readily visible and accessible parts only, and no testing was undertaken to the electric heater or any associated electrical installation.

The chimney breast and fireplace were found to be in generally fair condition overall, but with visible age related wear and deterioration. Localised cracking and some failed or weathered mortar joints were noted to the exposed brickwork, together with areas of dark staining to sections of the internal brick surfaces. The tiled hearth and fireplace base were generally serviceable, although showing minor cosmetic wear. The timber mantel appeared serviceable at the time of inspection but was partly obscured by decorative items. No comment can be made on the serviceability or safety of the freestanding electric heater, as this was not tested.

Localised repair and maintenance are recommended to the exposed brickwork, including repointing to defective mortar joints and making good minor cracking where required. Stained areas should be cleaned and monitored, and the chimney breast should be kept under review for any progression of cracking or signs of moisture related deterioration. The freestanding electric heater should be checked in normal use and, if required, reviewed by a suitably qualified electrician or competent contractor if there are any concerns regarding its operation or safety.

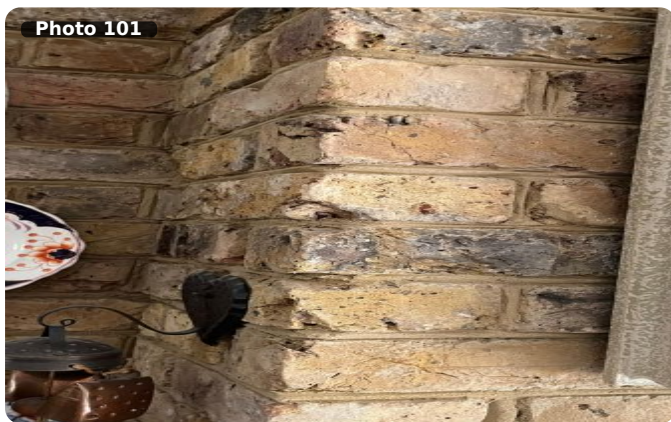
#### Condition Rating 2.

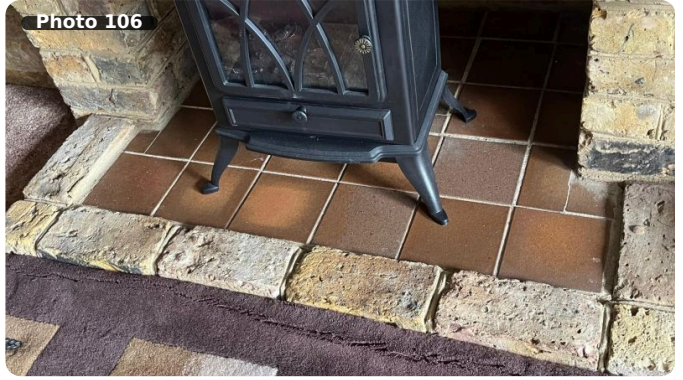
The property is fitted with a kitchen comprising fitted timber wall and base storage units, laminate floor finishes, tiled wall splashbacks and a timber boarded ceiling. The kitchen is arranged with stone effect worktop incorporating a sink and mixer tap, together with fitted appliances including an electric hob, oven, cooker hood, dishwasher and refrigerator. Inspection was limited to the readily visible and accessible parts only, and not all cupboards or concealed areas were inspected in line with the limitations of the level 2 survey.

The kitchen was found to be in generally serviceable condition, although showing age related wear and tear. The fitted units were broadly operational at the time of inspection, but there was evidence of general wear to hinges, surfaces and finishes. Localised deterioration was noted to the timber trim adjacent to the refrigerator, consistent with moisture exposure. The tiled splashbacks are dated in appearance and show slight discolouration and dirt accumulation to grout lines and sealant joints, particularly near the sink area. Localised cracking was also noted to the worktop finish near the sink. Corrosion was visible to the light fittings beneath the wall units. No appliances, electrical fittings or mechanical extraction were tested.

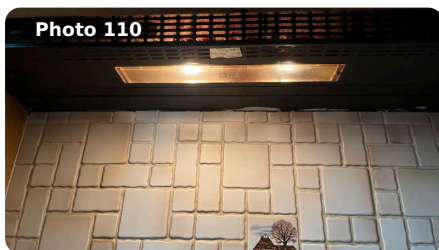
The property was fitted throughout with timber internal doors with associated ironmongery and timber skirtings. Overall, the internal joinery was in generally fair condition for the age and type of the property, although a number of defects associated with wear and tear, restricted operation and localised deterioration were noted at the time of inspection. The lounge door, which is of timber construction with glazed panes, was observed to have a cracked glass pane, although the door remained operational. The kitchen door, also of timber construction with glazed panes, was functional but was noted to be stiff in operation and restricted at threshold level. The bathroom doorway within the joinery section showed signs of wear and tear to the threshold, and the door itself was stiff in operation. The door from the bathroom to Bedroom 3 was also functional but restricted at floor level.

The door from the kitchen to the conservatory was operational at the time of inspection; however, peeling paint was noted to the metal threshold, and an exposed gap was visible at the junction between the timber door frame and adjacent wall. The doors leading to the conservatory from the lounge and Bedroom 1 were locked and obstructed by stored items, and therefore their operation could not be confirmed. The en-suite bathroom to Bedroom 1 had no fitted door, and the timber door frame and threshold showed a poor surface finish together with localised hairline cracking at the junction between the frame and adjoining wall. The door to Bedroom 2 from the utility room was restricted by a doorstop at the time of inspection, so its operation could not be fully assessed, although localised deterioration was visible to the lower part of the door leaf. The door in Bedroom 3 leading to the side alleyway was also obstructed by stored items and inspection was limited.

The timber door frames and skirtings throughout the property showed general signs of age-related wear and tear, including minor scratches, localised surface deterioration and some evidence of timber decay in isolated areas. Exposed gaps were noted between skirting and wall finishes in parts of the joinery section, resulting in dust accumulation. Within the conservatory, the timber skirtings were in poorer condition, with peeling finishes, scratches and exposed gaps at skirting to wall junctions. The cracked glazed pane to the lounge door should be replaced, stiff and restricted doors should be adjusted and repaired as required, and areas of localised timber deterioration should be made good and redecorated where necessary. Further inspection of obstructed and locked doors should be undertaken once access is available.

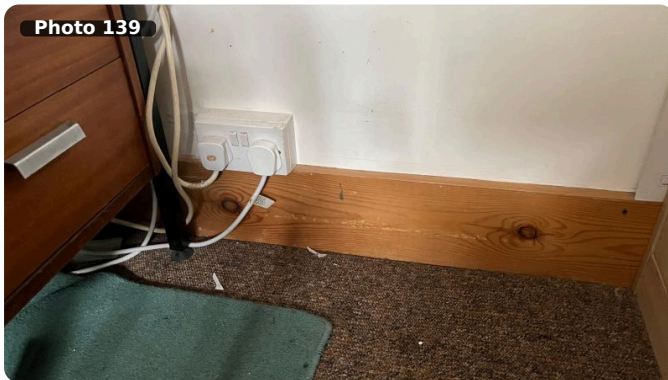
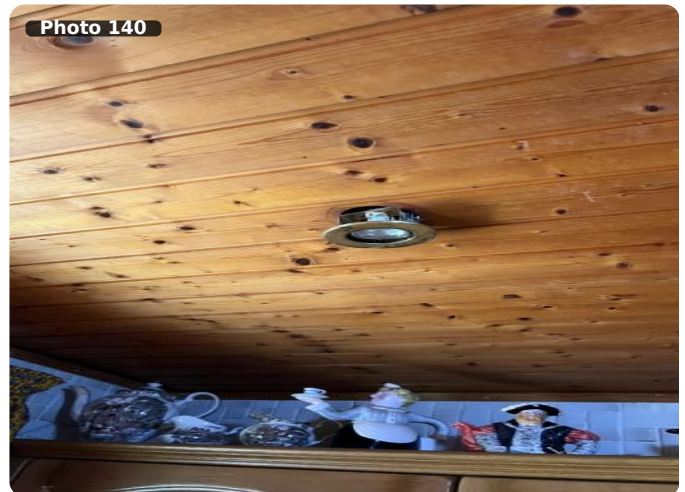
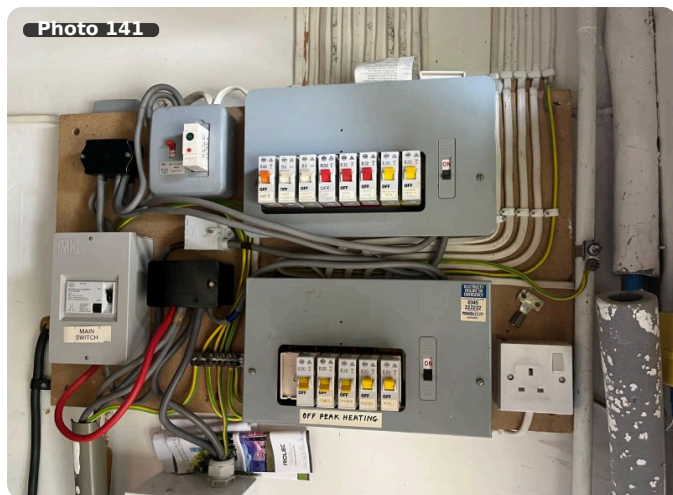
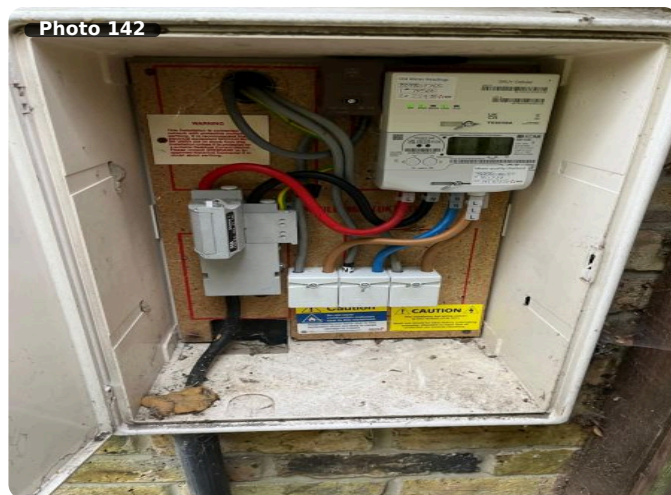
The property was observed to have a mains electricity supply, which was live at the time of inspection. Consumer units were identified within the garage, and an additional electrical service cabinet was noted externally at the front side elevation. Accessible switches, socket outlets and visible fittings were inspected on a visual basis only.

The electrical installation was not tested as part of this inspection and no Electrical Installation Condition Report, completion certificates or other relevant documentation were provided for review. Visual defects noted included a socket outlet fitted at very low level, directly above the skirting in bedroom 3, and a loose spotlight fitting with exposed wiring in the kitchen. These matters give rise to safety concerns, and the visible condition of the installation cannot therefore be regarded as satisfactory on the basis of a visual inspection alone.

A suitably qualified electrician should be instructed to carry out a full inspection and testing of the electrical installation and to provide an appropriate Electrical Installation Condition Report before exchange of contracts. Urgent attention should be given to the loose kitchen light fitting and exposed wiring, and any necessary remedial works should be completed in accordance with current standards. Until the installation has been properly tested, no assurance can be given as to its safety or compliance.

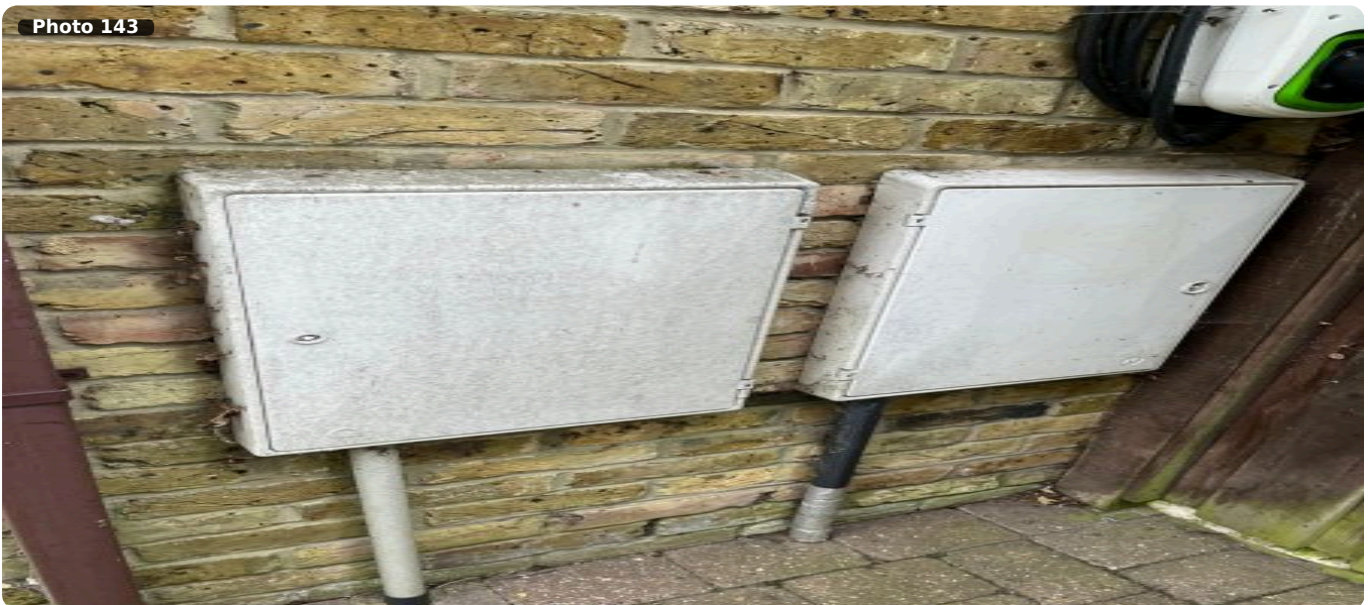
**Condition Rating 3.****Photo 143**

The property was observed to have an external gas meter box positioned at the front side elevation. The kitchen was fitted with an electric cooker at the time of inspection. The gas meter box was present externally, but it was stiff and could not be opened during the inspection, and therefore the meter installation and associated visible components could not be inspected.

No testing of the gas installation, meter or associated appliances was undertaken as part of this survey, and no Gas Safety Record, servicing documentation or other relevant certification was provided for review. As access to the meter box could not be gained, no comment can be made on the condition, adequacy or serviceability of the gas meter or supply installation.

A suitably qualified Gas Safe registered engineer should be instructed to inspect the gas meter installation and carry out appropriate checks to the gas supply and any associated system before exchange of contracts. The meter box should be made accessible and any defective locks, hinges or fixings attended to as necessary. Until the installation has been properly inspected and relevant certification provided, no assurance can be given as to its safety or condition.

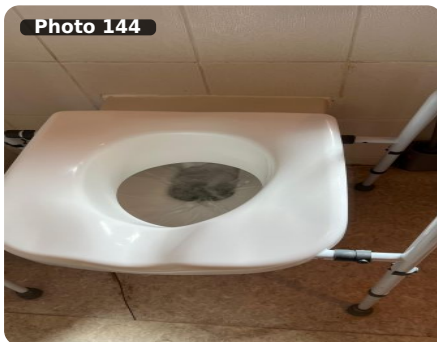
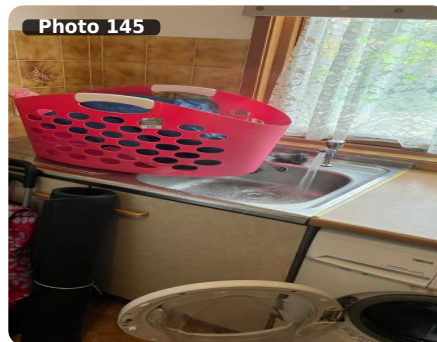
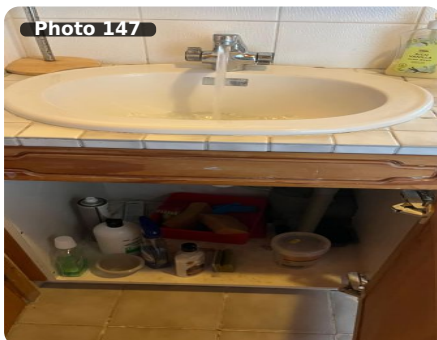
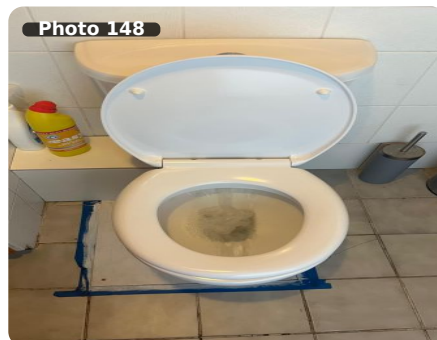
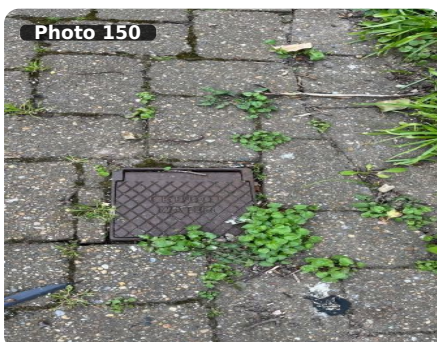
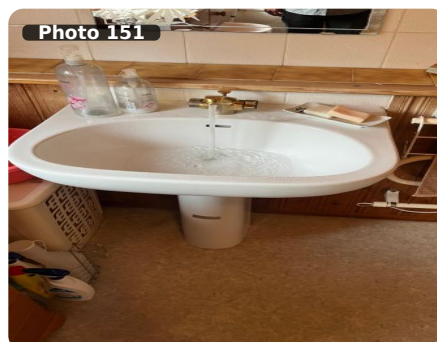
The property was observed to have a mains water supply serving the kitchen sink, utility sink and the accessible sanitary fittings within the bathrooms. A water meter was identified externally at the front of the property near the porch area. Inspection of the plumbing installation was limited to a visual assessment of the readily accessible fixtures and fittings only.

At the time of inspection, water was running to the kitchen sink, utility sink, bathroom basins and WCs, and no active leakage was noted when the accessible fittings were operated or when the WCs were flushed. The visible sanitary fittings appeared to be generally serviceable in normal use at the time of inspection. No stopcock was identified beneath the kitchen sink, although access within the base unit was restricted by stored household items and therefore full comment cannot be made on concealed pipework or fittings.

No pressure testing, flow testing or further investigation of the plumbing system was undertaken, and no water-related certificates, service records or other documentation were provided for review. The installation should therefore be subject to normal ongoing maintenance, and the main internal stopcock should be identified and made readily accessible. As the inspection was limited to visible and accessible parts only, concealed defects cannot be ruled out.

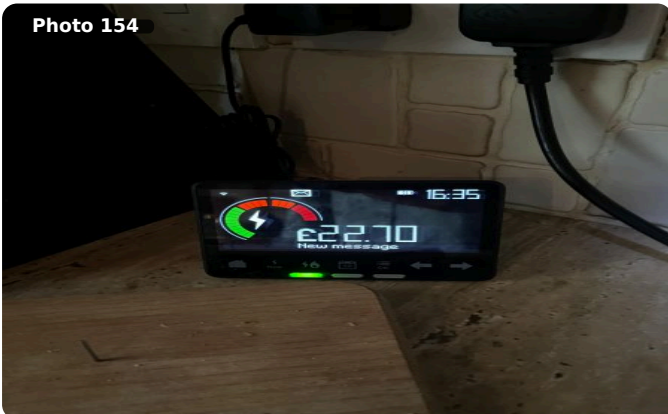
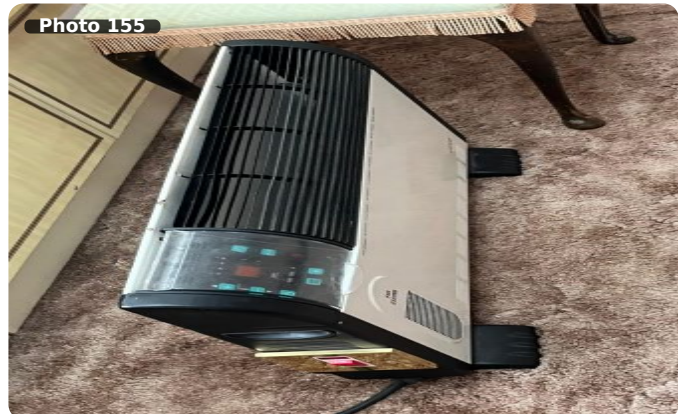
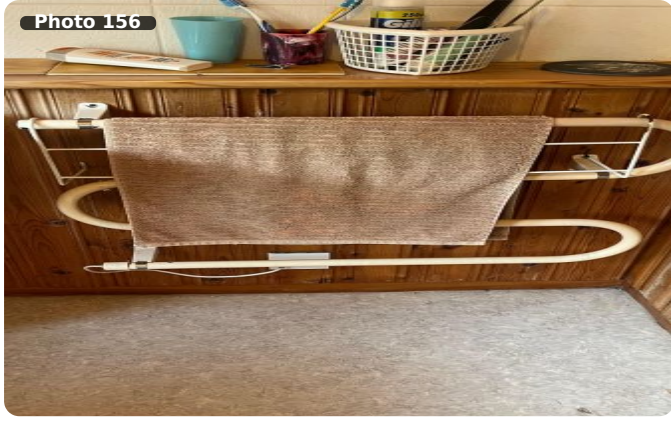
At the time of inspection, the property was observed to be fitted with a hot water cylinder located within the storage cupboard in the joinery area. No conventional boiler was identified during the inspection.

The inspection of the installation was limited to a visual assessment of the parts readily accessible at the time of survey only. No testing of the hot water system, cylinder, controls or associated components was undertaken, and no comment can therefore be made on the serviceability, efficiency or remaining life expectancy of the installation. No service records, installation certificates or other relevant documentation were made available for inspection.

**Condition Rating 3.**

A suitably qualified heating engineer should be instructed to inspect and test the hot water installation and confirm its safe operation, condition and adequacy. The purchaser should also obtain details of the age, servicing history and specification of the system before legal commitment.

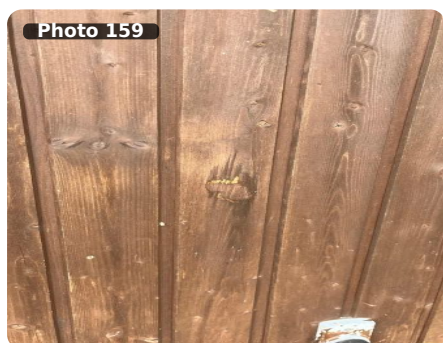
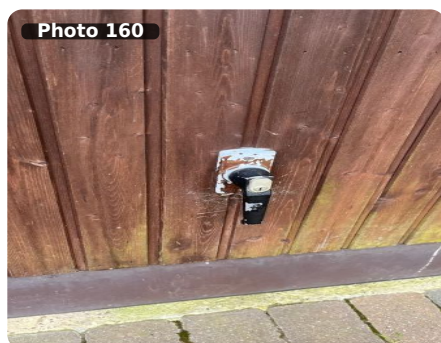
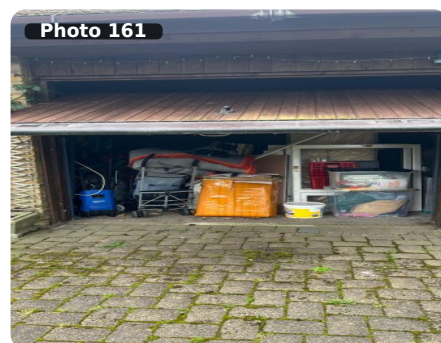
The property was observed to benefit from two principal timber sheds together with a smaller timber storage structure located within the rear garden. One of the main sheds was accessible at the time of inspection and appeared to be divided into two sections with separate openings. The other main shed and the smaller timber storage structure were locked at the time of inspection and therefore were subject to a limited visual inspection only. The areas surrounding the sheds were noted to contain dense vegetation and general garden debris, which further restricted full inspection in places.

The accessible shed showed general age related wear and weathering to the timber structure. Externally, the timber cladding and joinery showed poor surface finish, with widespread weathering, surface deterioration, peeling finishes, and localised algae and moss growth. Internally, no serious structural distortion was apparent within the accessible areas; however, one section showed deteriorated timber boarding and decayed surfaces, which may allow moisture ingress if left unattended. The roof coverings to the sheds appeared to be felted and showed moss, algae growth. The locked sheds also showed similar external deterioration, including weathered timber surfaces, biological growth and localised peeling finishes. Overall, the sheds were in poor to fair condition and require repair and maintenance.
