Level 2

# Your survey report

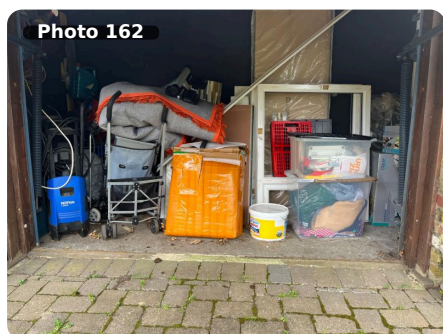
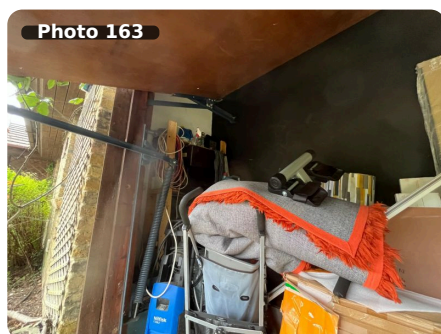
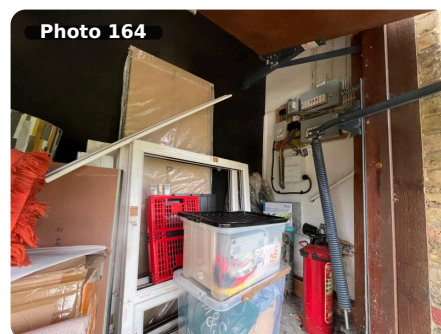
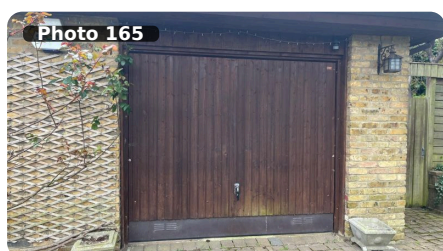
The property was observed to benefit from two principal timber sheds together with a smaller timber storage structure located within the rear garden. One of the main sheds was accessible at the time of inspection and appeared to be divided into two sections with separate openings. The other main shed and the smaller timber storage structure were locked at the time of inspection and therefore were subject to a limited visual inspection only. The areas surrounding the sheds were noted to contain dense vegetation and general garden debris, which further restricted full inspection in places.

The accessible shed showed general age related wear and weathering to the timber structure. Externally, the timber cladding and joinery showed poor surface finish, with widespread weathering, surface deterioration, peeling finishes, and localised algae and moss growth. Internally, no serious structural distortion was apparent within the accessible areas; however, one section showed deteriorated timber boarding and decayed surfaces, which may allow moisture ingress if left unattended. The roof coverings to the sheds appeared to be felted and showed moss, algae growth. The locked sheds also showed similar external deterioration, including weathered timber surfaces, biological growth and localised peeling finishes. Overall, the sheds were in poor to fair condition and require repair and maintenance.

### Condition Rating 3.

The timber sheds should be cleared where necessary and fully opened up for closer inspection. All deteriorated or decayed timber elements should be repaired or replaced as appropriate, and the external timber surfaces should be prepared, treated and redecorated to reduce the risk of further weathering and moisture penetration. Roof coverings should be checked and renewed where required. Vegetation and debris around the sheds should also be cut back and removed to improve ventilation, reduce damp retention and allow ongoing maintenance access.

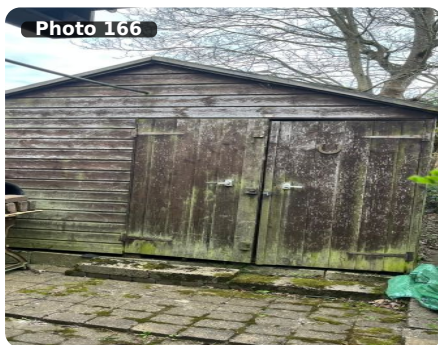
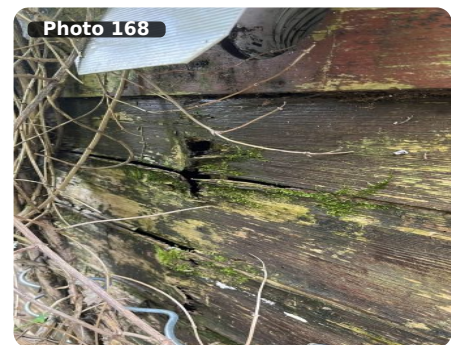
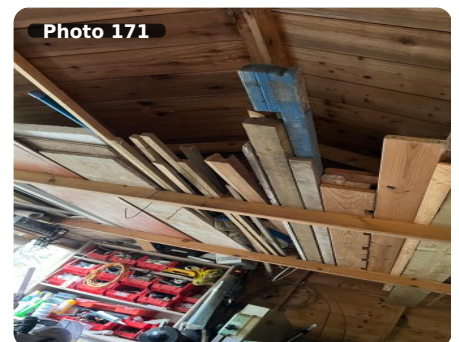
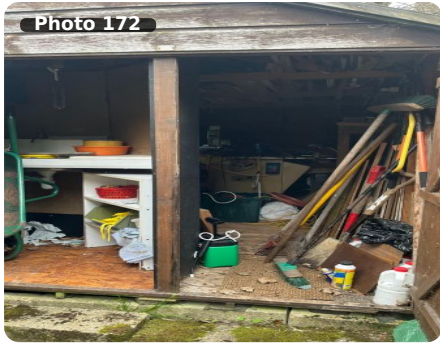
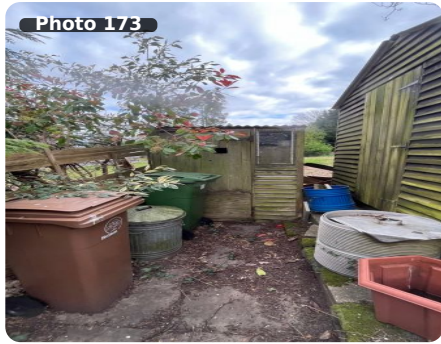
The property was observed to benefit from a spacious paved driveway to the front elevation together with a seating area. The front grounds generally appeared serviceable, although the steps and pathway leading to the seating area were uneven in places, and the seating area was noted to be covered with a build up of dry leaves and general debris. Access is also provided to the rear garden by side passageways located to both the left and right sides of the property.

The right hand side passageway was in generally reasonable condition and is bounded by a parapet wall and fencing shared with the neighbouring property. The ground surface is paved, although general weathering, natural vegetation growth within joints, and some stored household items were noted. The left hand side passageway was more restricted due to stored items and debris. The shared timber fencing to this side showed deflection and deterioration to timber boards. The paved surface in this area showed cracking, debris, leaf build up and localised unevenness. To the rear, the grounds around the timber sheds were heavily overgrown with dense vegetation and garden debris, and the internal timber fence separation also showed deflection and deterioration. The property further benefits from a rear garden incorporating a pond. The ground around the pond area was uneven, with an irregular walkway which may present a trip hazard. Standing water within the pond appeared stagnant and a foul odour was noted at the time of inspection. Overall, the external grounds are in need of maintenance and improvement.

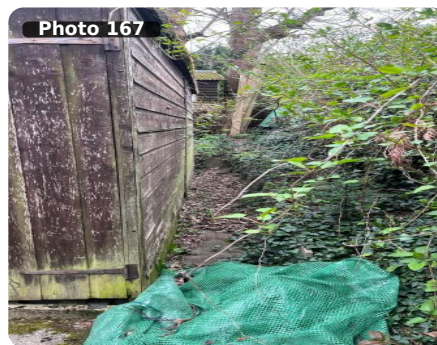
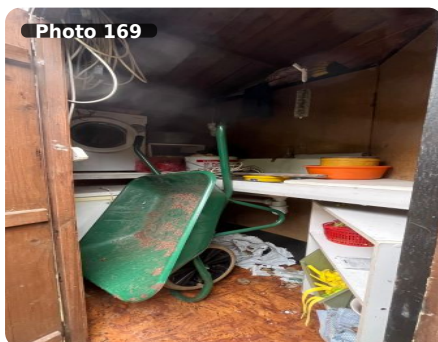
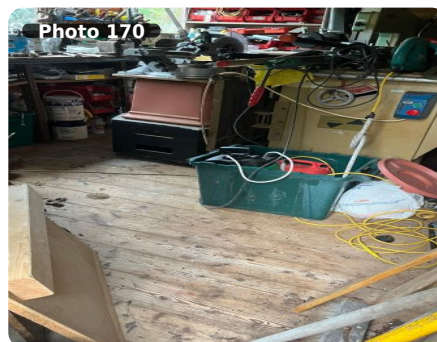
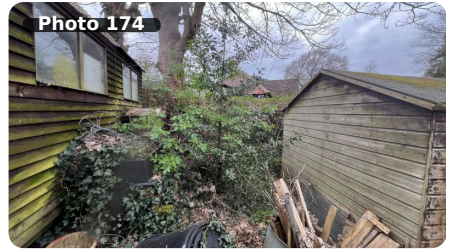
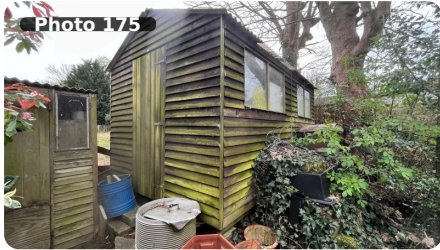
### Condition Rating 3.

The external grounds should be cleared of debris and overgrown vegetation, with all garden areas properly maintained and cut back to allow safe access and prevent further deterioration to adjacent fences and outbuildings. Uneven, cracked or defective paved surfaces should be repaired where necessary to reduce trip risks. The shared boundary fencing should be repaired or replaced as appropriate. The pond should be cleaned, and its condition and water quality monitored, particularly where stagnant water and odour are present. Regular maintenance of the grounds is recommended to preserve usability and reduce ongoing risks associated with vegetation growth and uneven surfaces.
