Review of Failures of Photovoltaic Modules

Report IEA-PVPS T13-01:2014

Performance and Reliability of Photovoltaic Systems

Subtask 3.2: Review of Failures of Photovoltaic Modules

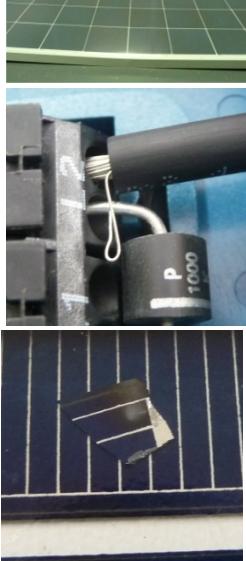
Chapter	Type	Safety	Power	Image
--	Bent or misaligned external surfaces, substrates, frames, and junction boxes to the extent that the installation and/or operation of the module would be impaired Module wire touching the diode with the risk of arcs- operation is compromised Cell fragment laminated in the module, operation could be impaired	B(m,e) B(f) B	A A A

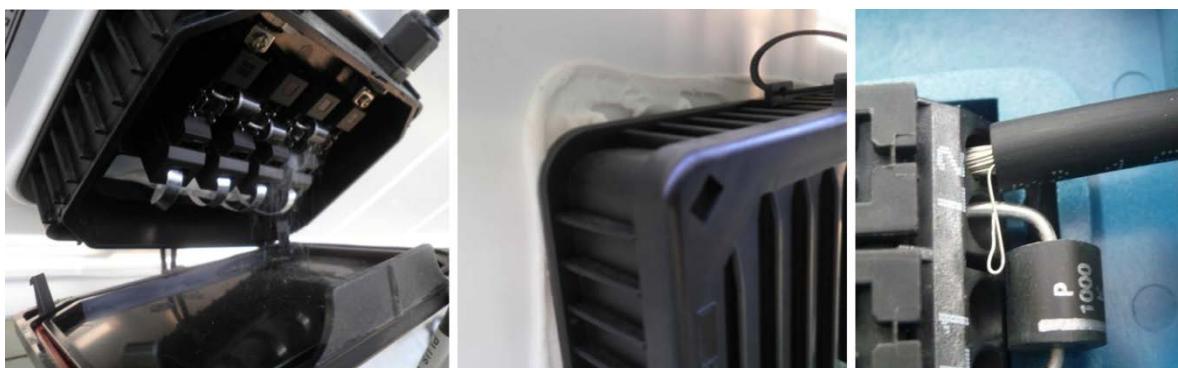
Fig. 6.1.3: Junction box failures: Left photo shows an open junction box in the field, the middle one a poorly bonded JB on the backsheet, and the right one a JB with poor wiring.

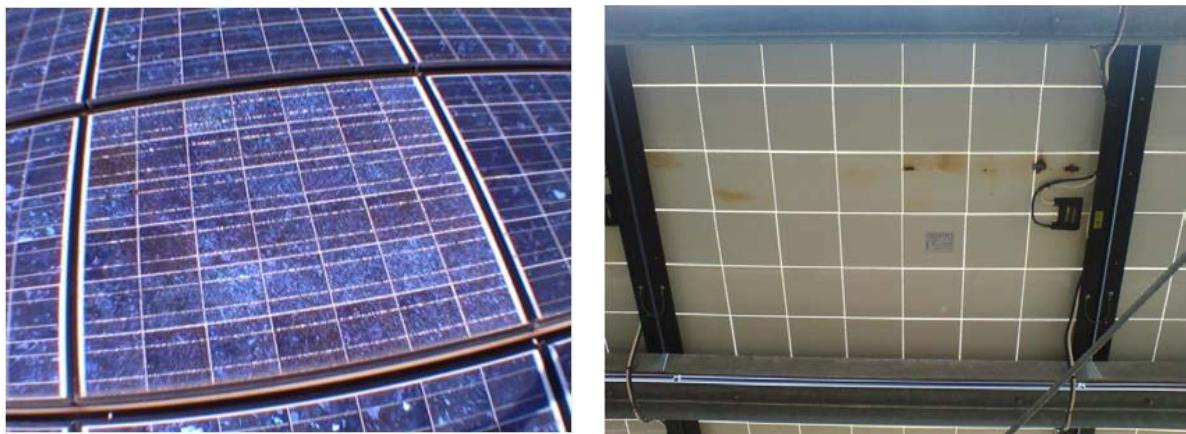
Fig. 6.2.17: Final stage. Left: glass breakage of a PV module caused by broken cell interconnect ribbons. Right: burn marks on the PV module rear side caused by broken cell interconnect ribbons.

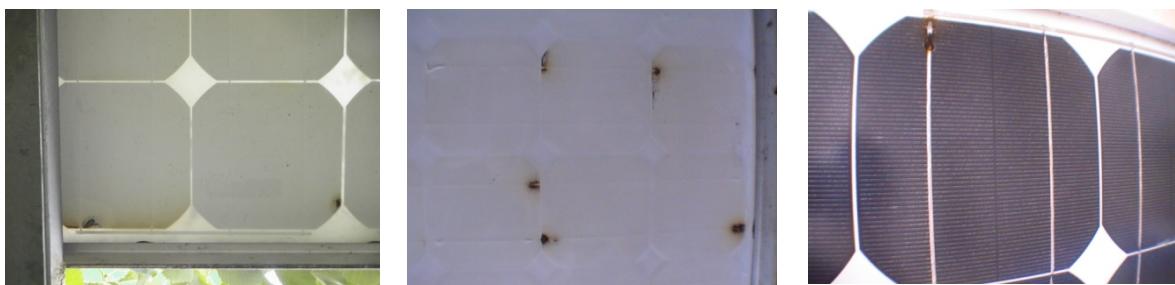
Fig. 6.2.22: Burn marks caused by open-circuit bypass diodes.

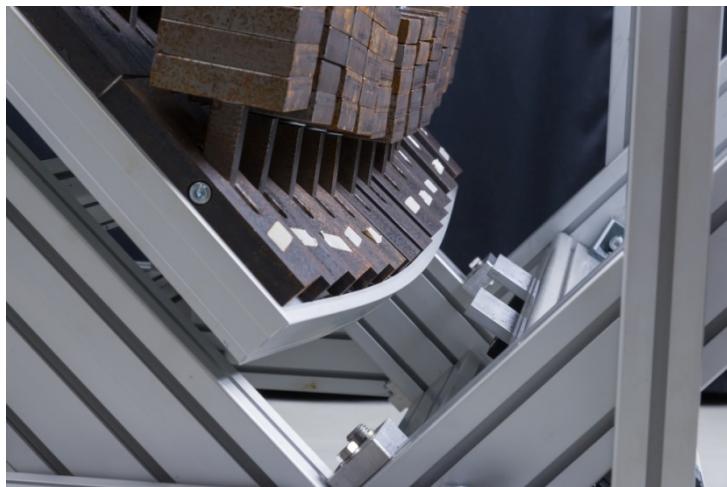
Under a load of only 15% of initial load and a two-point load application, modules already revealed weaknesses from lack of frame rigidity, with deformations of up to 5 mm. The slight deformation of the frame is also greatly influenced by the loosening of the adhesive bonds between the frame and the glass surface. With different frame designs we observed a single specimen with screws broken off from the corner clamps.

Figure 7.2.1: New test apparatus for snow load testing at TÜV Rheinland 2012: Application of load elements causing the bending of a PV module frame.
