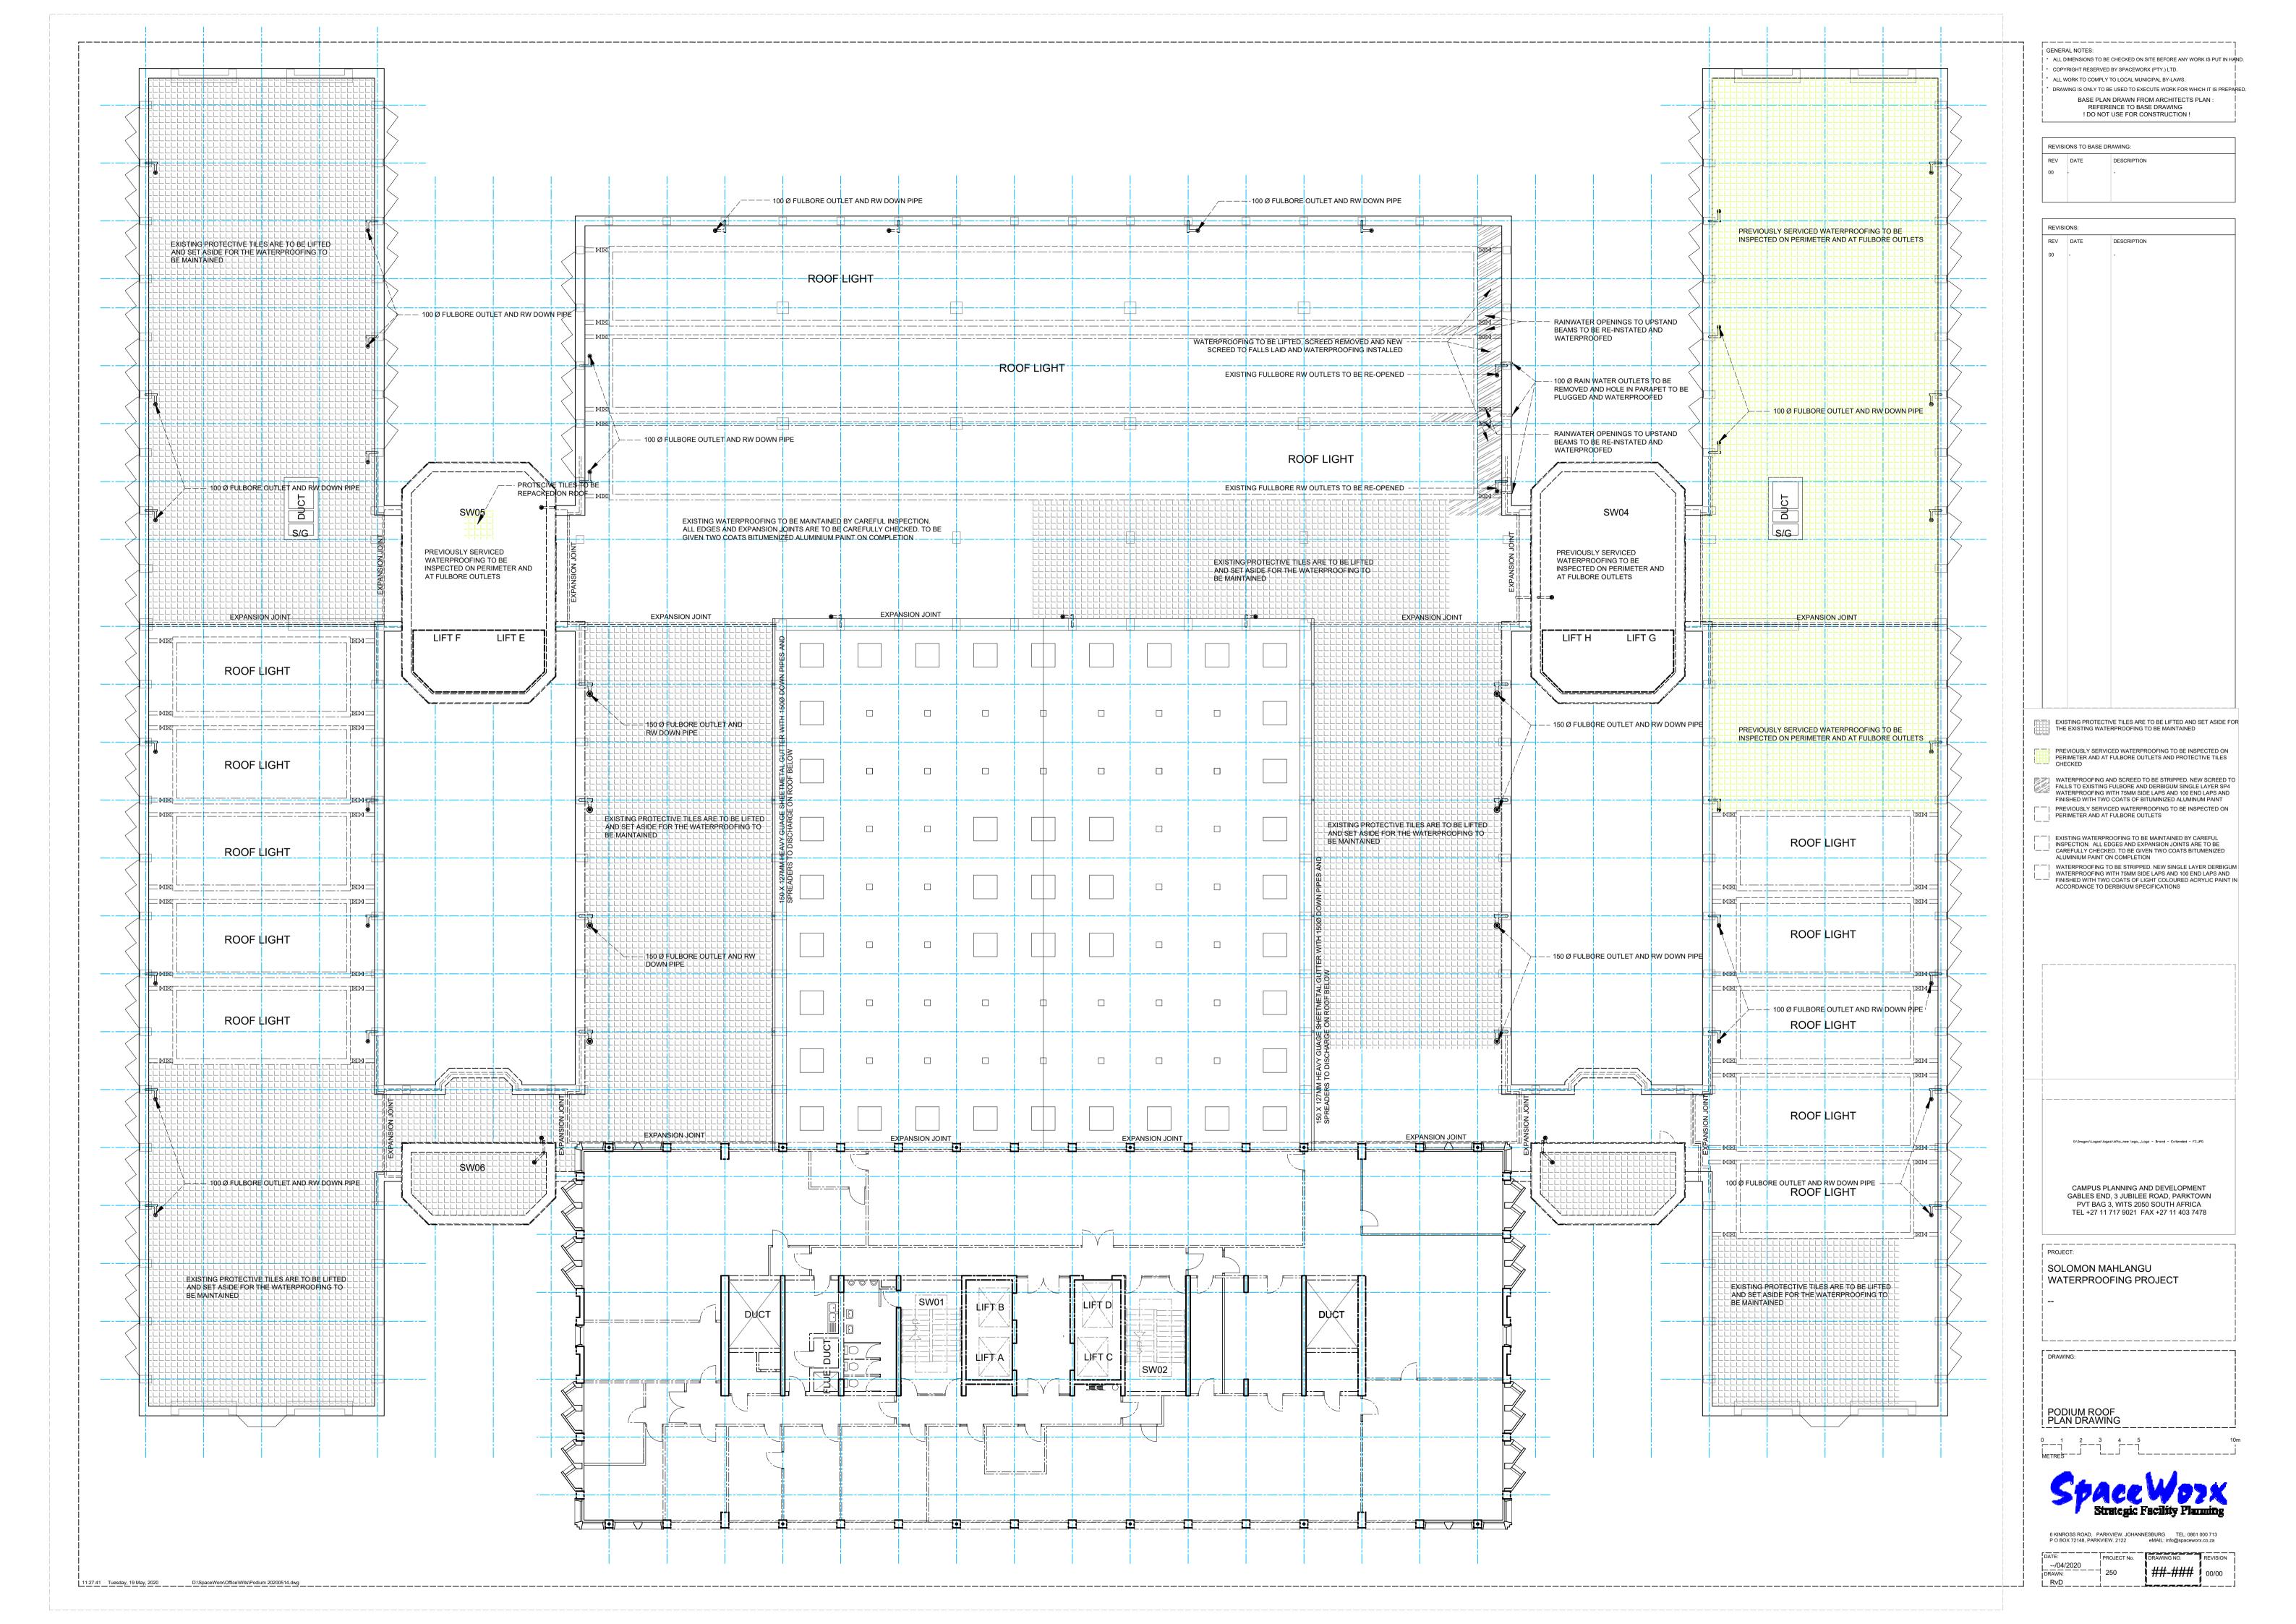
EXISTING PROTECTIVE TILES ARE TO BE LIFTED AND SET ASIDE FOR THE EXISTING WATERPROOFING TO BE MAINTAINED

PREVIOUSLY SERVICED WATERPROOFING TO BE INSPECTED ON PERIMETER AND AT FULBORE OUTLETS AND PROTECTIVE TILES CHECKED

PREVIOUSLY SERVICED WATERPROOFING TO BE INSPECTED ON PERIMETER AND AT FULBORE OUTLETS

EXISTING WATERPROOFING TO BE MAINTAINED BY CAREFUL INSPECTION. ALL EDGES AND EXPANSION JOINTS ARE TO BE CAREFULLY CHECKED. TO BE GIVEN TWO COATS BITUMENIZED ALUMINUM PAINT ON COMPLETION

WATERPROOFING AND SCREED TO BE STRIPPED. NEW SCREED TO FALLS TO EXISTING FULBORE AND DERBIGUM SINGLE LAYER SP4 WATERPROOFING WITH 75MM SIDE LAPS AND 100 END LAPS AND FINISHED WITH TWO COATS OF BITUMINIZED ALUMINUM PAINT

WATERPROOFING TO BE STRIPPED. NEW SINGLE LAYER DERBIGUM SP4

WATERPROOFING WITH 75MM SIDE LAPS AND 100 END LAPS AND FINISHED WITH TWO COATS OF LIGHT COLOURED ACRYLIC PAINT IN

ACCORDANCE TO DERBIGUM SPECIFICATIONS
