Our Ref No.: 14789/ICICI/19-20

IMMEDIATE LOSS ADVICE

NAME OF INSURED : M/s. Kloud 9 International

NAME OF POLICY : Standard Fire & Special Perils Policy

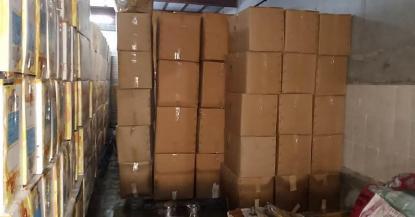
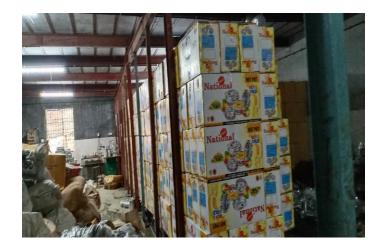
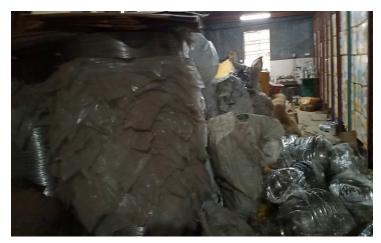
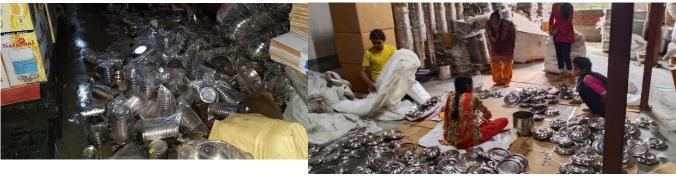
PHOTOGRAPHS : Refer below

We carried out the survey on 8th August 2019. The water level was around 2 ft inside the premises & around 3 ft at out side the shed. The stock of utensils such as spoons, glasses, mugs, casseroles of stainless steel and chromium plated were affected due to water. The cardboard boxes, mugs, casserole etc were also found affected. The water entered inside the plastic packing. The affected material was taken out separately from the packages and cleaning and polishing activity was in progress prior to our visit. The machinery such as spot welding machine, weighing machine, found water affected. Detailed testing is to be required and accordingly advised insured to provide us the estimate of repairs. The detailed segregation of the affected stock is yet to carried out.
