FINAL REPORT

Our Ref No.:	Insurers Ref		
13789/ICICI/18-19	Insured Name: Tri-Wall Pak Pvt. Ltd.,		
	Policy No. 1001/119039479/01/000		
	Type of policy: Standard Fire & Special Perils Policy		
	Claim No. : FIR000257787		
	Date of loss: 1st May 2018		
Report Date: July 11, 2019	Date of survey: 3 rd & 4 th May 2018, 27 th Dec 2018

Final survey report regarding claim preferred by M/s. Tri-Wall Pak Pvt. Ltd for reported loss/damage to their property due to reported fire, insured under Standard Fire and Special Perils Insurance Policy

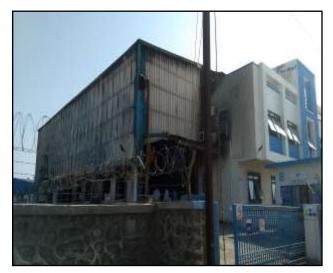
5.1

The premise was taken on the rental basis. It was bounded by a compound wall. The total area of the plots is 15000 Sq ft. The premises consisted of two blocks (manufacturing block and office block) adjoining to each other.

The manufacturing block had masonry walls of up to height of around 4 feet and thereafter, GI cladding is provided with roof of GI sheets laid on MS frame work. While the office building is RCC G+1 structure adjoining to the manufacturing block. The G+1 building was being used for office administrative work.
