Our Ref No.: 14868/ICICI/19-20

Date: 11th September 2019 Claim No. FIR002134204

IMMEDIATE LOSS ADVICE

NAME OF INSURED : Dev Sweets

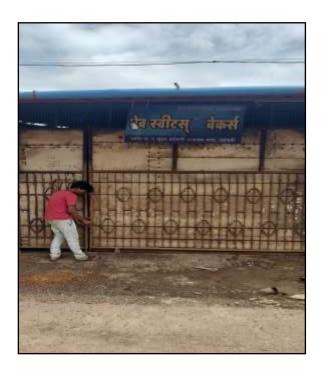
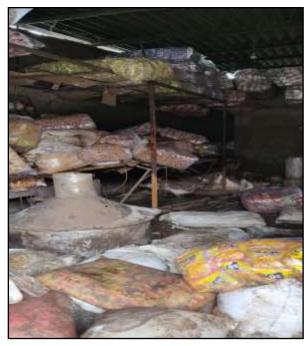
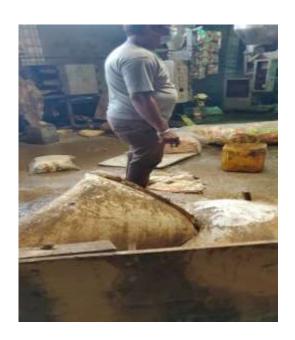
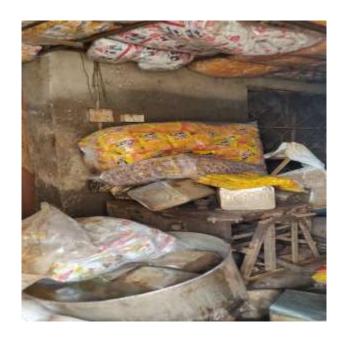
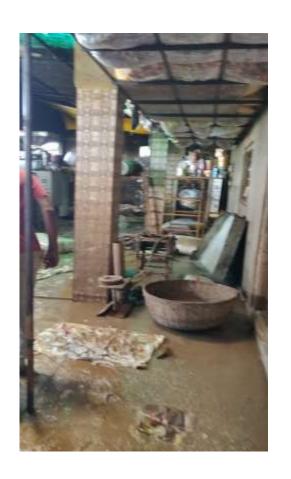
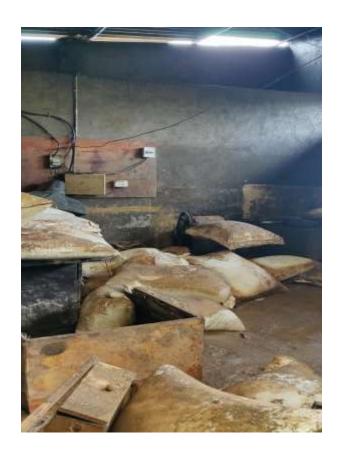
We carried out the survey on 15th August 2019. The insured is dealing in manufacturing of confectionary items such as Kurkure, Namkeen etc.. The water level was around 9 ft outside & inside the factory & godown. Insured have two locations. (Factory & godown). We have inspected both the locations. The mud marks and water marks observed in the factory as well as in the godown. In the factory premises raw material, finished goods were reportedly kept where as in the godown packing material was kept.

- Various machinery such as packing machine, dryer, small packing machine,
 Masala mixing machine, compressor etc were found affected.
- 2. The stock consisted of packing roll, finished packs of Kurkure & namkins etc were found wet & observed with the muddy water.
- 3. The building painting flooring were affected needs painting & cleaning
- 4. The electrical fittings, wirings were affected.

- To start the cleaning activity
- To keep the damaged material in demarcated place after cleaning for further inspection
- Prepare the list of complete damaged goods and salvageable goods.
- Confirm us the schedule for final inspection.
