From MS/ENB3	Our reference Prijo Ulahannan	Phone +91 80 6783 6100	E-Mail Prijo.ulahannan@in.bosch.com	Date: 18-Aug Report No.: Ather_01_TR		
Report: Title: Customer:	Ather India	esistance to rusting				
Document approv	'al					
	Name		Signature	Signature		
Prepared by	Prijo Ulahannan					
Reviewed by	Mahantesh Ramanna	var				
patented. A and the cha 3 samples to a some connector i check the f	Ather has approached arging station according to the solutions as specific corrosive environmental to the sar	Bosch (BGSW) to vang to IS 17017 select and Vehicle inlet were ecified in standard for ent. Test and accepta	charging connector for electrical alidate the charging connector alidate the charging connector rive tests as prescribed by Ather used for test. The task was to a specified duration to check ance criteria are as per IS 170	between the per requirement to expose the the behavior	vehicle nts. samples of

From	Our reference	Phone	E-Mail	
MS/ENB3	Prijo Ulahannan	+91 80 6783 6100	Prijo.ulahannan@in.bosch.com	Date: 18-Aug-2022 Report No.: Ather_01_TR

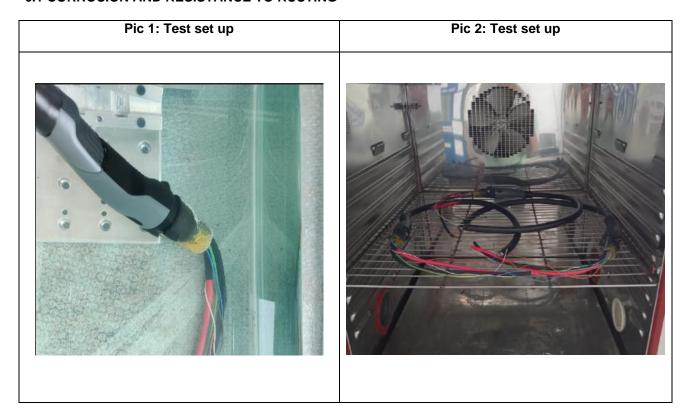
6.1 CORROSION AND RESISTANCE TO RUSTING

All 3 connector samples have passed the test. All the test parameters are within the specified limit of assessment criteria.

After the test Surfaces has no signs of rust – OK (See chapter 5.4 for Criteria)
