From	Our reference	Phone	E-Mail	ı	
MS/ENB3	Prijo Ulahannan	+91 80 6783 6100	Prijo.ulahannan@in.bosch.com	Date: 18-Aug Report No.: Ather_02_TF	
Report: Title: Customer:	Test report Flexible cables a Ather India	and their connection			
Document appro	oval				
	Name		Signature		
Prepared by	Prijo Ulahannan				
Reviewed by	Mahantesh Ramannav	ar			
and the charging station according to IS 17017 selective tests as prescribed by Ather requirements. Samples of vehicle connector used for test. The task was to perform pull test on samples, followed by a torque test to evaluate tensile strength of the cable with assembly. Test and acceptance criteria are a per IS 17017 chapter no. 25.3 to check the functionality of the samples.					•

From	Our reference	Phone	E-Mail	
MS/ENB3	Prijo Ulahannan	+91 80 6783 6100	Prijo.ulahannan@in.bosch.com	Date: 18-Aug-2022
				Report No.: Ather_02_TR

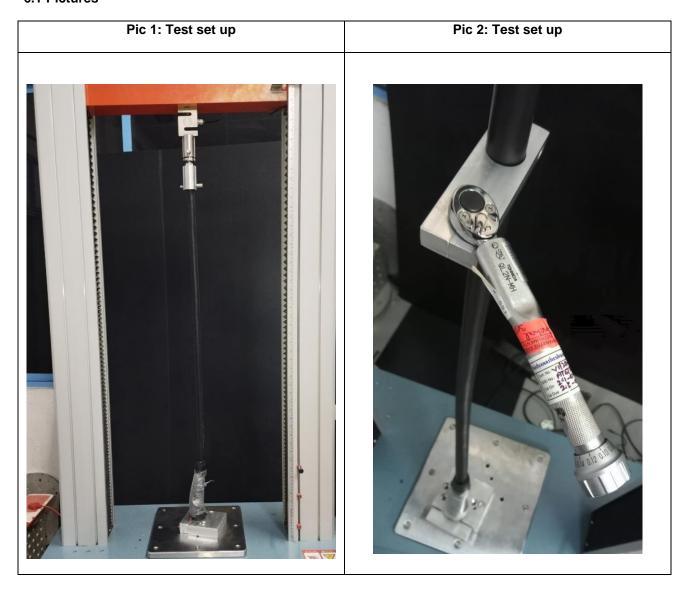
6.1 Pictures

All connector samples have passed the test. All the test parameters are within the specified limit of assessment criteria.
