NIST Technical Note 2165

Fire Resilience of a Steel-Concrete Composite Floor System: Full-Scale Experimental Evaluation for U.S. Prescriptive Approach with a 2-Hour Fire-Resistance Rating (Test #1)

October 2021

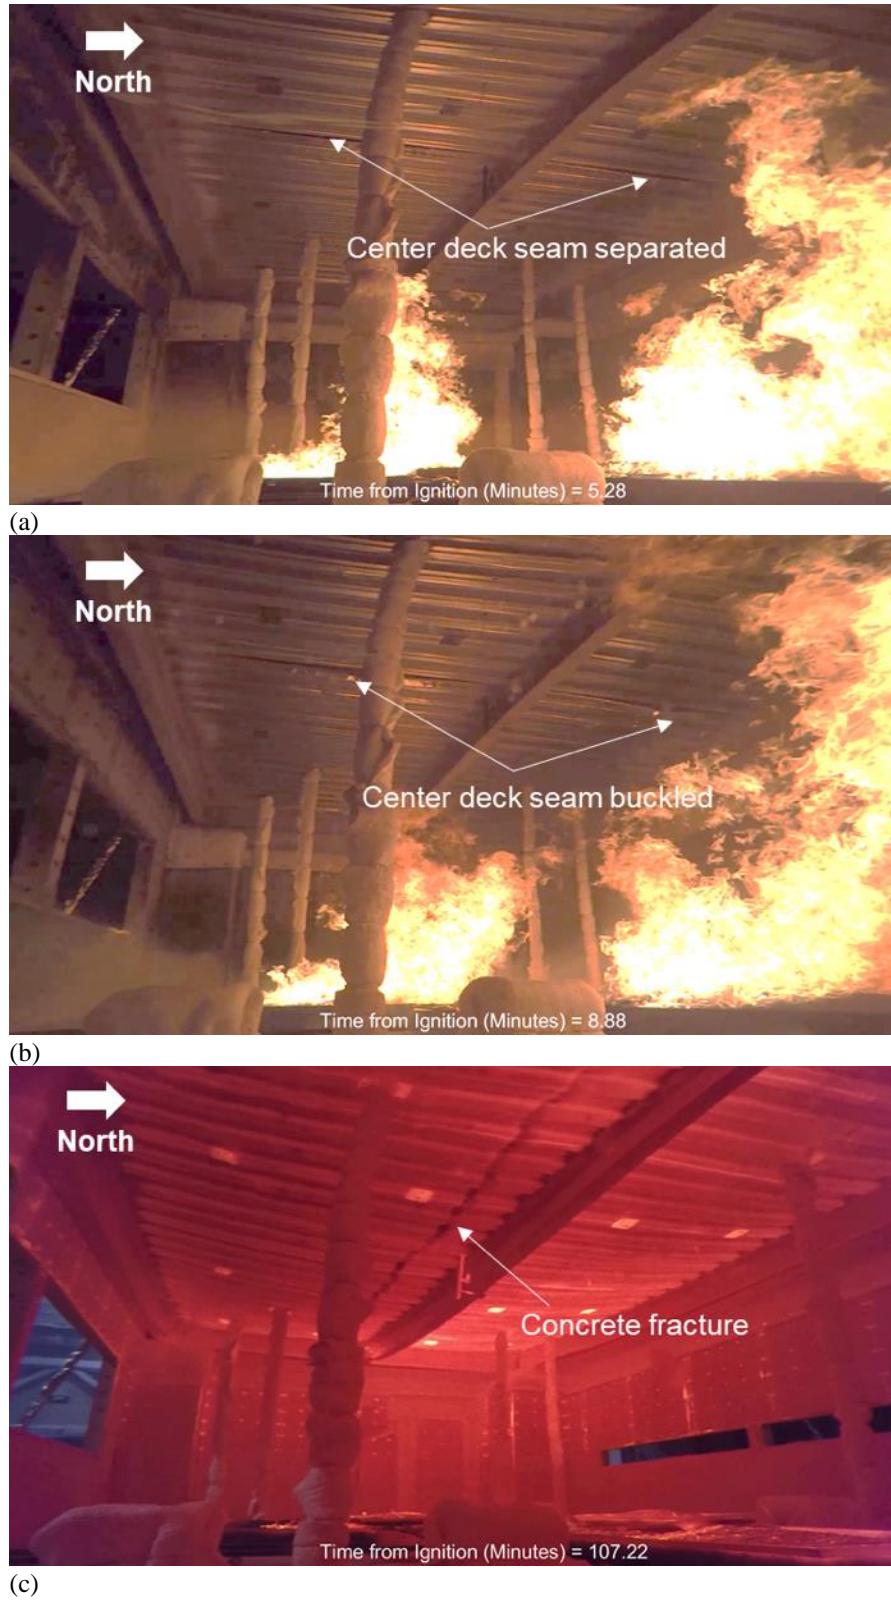
Time (min)	Observations	Figures
5	A center seam of the steel decking began to separate, indicating failure of deck fasteners in the mid panel.	Fig. 4-24a
9	Buckling of the steel decking was visible.	Fig. 4-24b
12	Buckling of north side of the steel decking (between the secondary beam and the north primary beam) was visible, indicating delamination of steel decking.	Fig. 4-25
18	Water appeared on top of the slab through concrete cracks.	Fig. 4-26a
24	Concrete cracks became clearly visible north of the north primary beam.	Fig. 4-26b
41	A loud report was heard; several water-filled drums placed on the east surrounding bay trembled; some strain and displacement data were shifted up or down, simultaneously; concrete fractures around the perimeter of the heated slab were visible; heavy (wet) steam appeared on top of the heated concrete.	Fig. 4-27a
69	A loud report was heard; some strain and displacement readings were shifted up or down; concrete cracks appeared south of the secondary beam, propagating from the midspan toward the east or west direction.	Fig. 4-27b Fig. 4-29a

82 to 90	The glowing steel deck became visible through mid-panel concrete fractures; the gap between fractured concrete widened, indicating possible rupture of welded wire fabric.	Fig. 4-28a Fig. 4-29b
95 to 100	Steam from the concrete was almost disappeared; intermittent flames appeared on the concrete atop the beam-to-girder joints, indicating local deck and concrete fractures.	Fig. 4-27c
101	The values of HRRburner were affected by loss of the network connection used in the natural gas fuel delivery system	
106 to 107	Both fire and mechanical loading were removed.	Fig. 4-24c Fig. 4-28b Fig. 4-29c
> 107	The test floor assembly did not collapse during cooling.	Fig. 4-28c

Fig. 4-24. Snapshots from the test video viewing inside the test compartment at about (a) 5 min, (b) 9 min, and (c) 107 min after the burner ignition.

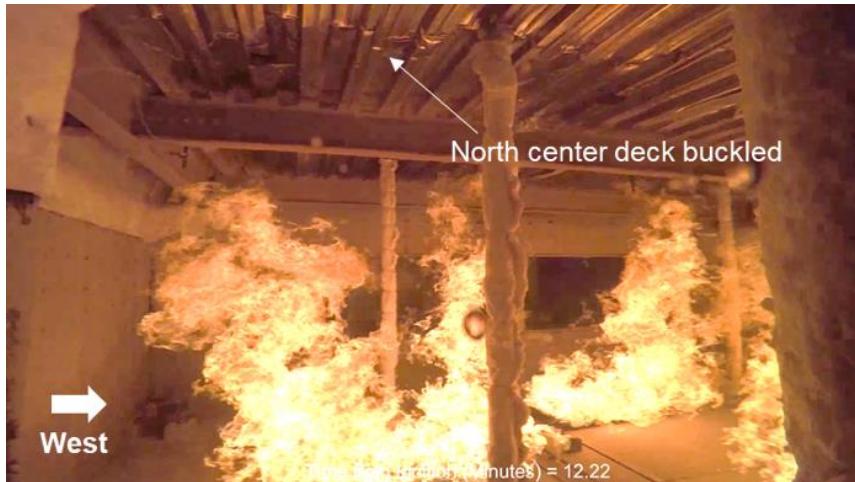
Fig. 4-25. A snapshot of the test video showing local buckling of the north steel deck at about 12 min.

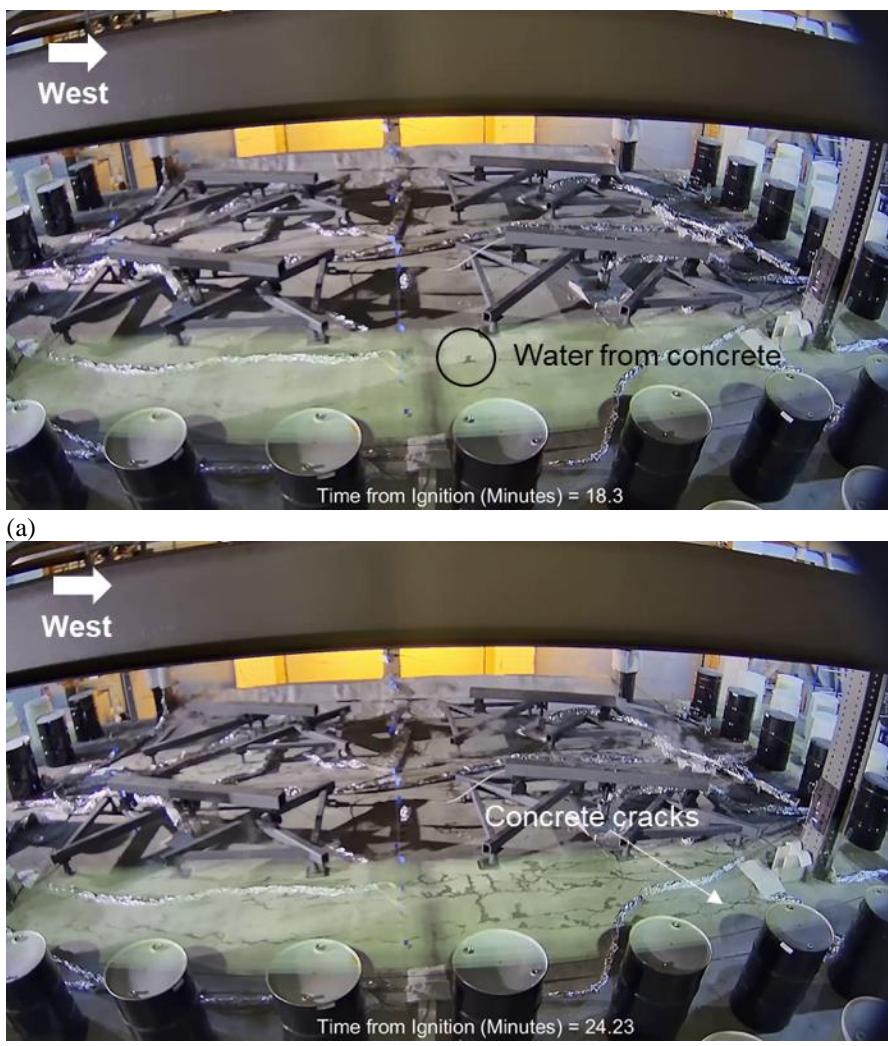
Fig. 4-26. Snapshots of the test video looking down on the top of the test floor assembly at about (a) 18 min and (b) 24 min.

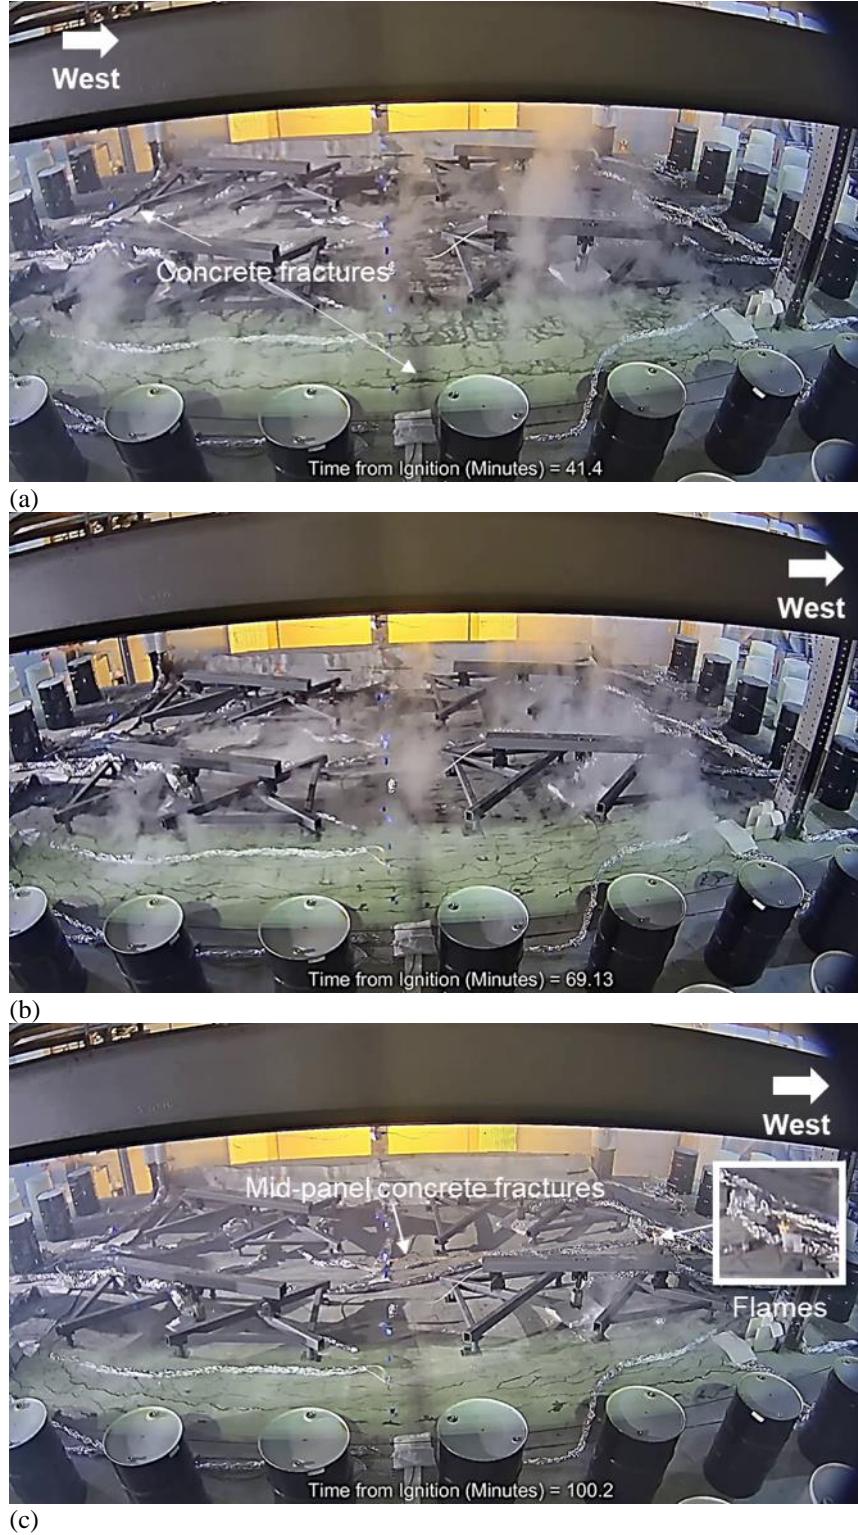
Fig. 4-27. Snapshots of the test video looking down on the top of the test floor assembly at about (a) 41 min, (b) 69 min, and (c) 100 min.

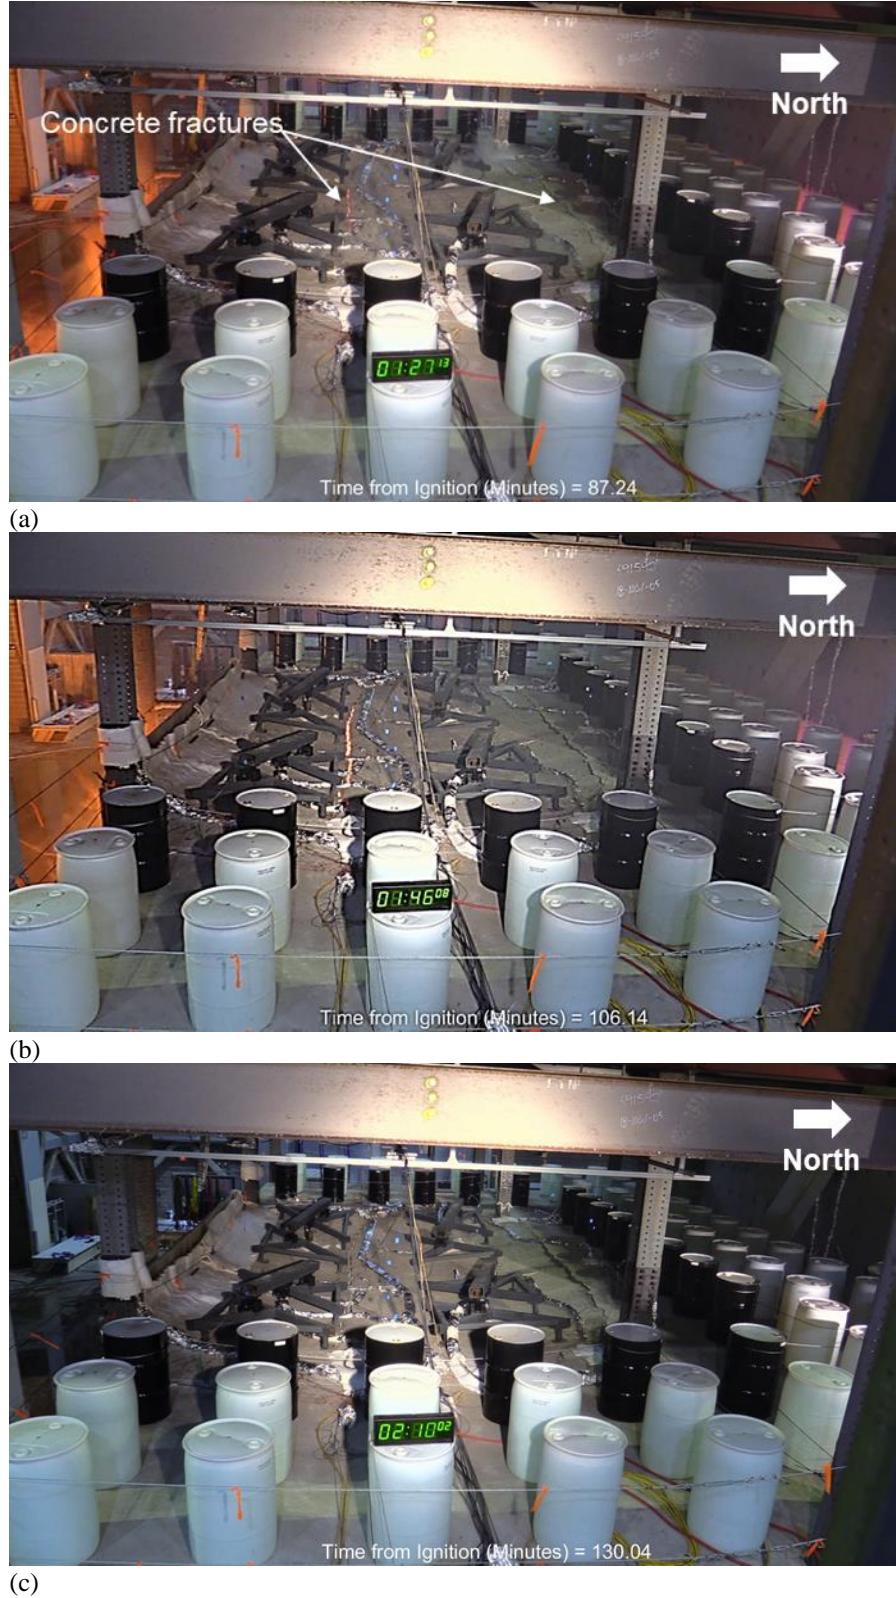
Fig. 4-28. Snapshots of the test video displaying the view from the east surrounding bay at (a) 87 min, (b) 106 min, and (c) 130 min (cooling).

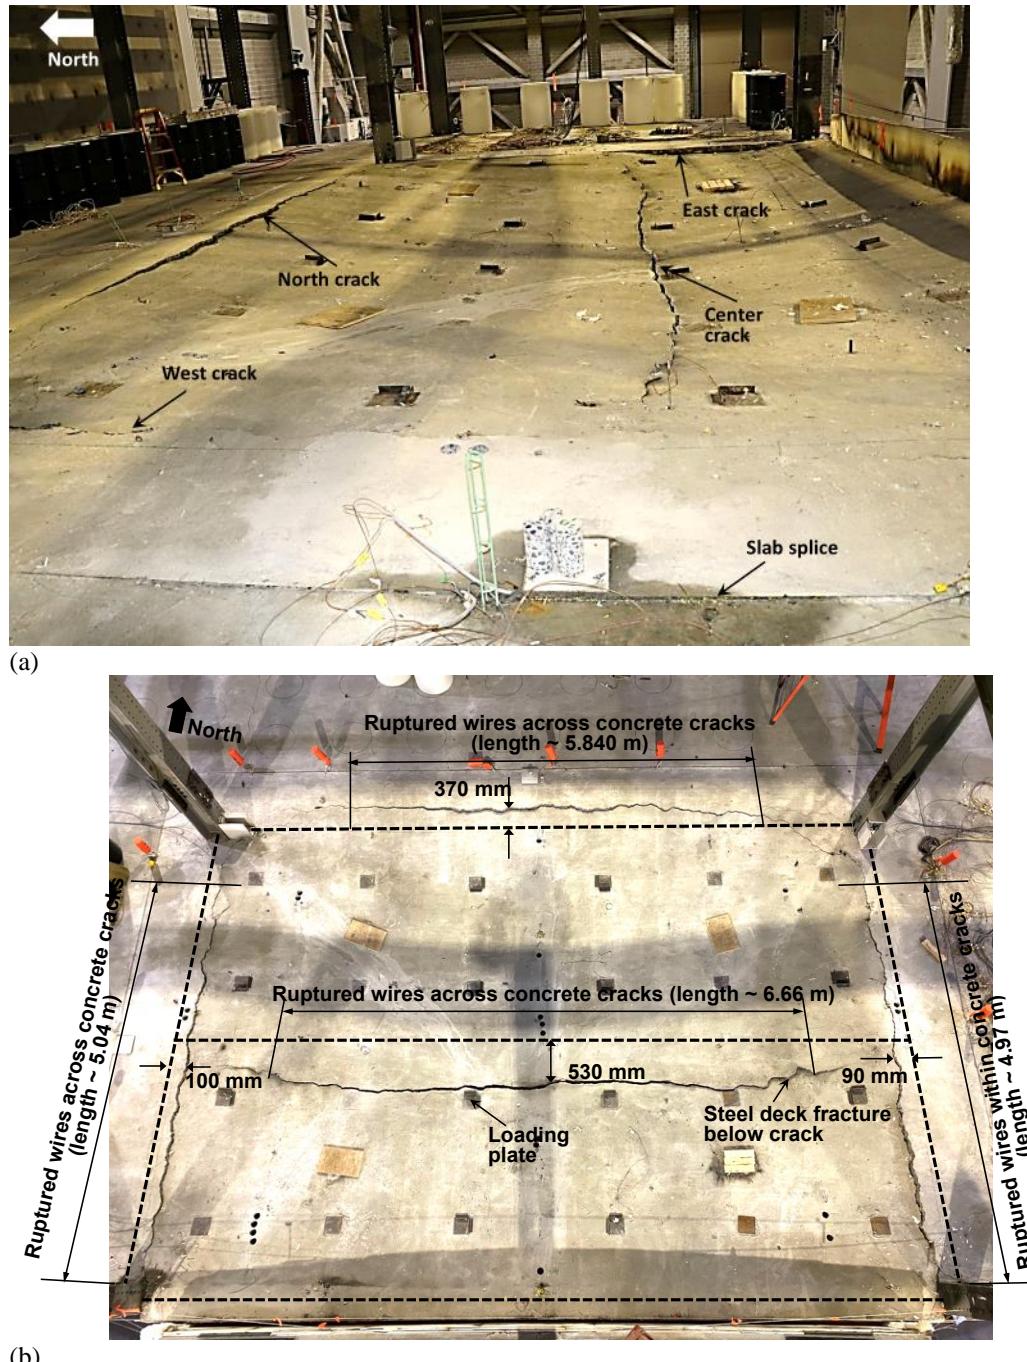
Fig. 4-38. Post-test photographs of (a) final deflected shape and (b) crack pattern of the test floor slab.

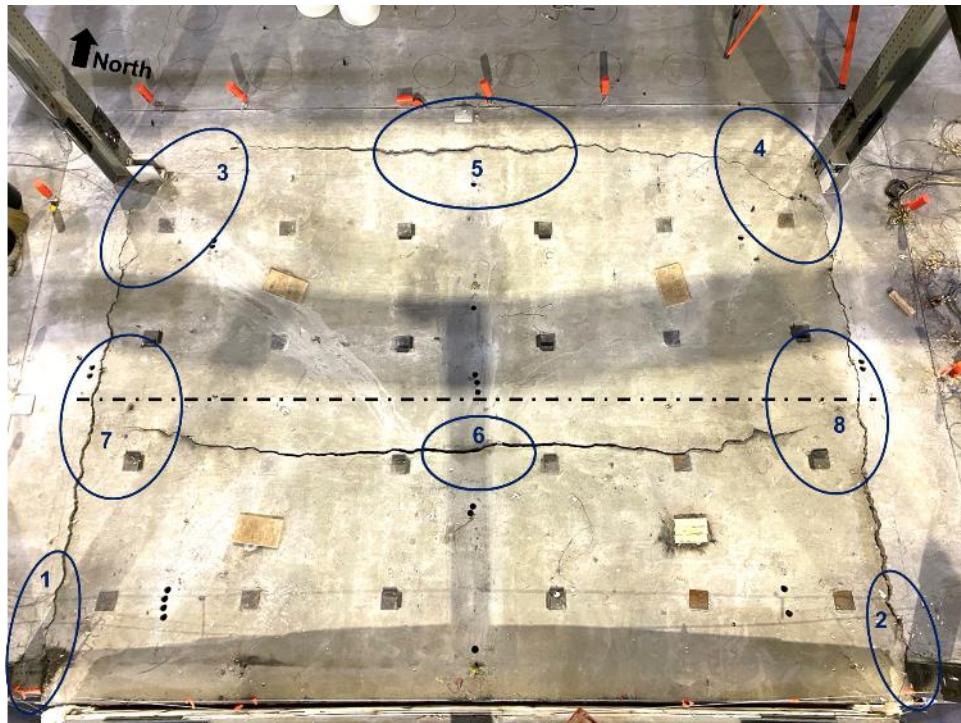
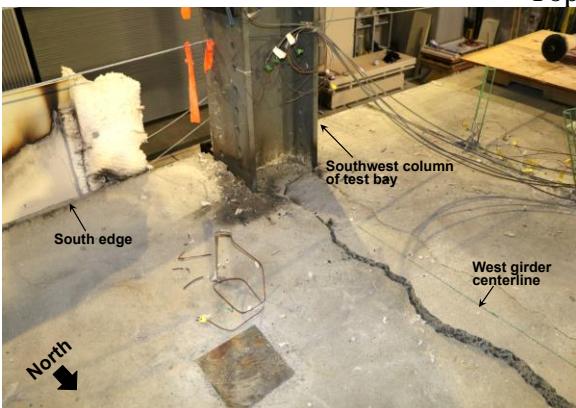
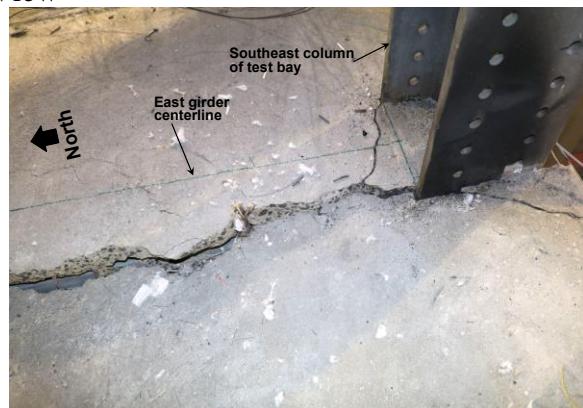
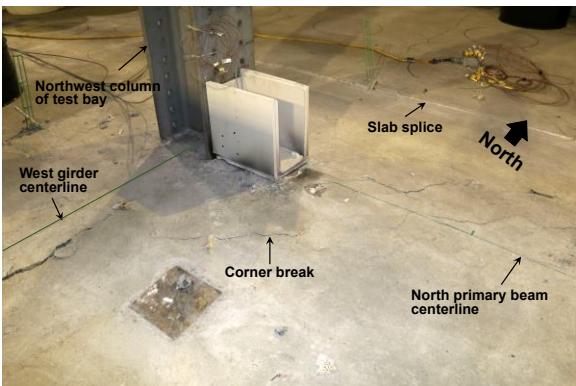
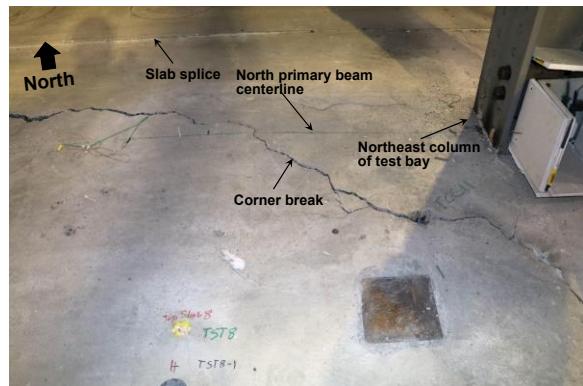
The north longitudinal crack was developed approximately 370 mm north of the north primary beam centerline but still within the footprint of the fire test compartment, Fig. 4-38b. The north edge of the fire test compartment was located 480 mm north of the north primary beam centerline (Refer to Chapter 2). Concrete fracture planes were located near the south ends of the No.4 reinforcing bars extended from the slab splice plate. Larger cracks were visible around the center of the north primary beam, location 5 in Fig. 4-39. The welded wire reinforcement was ruptured across the crack openings. Much smaller cracks appeared toward the interior columns; See locations 3 and 4 in Fig. 4-39. Only hairline surface cracks were visible on the concrete slab over the south edge beam.

The center longitudinal cracks were located approximately 530 mm south of the secondary beam centerline (Fig. 4-38b). Some of these cracks were much wider around the mid panel, with the final crack width of 50 mm or greater after cooling, and thinner toward the east or west girders. This result matches with the test observation that the concrete cracks were developed from the center and propagated towards the east and west girders. The wire reinforcement across these crack openings was ruptured (location 6 in Fig. 4-39).

Fig. 4-39. Post-test photographs of the test floor slab; locations 1 through 8 are closeups of concrete fractures.

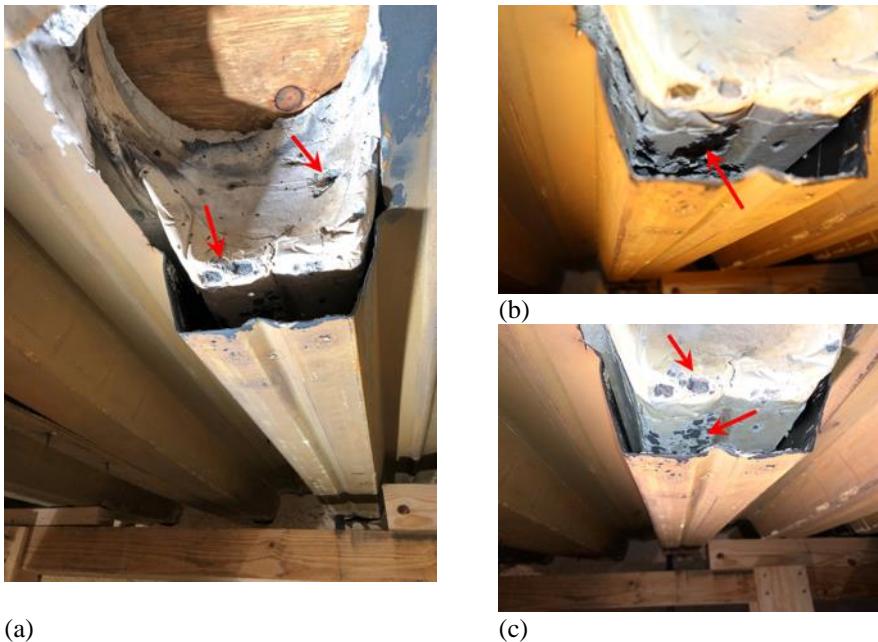
Fig. 4-40. Post-test photographs: (a) slab through-hole used for running a water-cooled loading tube; (b-c) deck delamination from concrete. Localized spalling is indicated by arrows.

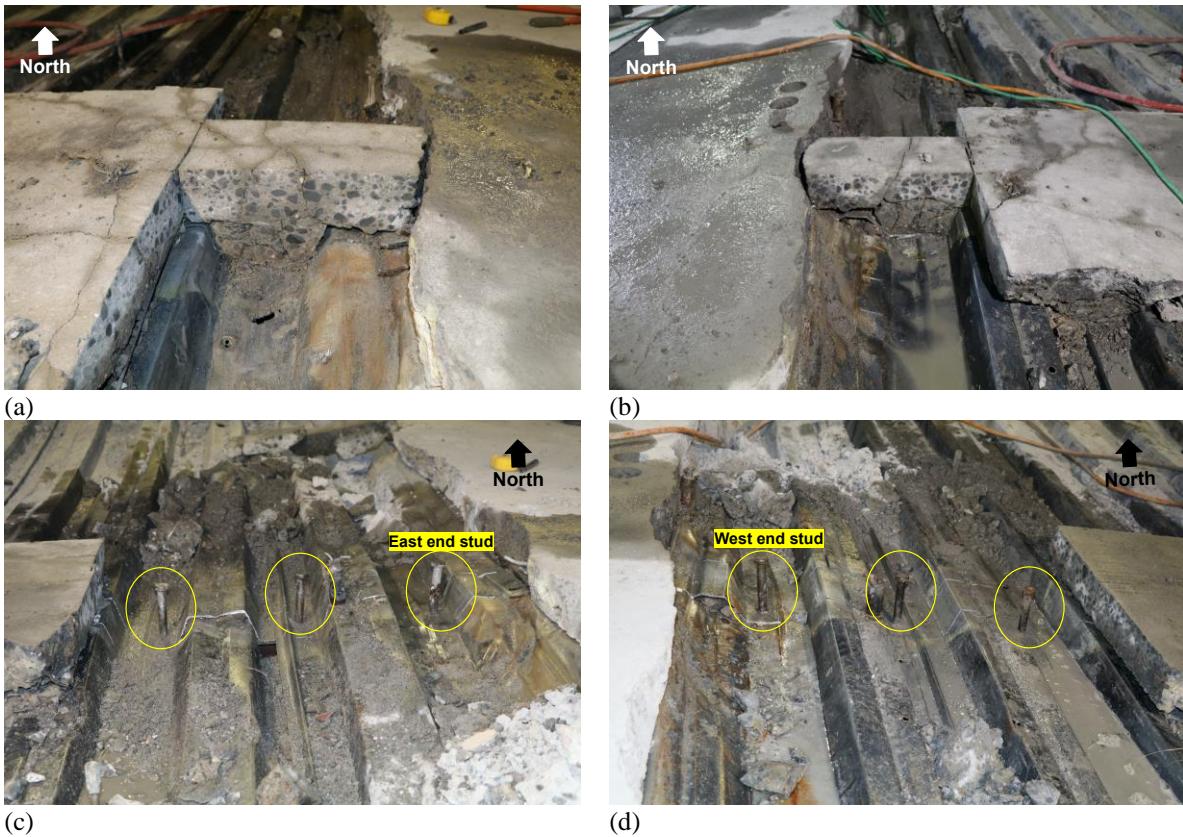
Fig. 4-41. Saw cut concrete over (a) east and (b) west ends of the secondary beam; three stud anchors at (c) east and (d) west ends of the secondary beam.

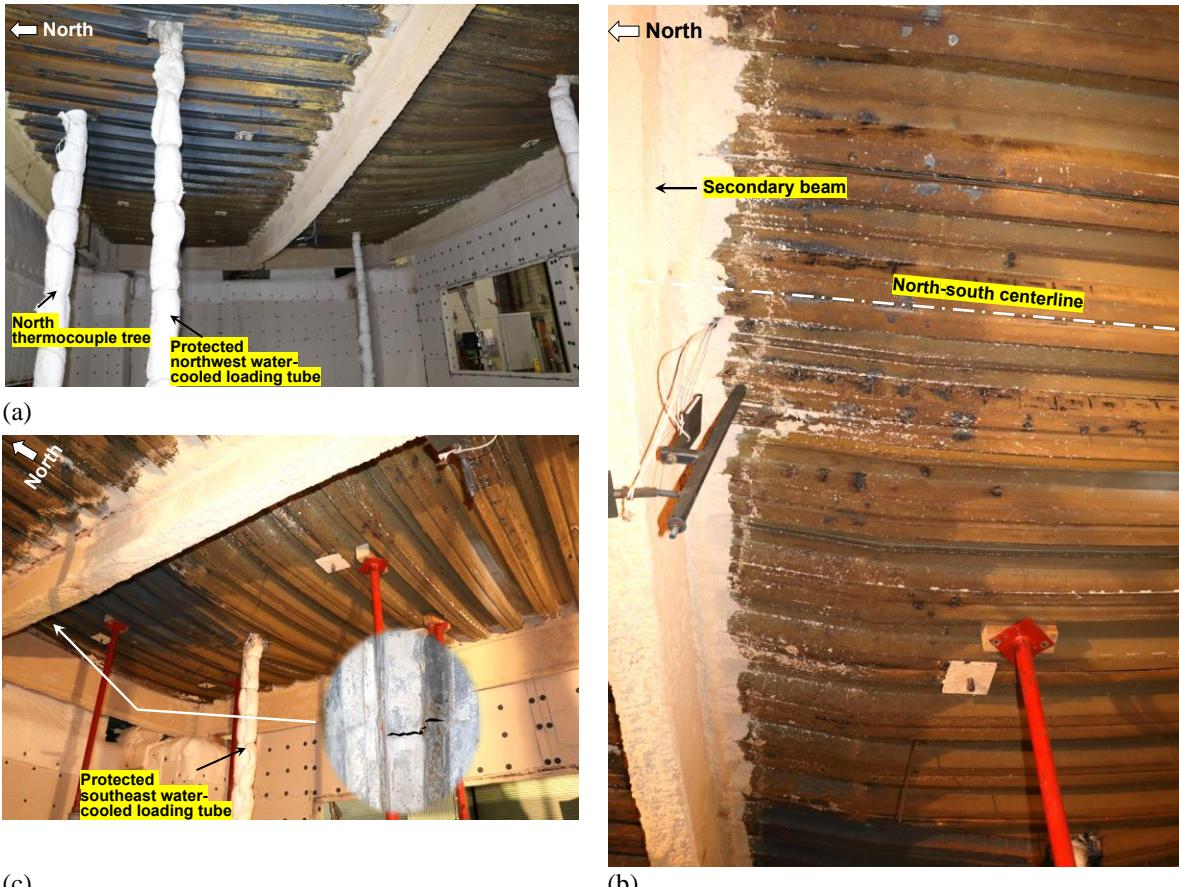
Fig. 4-42. Post-test photographs: (a) overall deflected shape and color of the exposed decking; (b) closeup of the steel decking south of the secondary beam; (c) southeast corner of the steel decking.

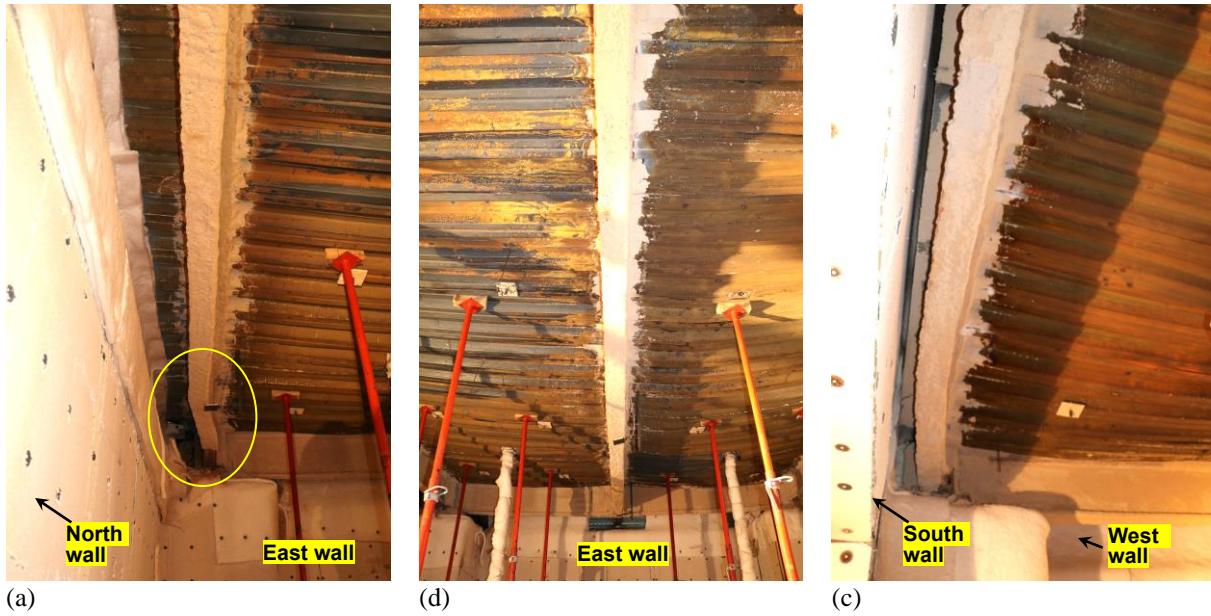
All exposed 9.1 m long beams and 6.1 m long girders exhibited permanent deformations in a variety of ways as shown in Fig. 4-43. The final value of the vertical displacement at midspan (after cooling) was measured 350 mm for the secondary beam (W16×31), 50 mm for the north primary beam, and 70 mm for the south primary beam. The midspan vertical deflection of the secondary beam recovered to approximately 40 % of its peak value measured during heating. In addition, the north and south primary beams exhibited lateral deformations and twisting, whereas the secondary beam was mostly bent in its strong axis.

Fig. 4-43. Post-test photographs: (a) north primary beam; (b) secondary beam; (c) south primary beam.

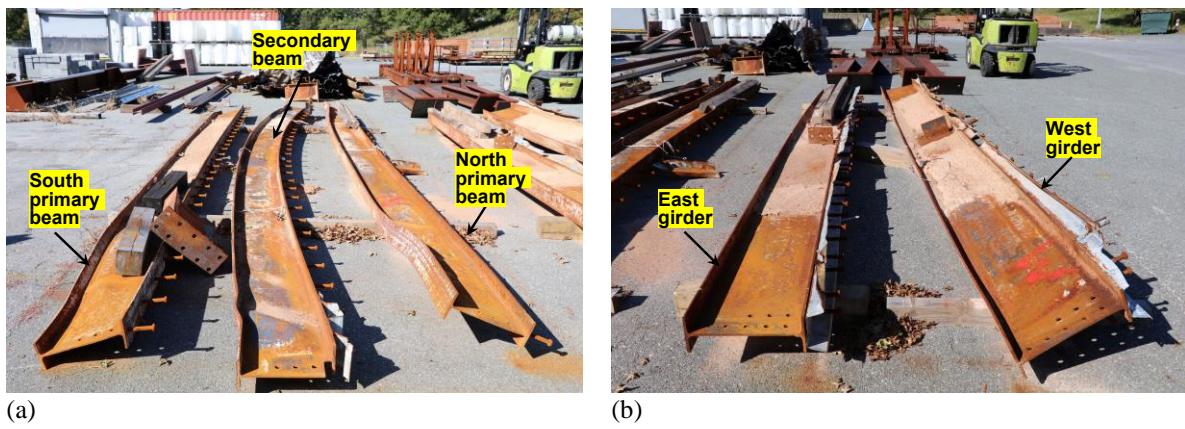
The west and east girders (W18×35) had the permanent vertical deflection of 20 mm and 15 mm, respectively. These girders were seldom deflected laterally. Photographs of the five steel members after demolition of the concrete slab are shown in Fig. 4-44.

Fig. 4-44. Post-test photographs: (a) W16×31 beams; (b) W18×35 girders.

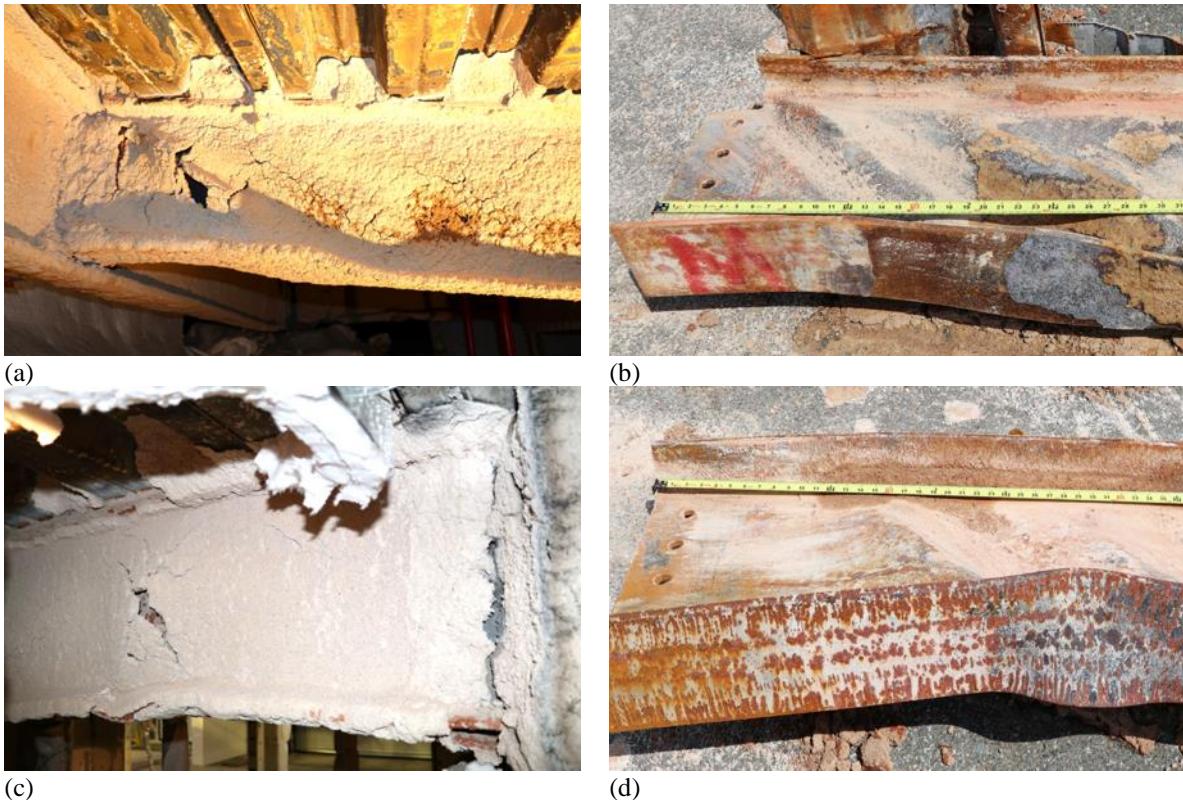
The north primary and secondary W16×31 beams also exhibited local buckling at the web and bottom flange toward their beam-end connections, Fig. 4-45. The region affected by local buckling was about 70 cm from the ends of the members. However, the W18×35 girders and the south primary W16×31 beam were barely buckled near their ends, Fig. 4-46.

Fig. 4-45. Post-test photographs: (a-b) west end of secondary beam; (c-d) west end of north beam.

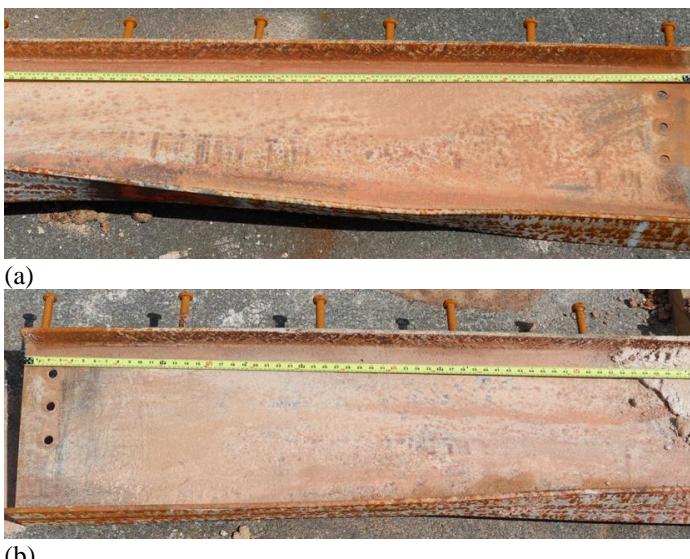
Fig. 4-46. Post-test photographs: (a) east and (b) west ends of south primary beam.

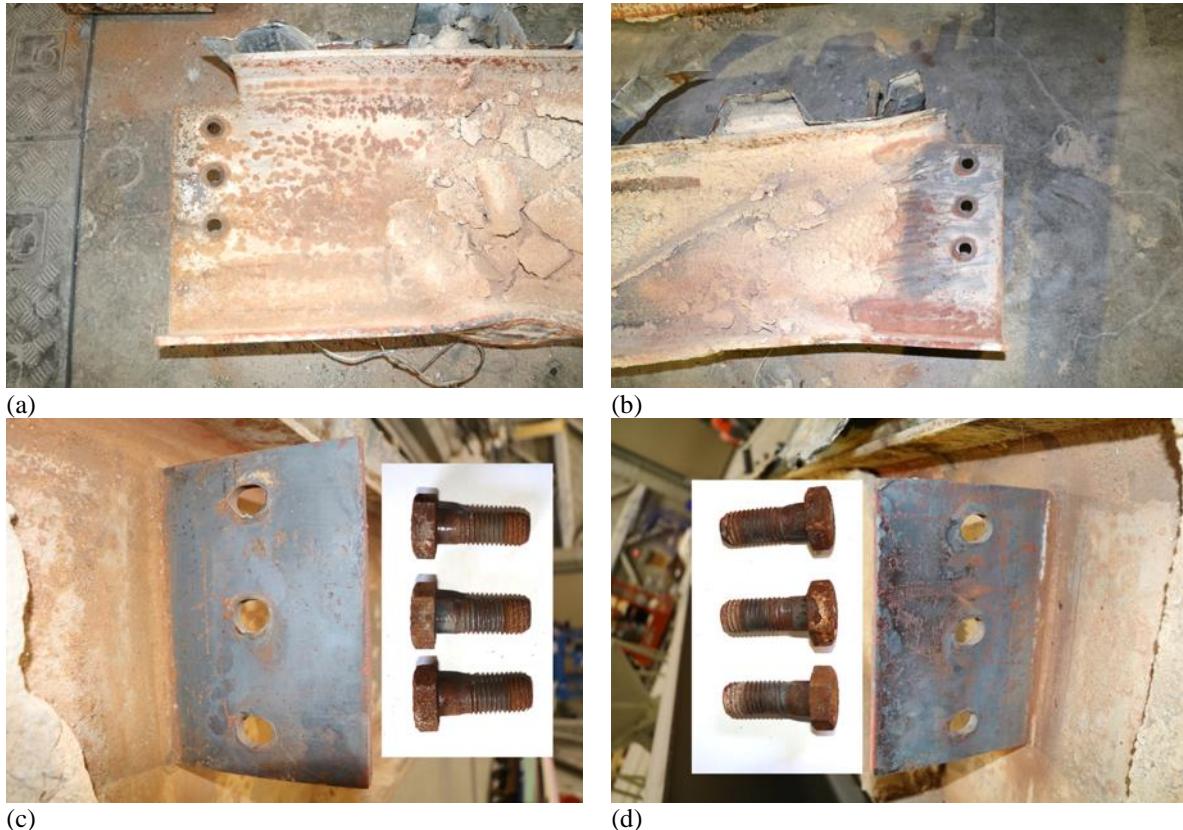
Fig. 4-47. Post-test photographs of the end connections of the secondary beam: (a) east beam web; (b) west beam web; (c) east shear tab connection; (d) west shear tab connection.

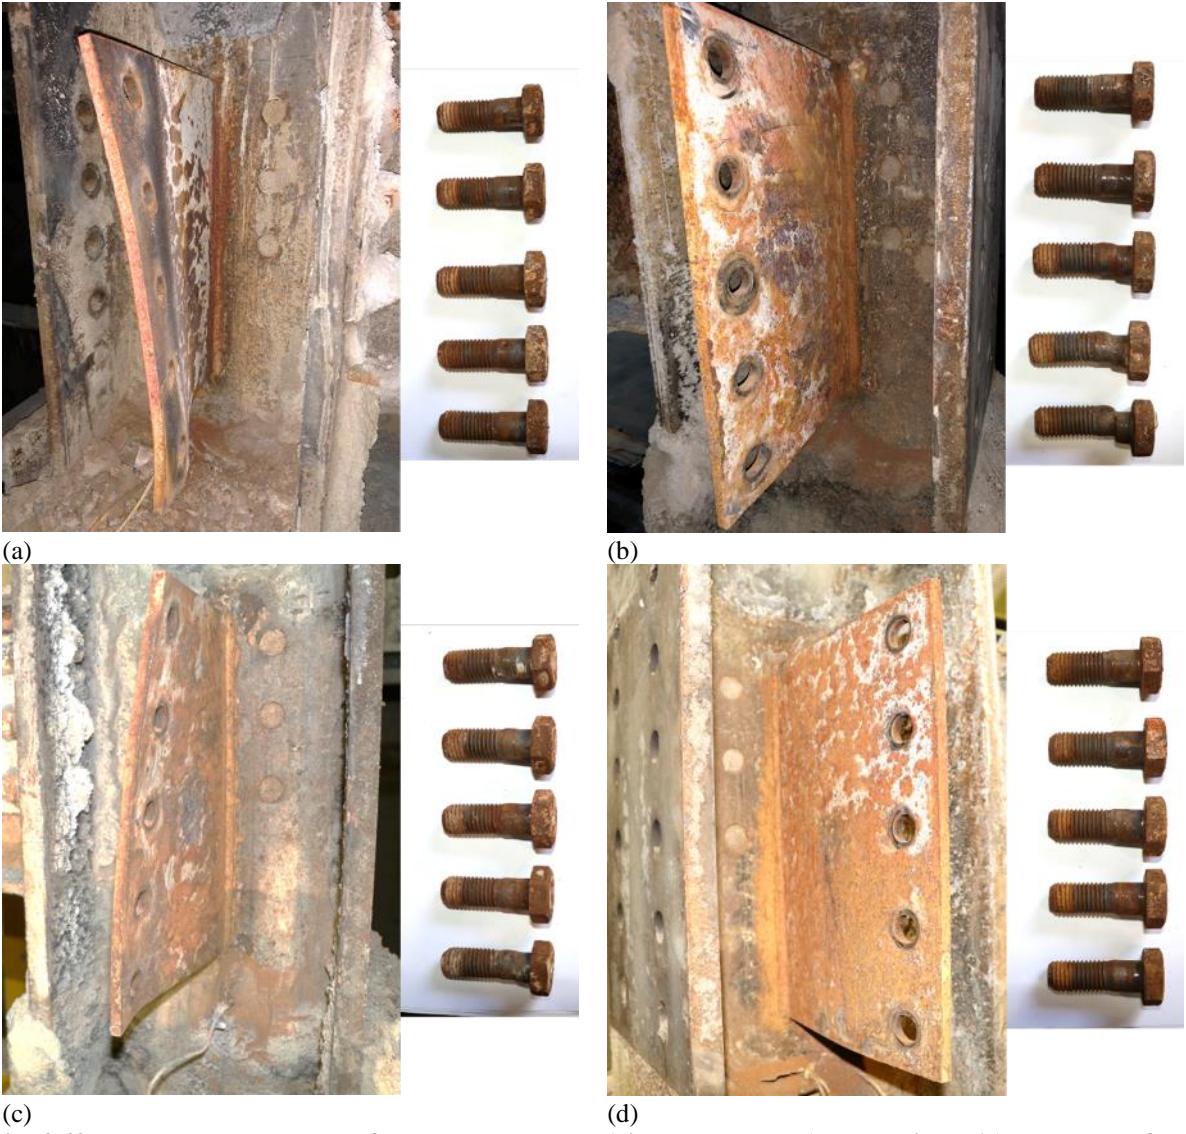
Fig. 4-48. Post-test photographs of extended shear tab (girder-to-column) connections: (a) north end of the east girder; (b) south end of the east girder; (c) north end of the west girder; (d) south end of the west girder.

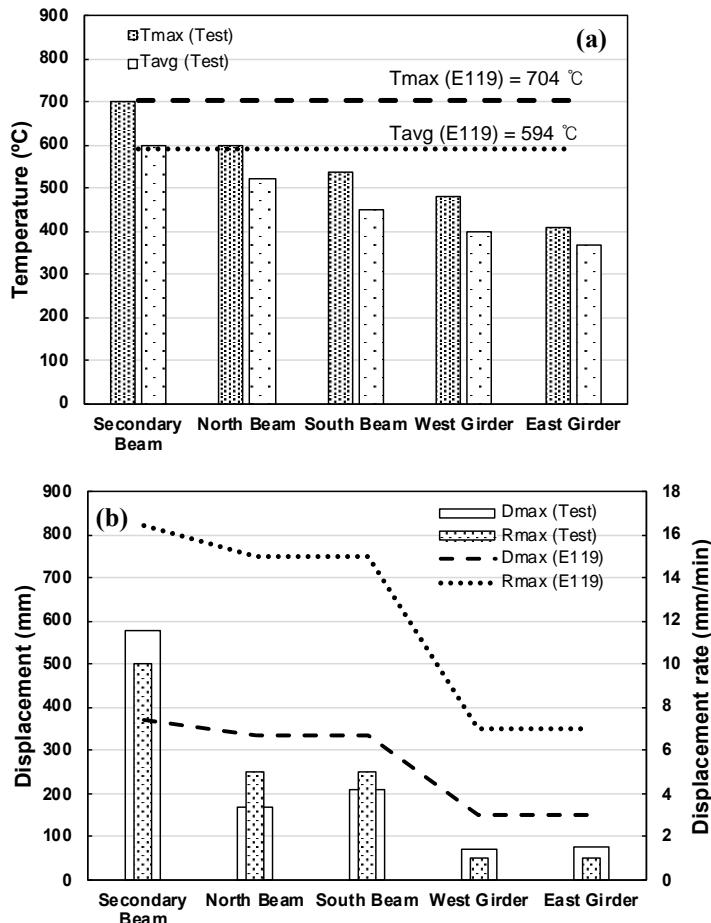
A comparison of the measured temperatures in this study with the ASTM E119 acceptance criteria is summarized in Fig. 4-49. As shown, the protected individual W16×31 beams and W18×35 girders of the test assembly were deemed to successfully meet the ASTM E119 limiting temperature and displacement criteria. The average concrete surface temperature measured by eight thermocouples distributed across the test assembly was approximately 120 °C prior to extinguishment of the test fire. Although displacements of the secondary beam exceeded the ASTM E119 limit during fire, a displacement rate was measured 40 % less than the ASTM E119 limit. It is to be noted that the total gravity load used in this study was determined from the ASCE 7 load combination of 1.2×dead load + 0.5×live load, which is only 30 % of the gravity load prescribed in the ASTM E119 standard. If the higher ASTM E119 load had been used instead, then it stands to reason that the displacement and displacement rate of the test floor would have been greater.

More importantly, this fire experiment revealed some potential issues related to the integrity of a composite floor assembly as part of compartmentation under fire loading. As reported in Sect.4.5.1, the center breach in the test floor slab, initiated prior to the specified rating period of 120 min, was accompanied by ruptures of the wire reinforcement in tension at the mid-panel displacement of 350 mm (the $L/26$ ratio) or greater. A minimum code-required amount of shrinkage reinforcement ($60 \text{ mm}^2/\text{m}$) used in the test assembly was insufficient to resist

thermally induced tension during the investigated fire. Although the steel deck continuously running in the transverse (north-south) direction of the test assembly appeared to be ductile at large vertical displacements, failure of side deck joints (fastener failure at the decking overlap), local deck ruptures, exposure of the heated decking units within concrete cracks allowed the penetration of flames and hot gases beyond the test compartment. This condition could have potentially ignited cotton waste placed on the unexposed surface, failing to meet the standard fire testing criterion ‘i’ as mentioned above.

Fig. 4-49. Comparisons of the test results with (a) limiting temperatures and (b) limiting displacements and displacement rates, where Dmax = maximum displacement and Rmax = maximum displacement rate.

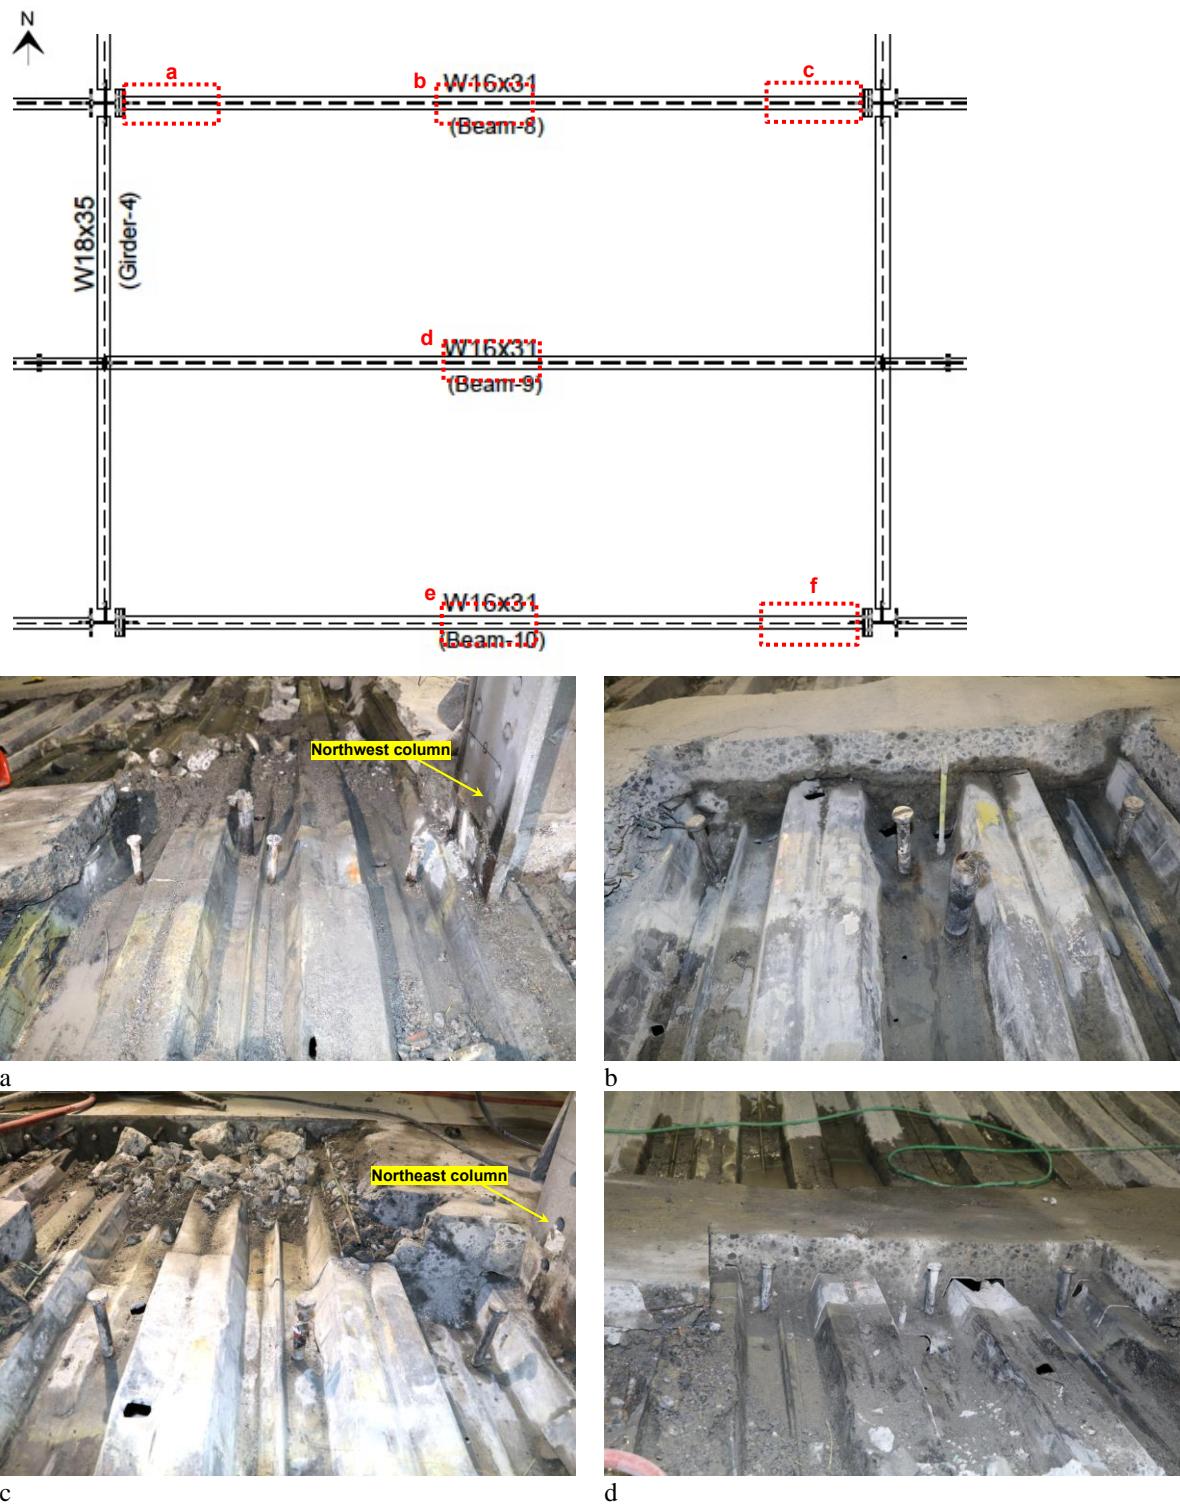
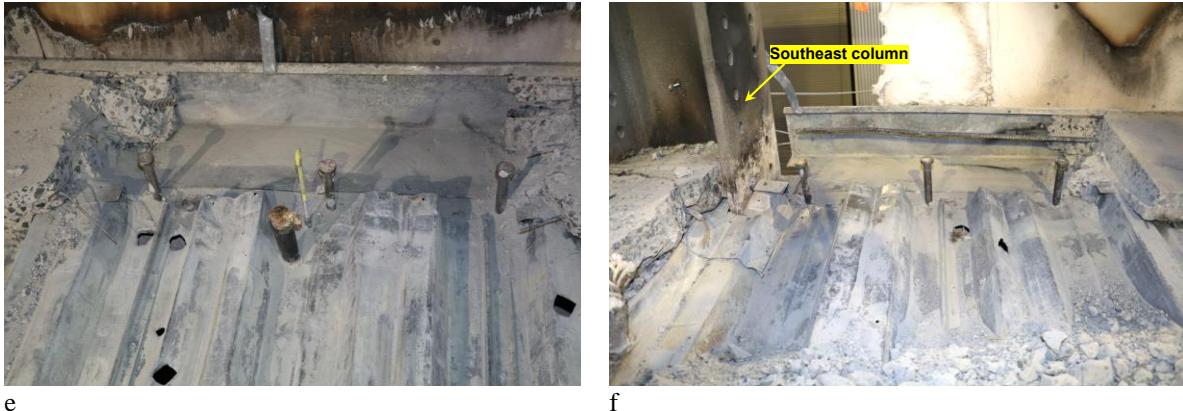
Fig. B-23. Post-test photographs of headed stud anchors in the test bay.

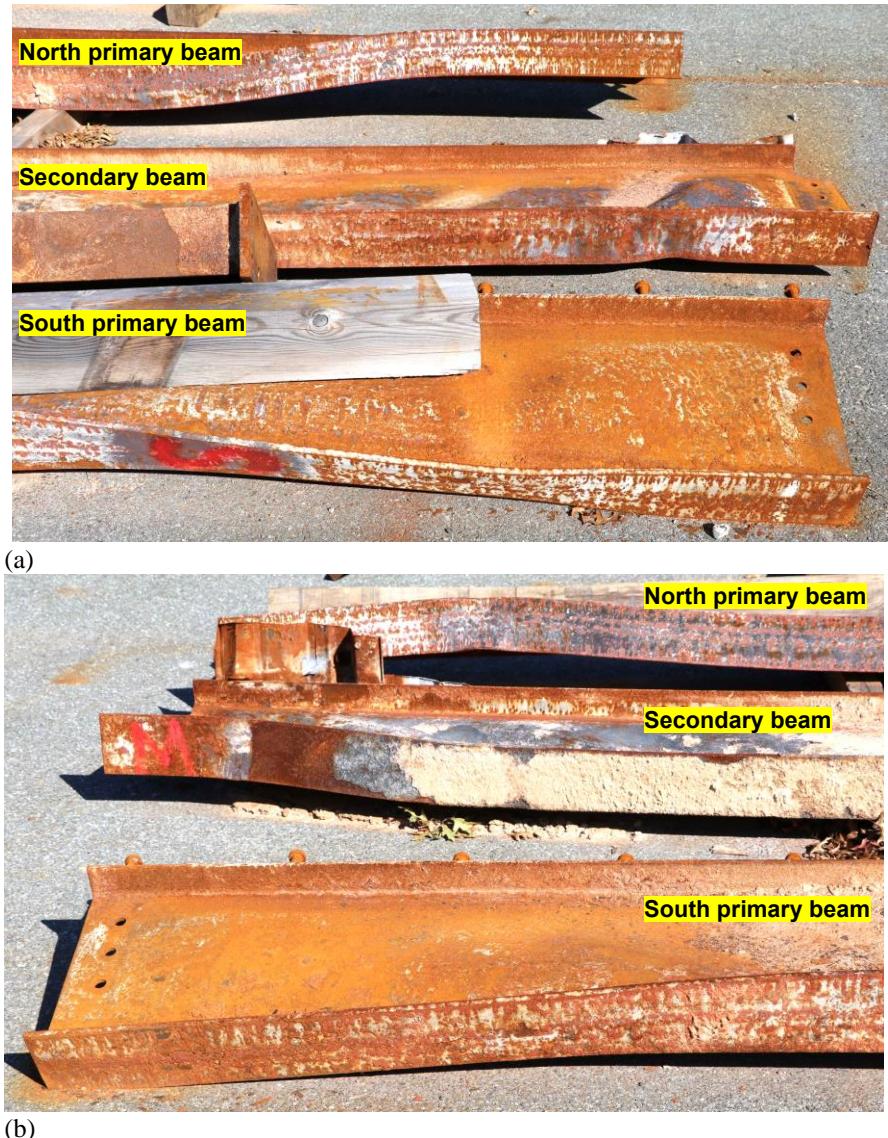
Fig. B-24. Post-test photographs of W16x31 beams in the test bay; (a) east end and (b) west end.
