NIST Technical Note 2165

Fire Resilience of a Steel-Concrete Composite Floor System: Full-Scale Experimental Evaluation for U.S. Prescriptive Approach with a 2-Hour Fire-Resistance Rating (Test #1)

October 2021

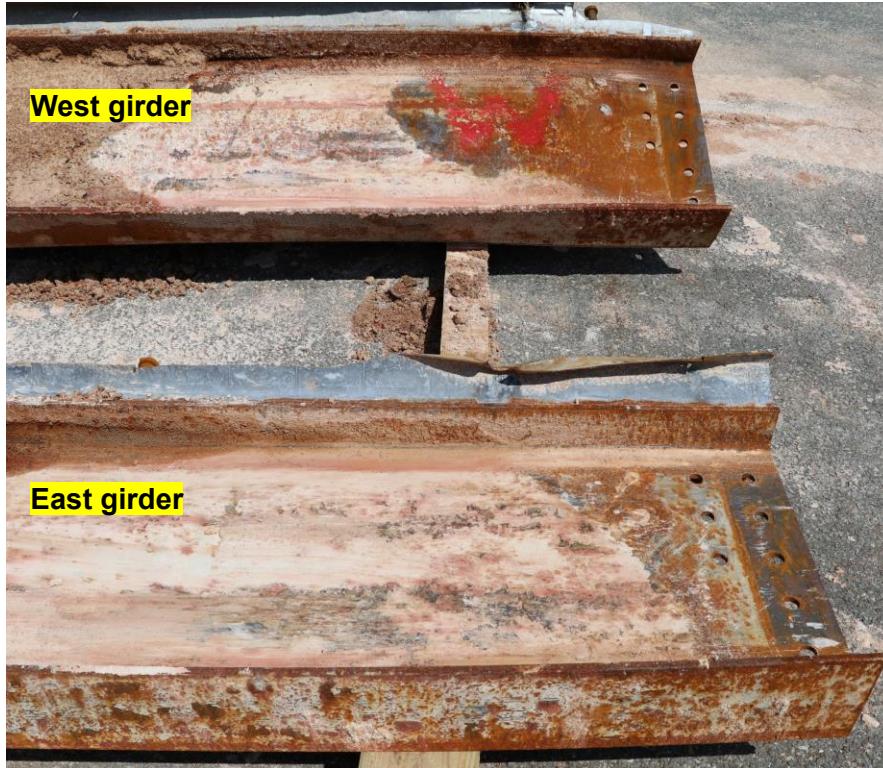
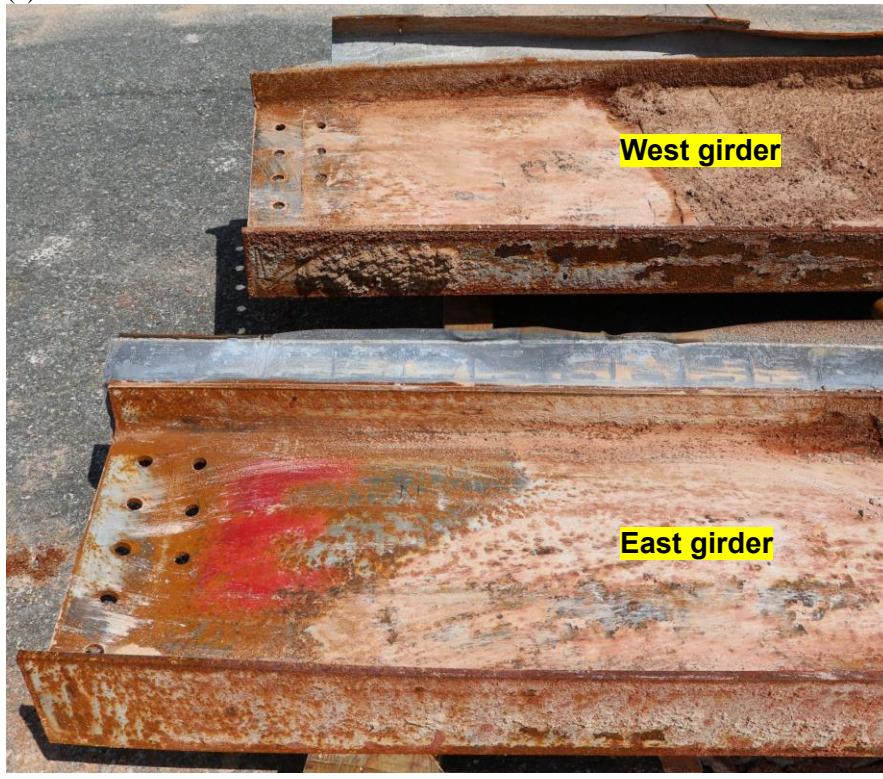
Fig. B-25. Post-test photographs of W18×35 girders in the test bay; (a) north end and (b) south end.

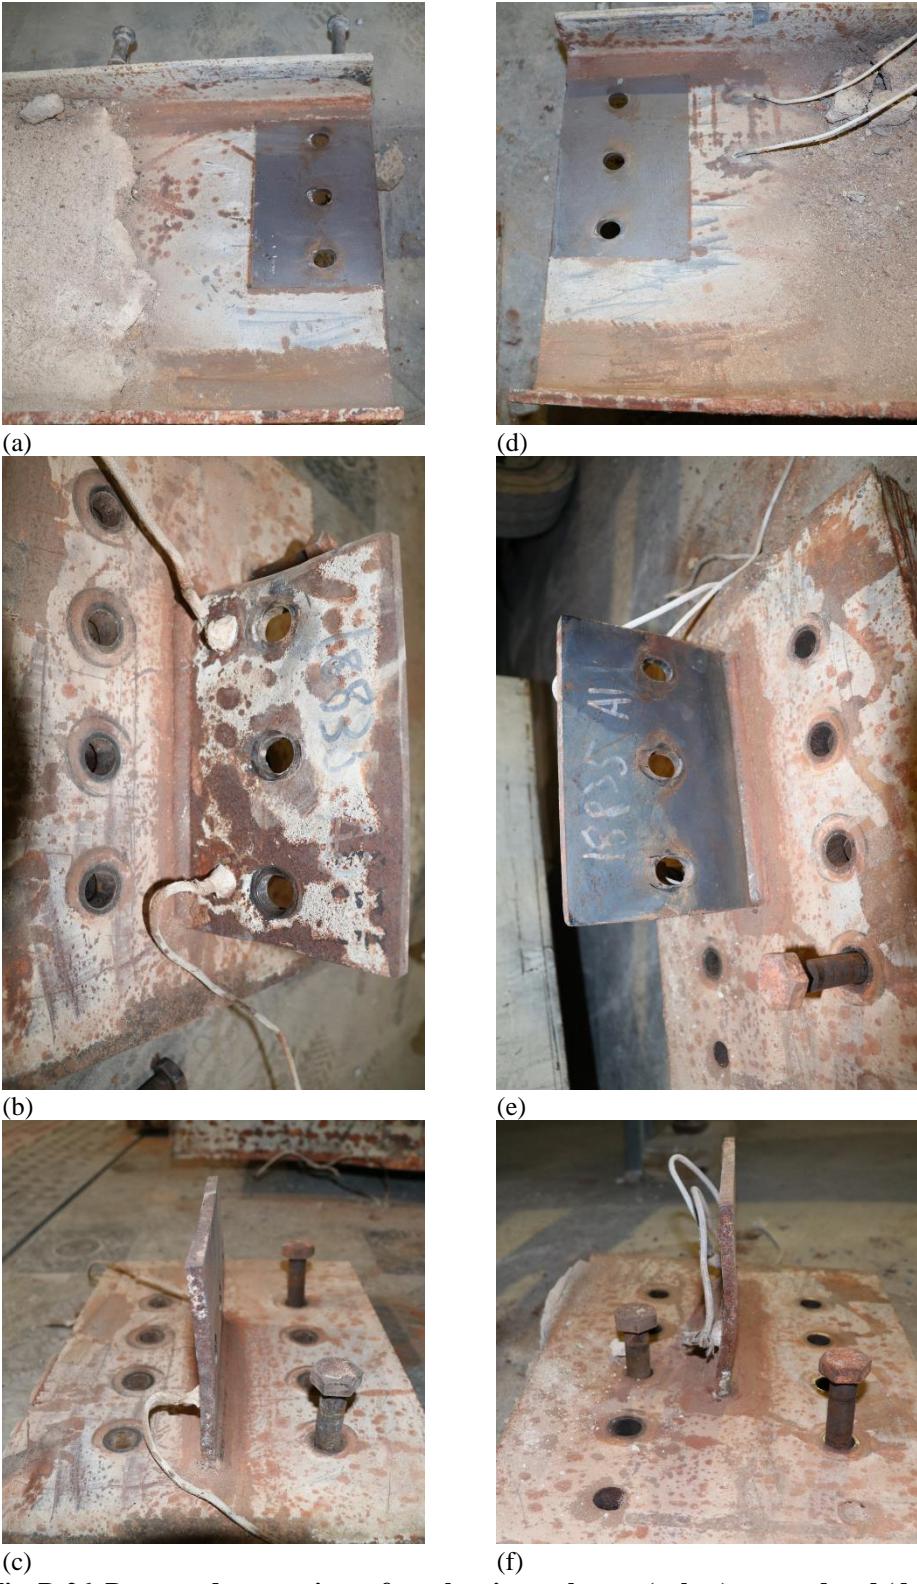
Fig. B-26. Beam-end connections of north primary beam; (a, b, c) east end and (d, e, f) west end.

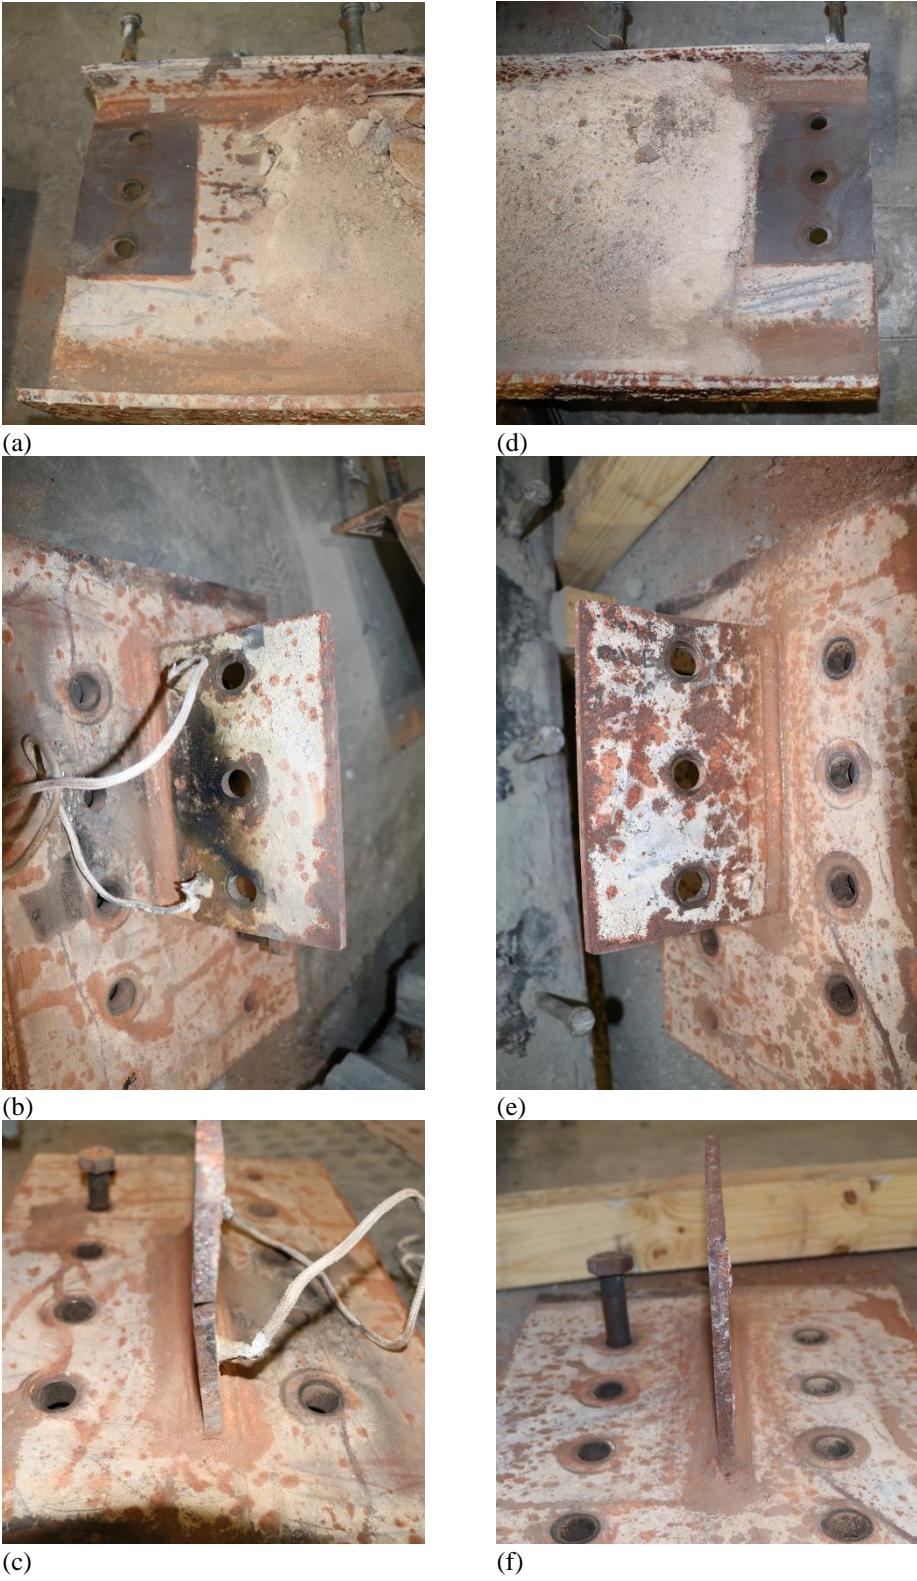
Fig. B-27. Beam-end connections of south primary beam; (a, b, c) east end and (d, e, f) west end.
