General Update

Antonio Feed update

Retrofitted Antonio Feed Installed at Antenna 2H

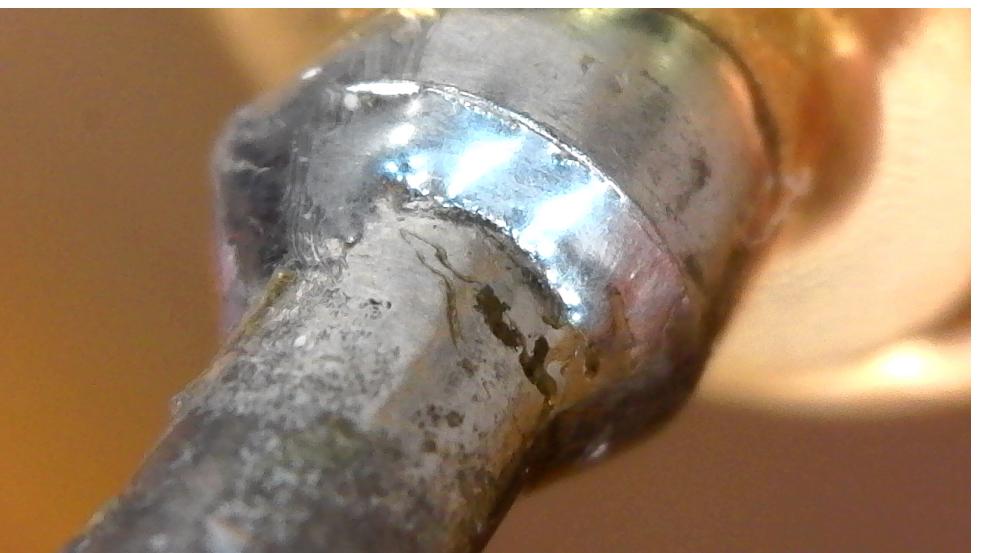
60Hz investigation 2H

- Investigated log-periodic feed!
- Looked at solder connection of coaxial cable.
- Broken tip-link found!
