Allen Telescope Array

Antonio Feed Inspection Report

February 21, 2020

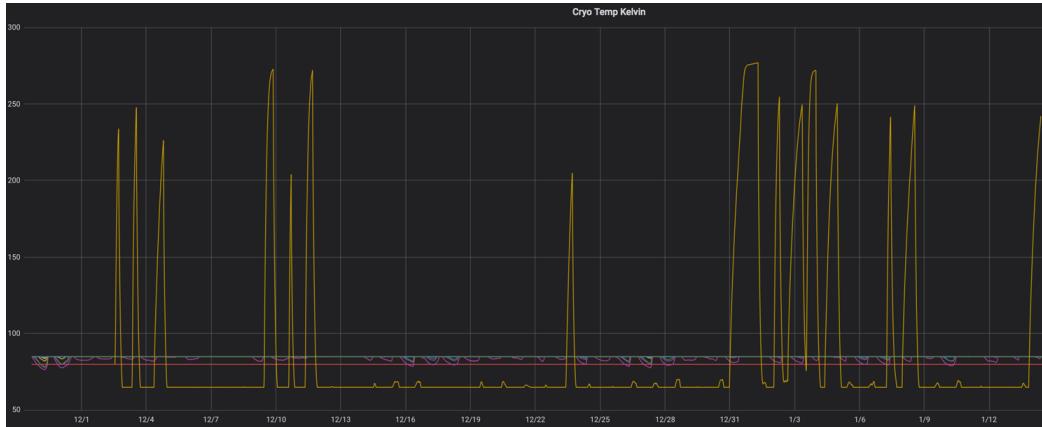
Following to that we started temperature cycling the feed in order to stress the tip-link prototype. (2nd of Dec. 2019). After 6 cycles from 65K to ambient temperature the feed was still operational. We then detuned the cryocooler in order test the robustness of the R02 tip-link with an increased vibration environment. After 3 temperature cycles with that configuration we confirmed by observing a target that the feed was still operational. Following to this, we performed 5 additional temperature cycles during which the feed failed(23rd of Dec. 2019). Figure 1, shows the temperature cycles over the entire test period.

Figure 1: Grafana plot of the feed temperature during the test period.

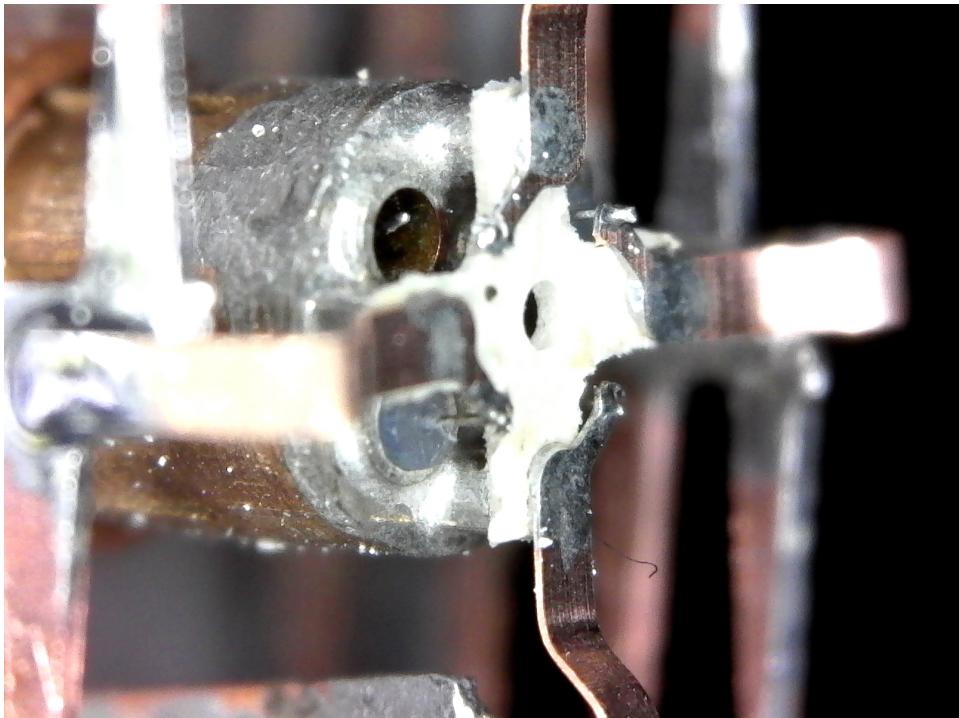
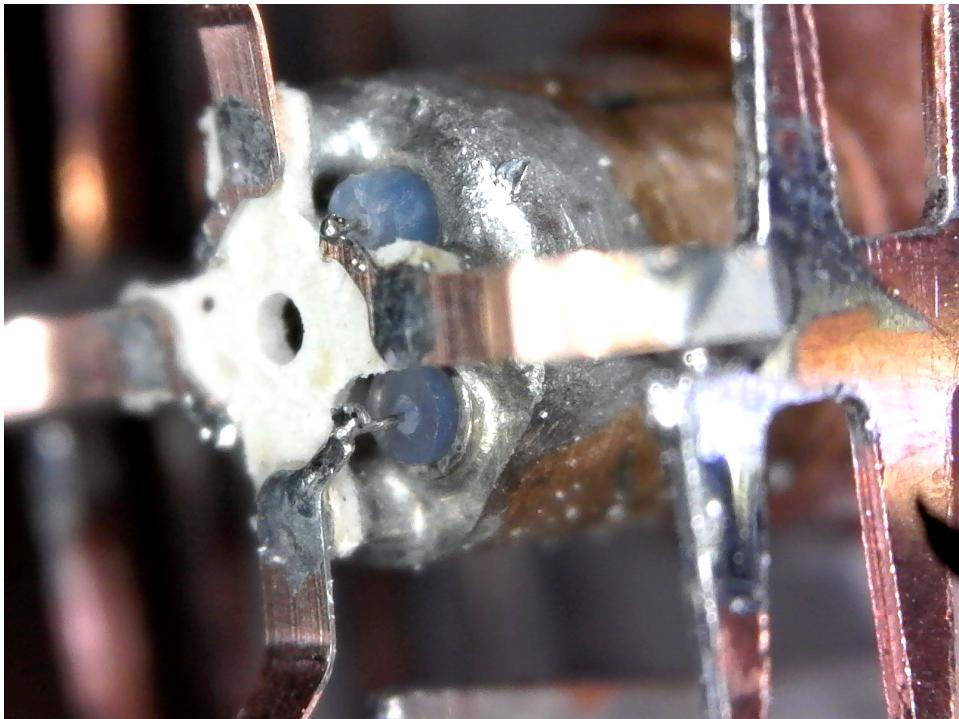
The inspection of the feed tip revealed that the prototype tip-link was still intact, and the failure was caused by the retraction of the center core of the coaxial cable. The pictures of the inspection from the 14th of Jan 2020, are shown in Figure 2. The log-periodic pyramid has been removed from the feed base and send to Minex, where the coaxial cable was removed and prepared for further X-RAY analysis.

Figure 2: Tip of feed 020 previously installed on 3C. (a) Shows the left-hand side of the tip, which has a broken connection where the center conductor is permanently retracted. (b) Shows the right-hand side of the tip which is still intact.

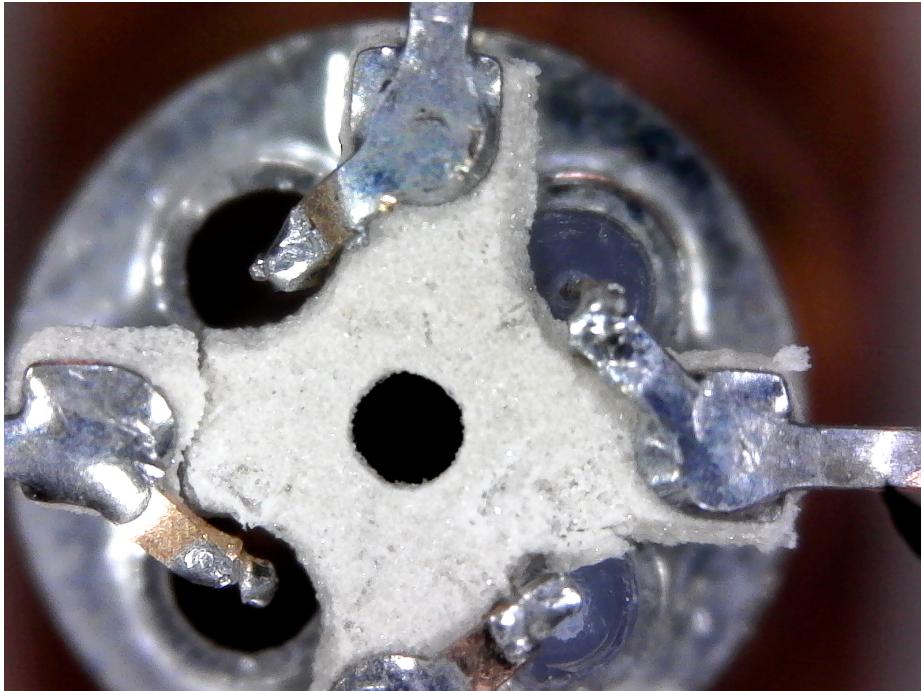
The inspection of the feed tip revealed that the original tip-link was still intact, and the failure was caused by the retraction of the center core of the coaxial cable. The pictures of the inspection from the 17th of Feb 2020, are shown in Figure 3 and 4. The log-periodic pyramid has been removed from the feed base and will be disassembled in order to inspect the LNA end of the coaxial cable.

Figure 3: Top view of the tip of feed 006, previously installed on 4J. One can see that on the left-hand side both coaxial cable center conductor are retracted. The lower left coaxial cable broke off and even caused the capacitor board to break.

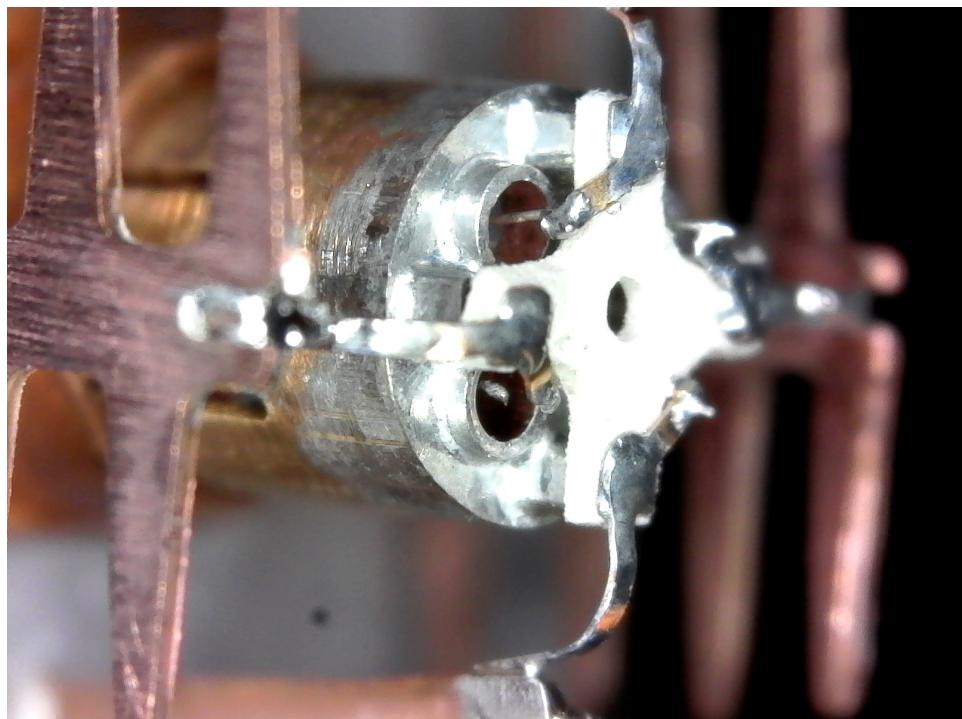
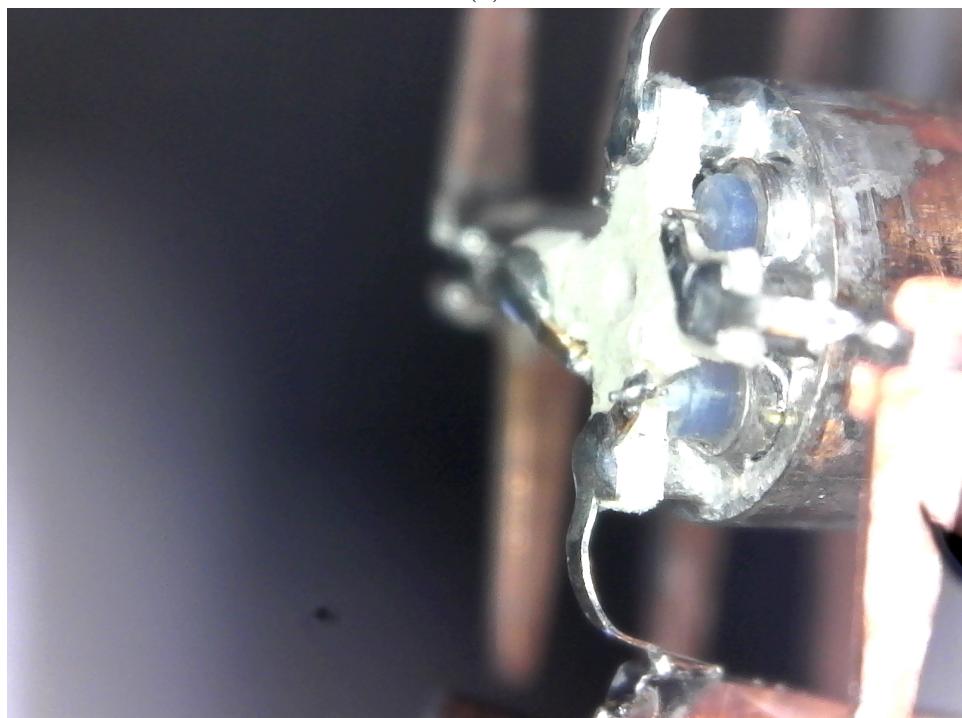
Figure 4: Tip of feed 006 previously installed on 4J. (a) Shows the left-hand side of the tip, which has a broken connection where the center conductor is permanently retracted. (b) Shows the right-hand side of the tip which is still intact.

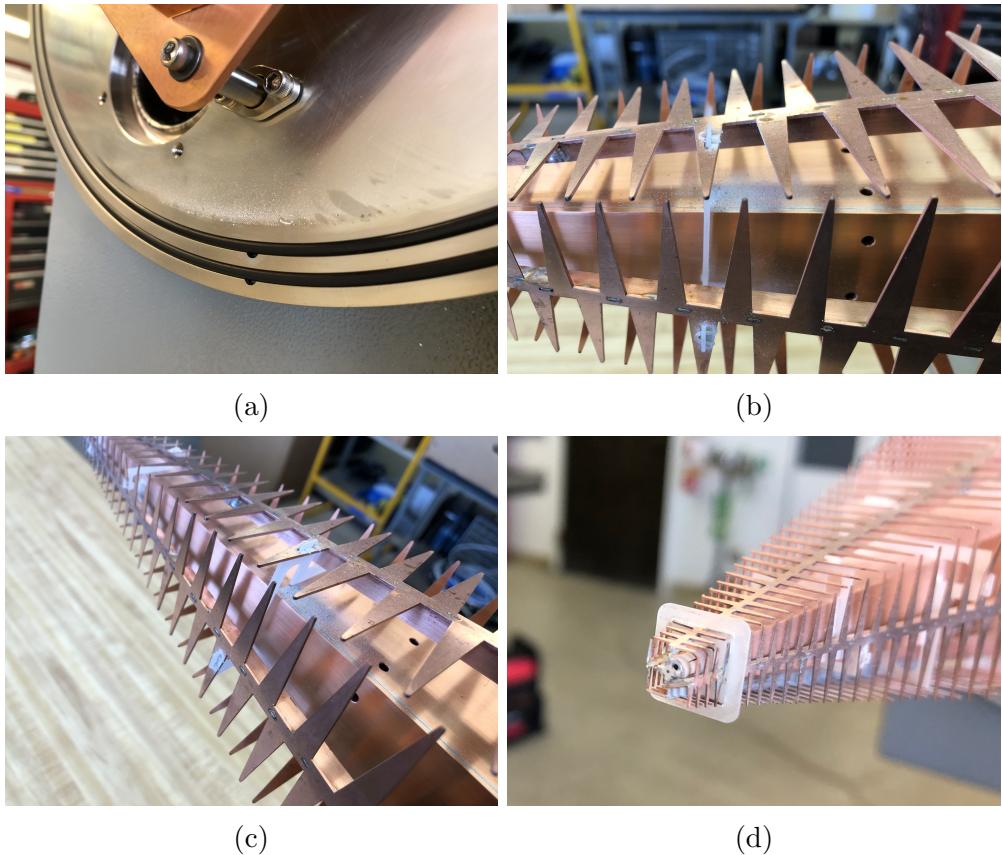
This feed is an original Antonio Feed with no modifications or retrofitted components. The feed has been identified as non operational during the feed system temperature measurements in Oct. 2019 and was switched off afterwards. As part of the tip failure investigation this feed was removed from antenna 1H and inspected. The overall condition of the log-periodic pyramid is shown in Figure 5. One can see that there is some amount of dust and particles located at the bottom of the base plate, as well as dust on the log-periodic pyramid itself. The inspection showed that the Rexolite fixture of the feed arms degraded by the vibrations of the cryocooler.

Figure 5: Inspection of the cryostat and log-periodic pyramid of feed 013 (1H). (a) Shows the bottom of the base plate of the cryostat, which is contaminated by white dust and other particles. (b) and (c) Show the wear of the Rexolite standoffs caused by the vibration of the log-periodic pyramid structure (white dust). (d) Shows the tip, which also has white dust on it.

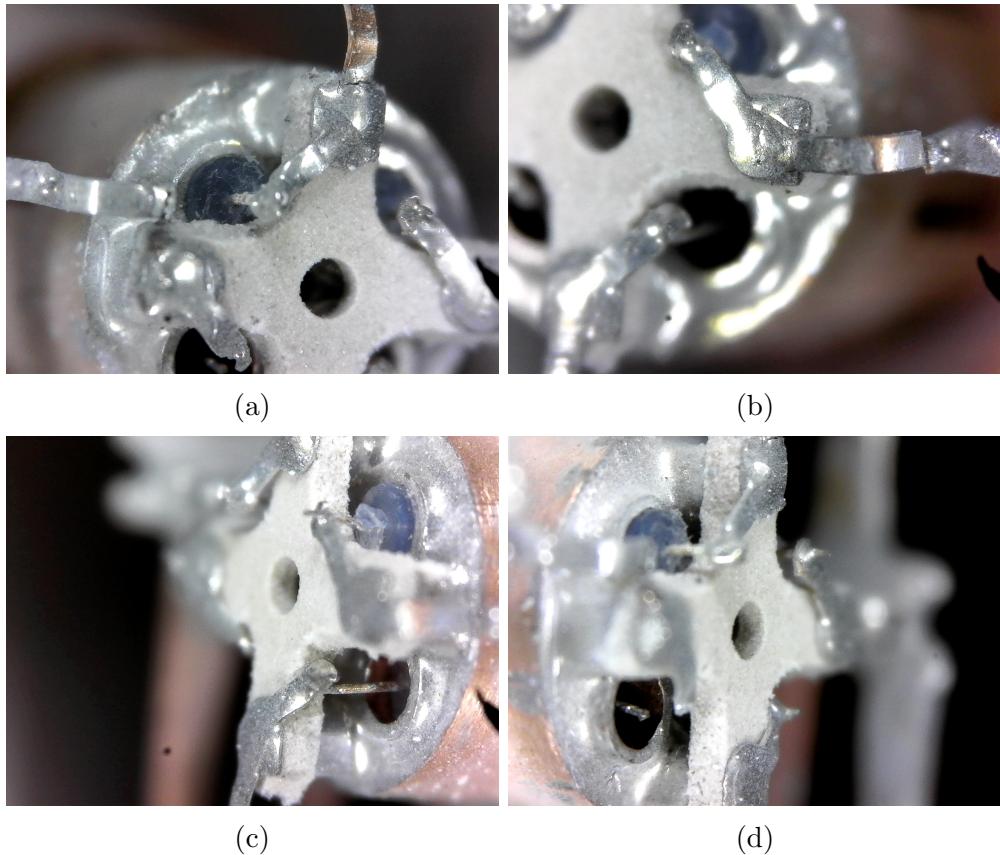
The inspection of the feed tip is shown in Figure 6. One can see that the failure of this feed is caused by a combination of coaxial center conductor retraction and broken tip-link connections to the feed arm. As this is a non retrofitted feed, it is very likely that the cryocooler is not tuned and therefore the vibrations experienced by the log-periodic feed were higher than in the revised feed versions.

Figure 6: Tip of feed 013 previously installed on 1H. (a) Shows a crack in the tip-link arm next to the capacitor pad. (b) Shows a broken tip-link connection. (c) Shows a retracted coaxial center conductor which is still connected to the tip-link. Although one can see that the tip-link is already bend downwards. (d) Shows the broken connection caused by a retracted coaxial center conductor.

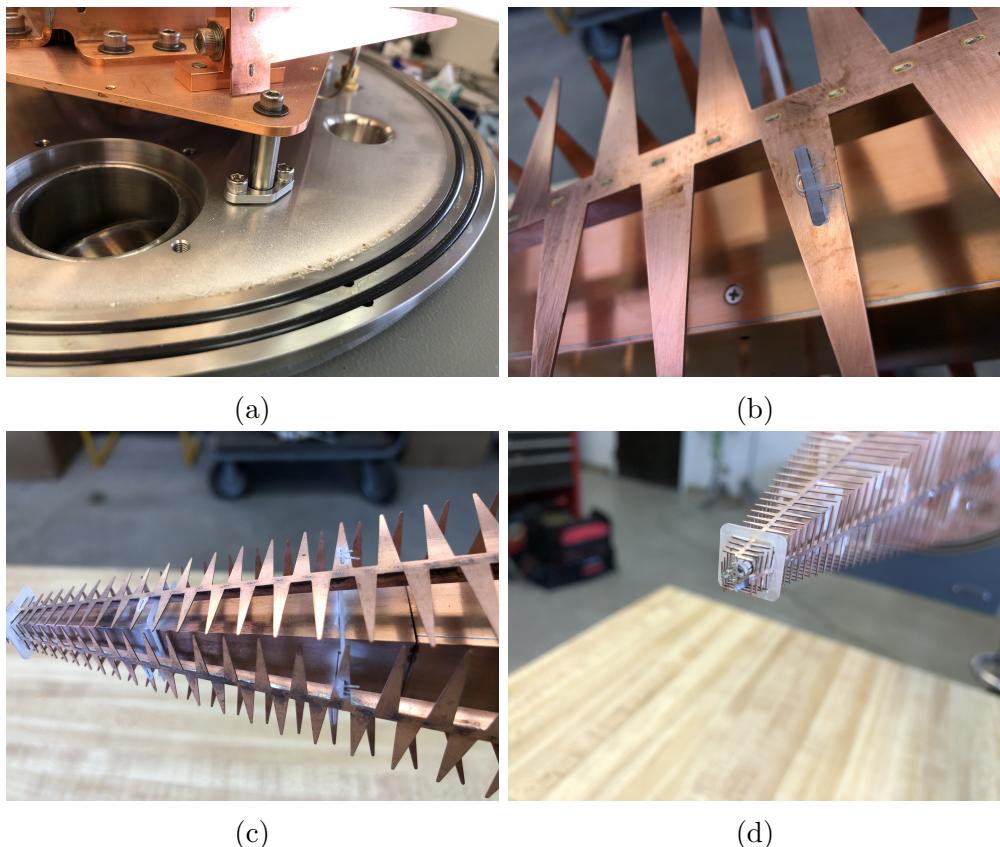
This feed is an original Antonio Feed with no modifications or retrofitted components. The feed has been identified as non operational during the feed system temperature measurements in Oct. 2019 and was switched off afterwards. As part of the tip failure investigation this feed was removed from antenna 1K and inspected. The overall condition of the log-periodic pyramid is shown in Figure 7. One can see that there is an extensive amount of dust and particles located at the bottom of the base plate, as well as dust on the log-periodic pyramid itself. The inspection showed that the Rexolite fixture of the feed arms was not sufficient to prevent movement and therefore caused the failure. This also explains the deformation of the feed arms at the tip of the log-periodic pyramid.

Figure 7: Inspection of the cryostat and log-periodic pyramid of feed 012.

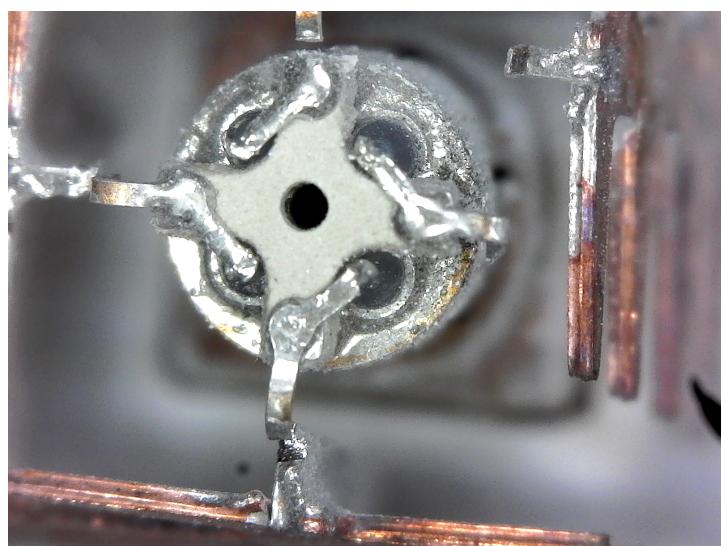
The inspection of the feed tip is shown in Figure 8 and 9. One can see that all coaxial connections are still in place and no sign of coaxial center conductor retraction is visible. However, all four tip-link connections are broken due to the insufficient mechanical support of the Rexolite standoffs. Adding to that, the vibration environment of that feed is unknown, hence it is very likely that the cryocooler is not tuned and therefore the vibrations experienced by the log-periodic feed structure were higher than in the revised feed versions.

Figure 8: Top view of the feed 012 tip.

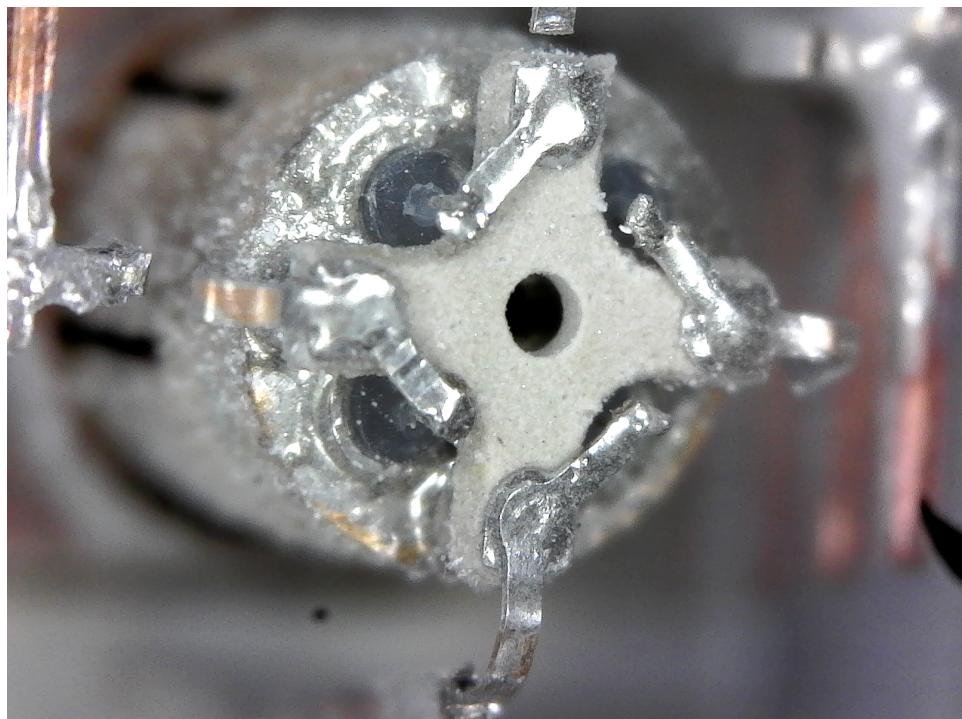
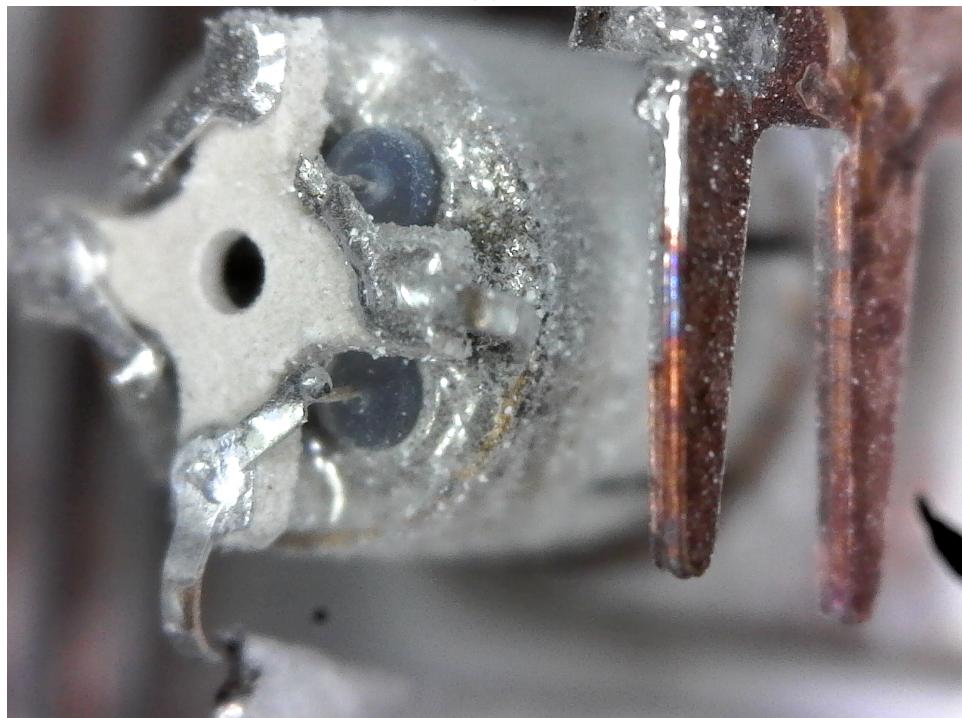
Figure 9: Tip of feed 012 previously installed on 1K. (a) The left-hand side of the tip, both coaxial connections are still intact, however the tip-link broke off. (b) The right-hand side of the tip shows the same failure mode.
