**GRADE :** 463 00  
**Ref AVO - 1026649**  
VALEO – Renault FFK

**EXPERT REPORT N° 26-009 :**

1. Subject : Return of broken brush from Renault FFK after 1542 km.

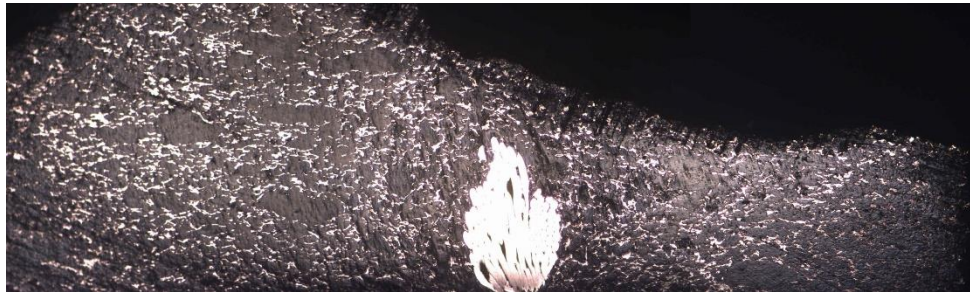
After polishing at back of brush, there are not crack visible at the cable level.

That means that there is no initial cracks in the brush coming from molding.
