Glider Deployment Report: AMLR08

(November 20, 2024)

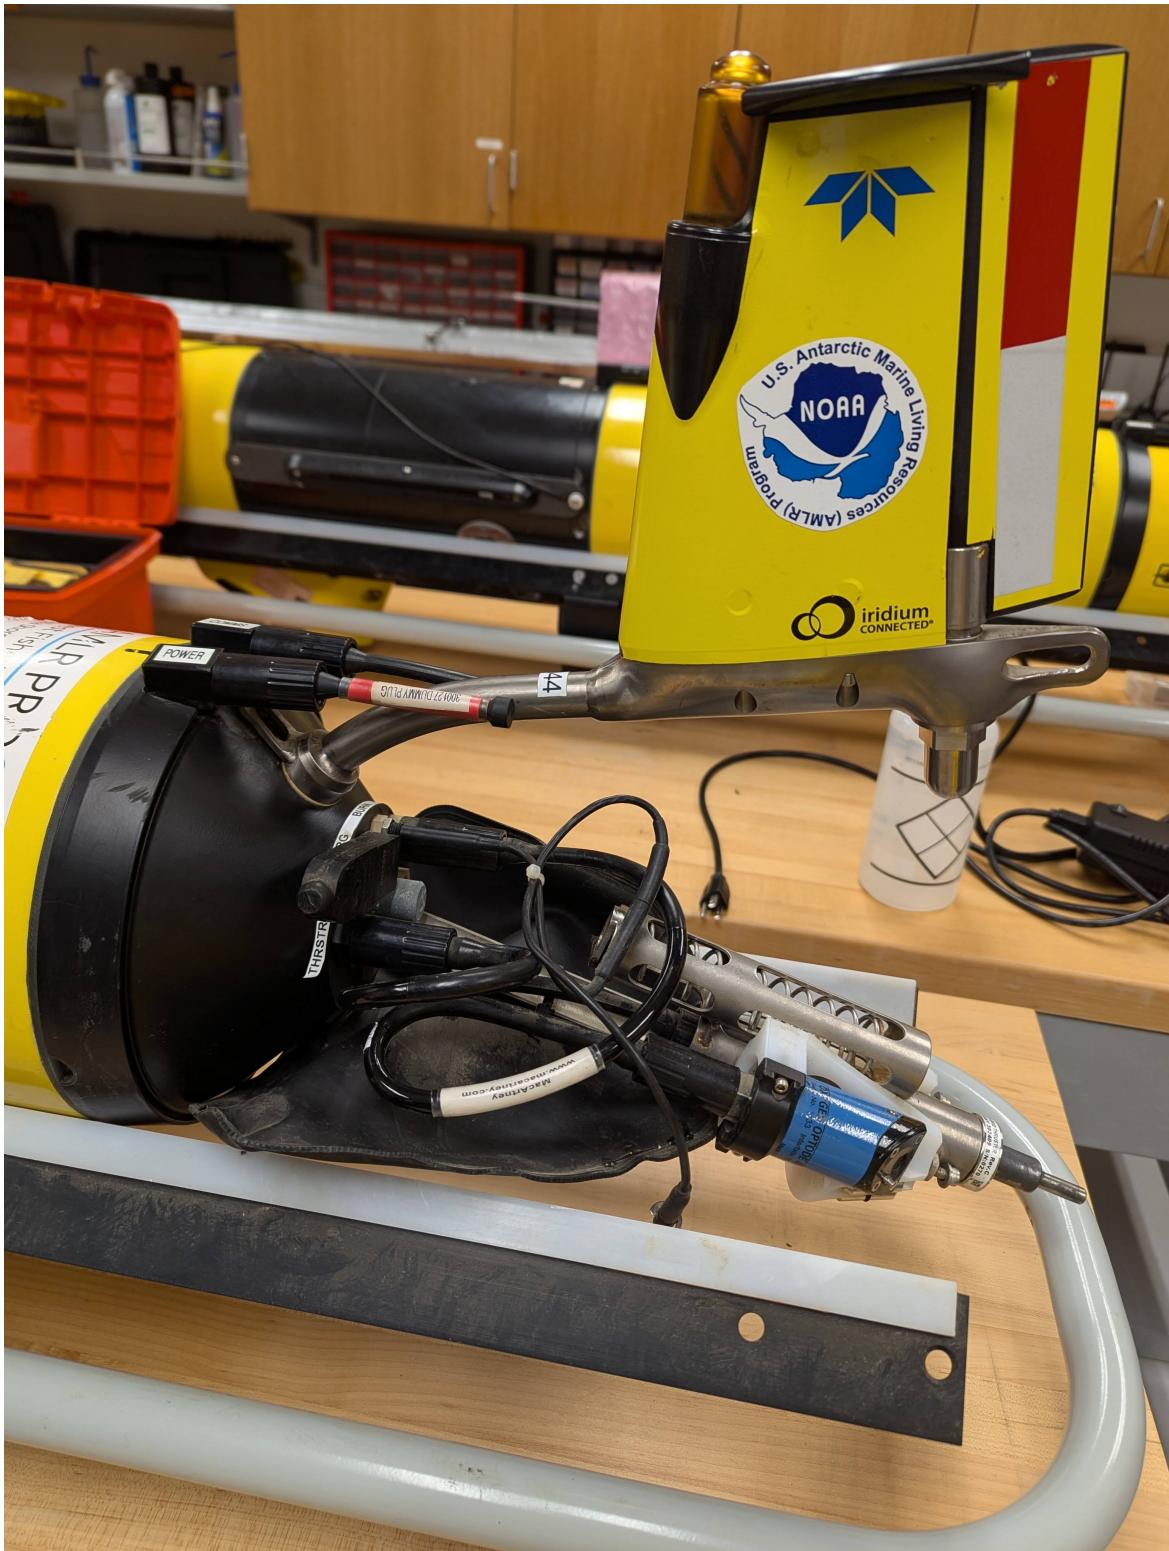
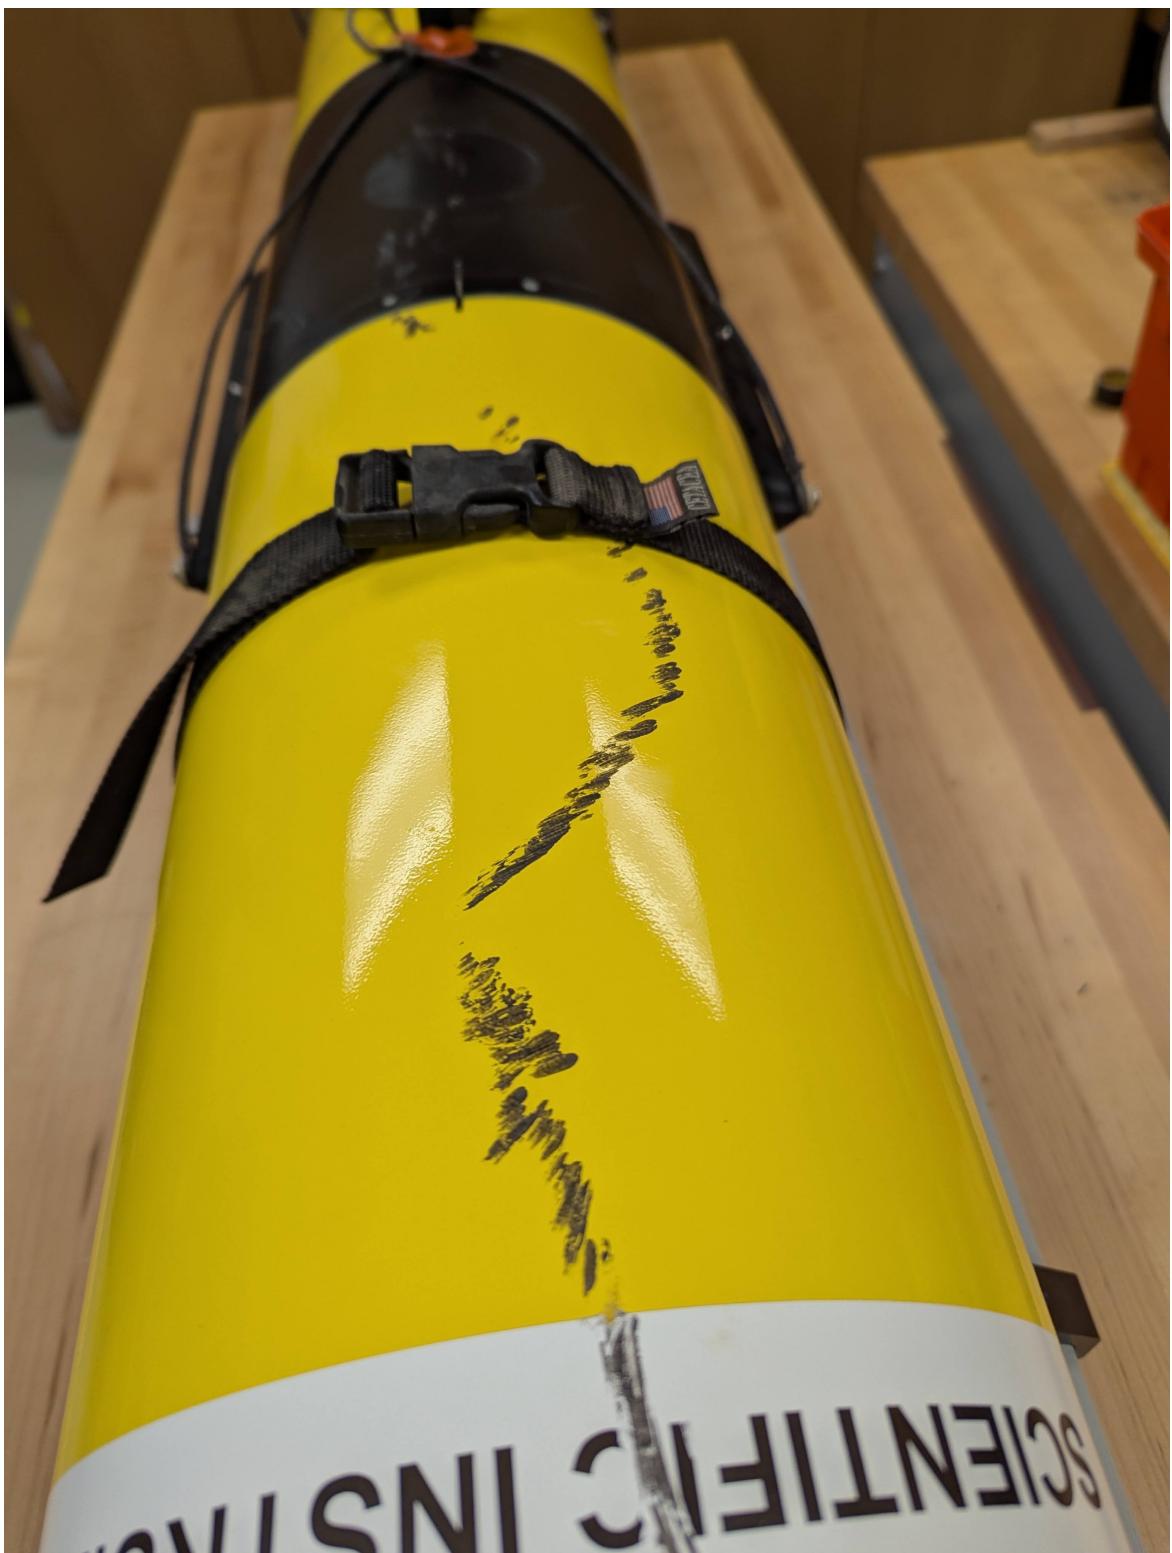
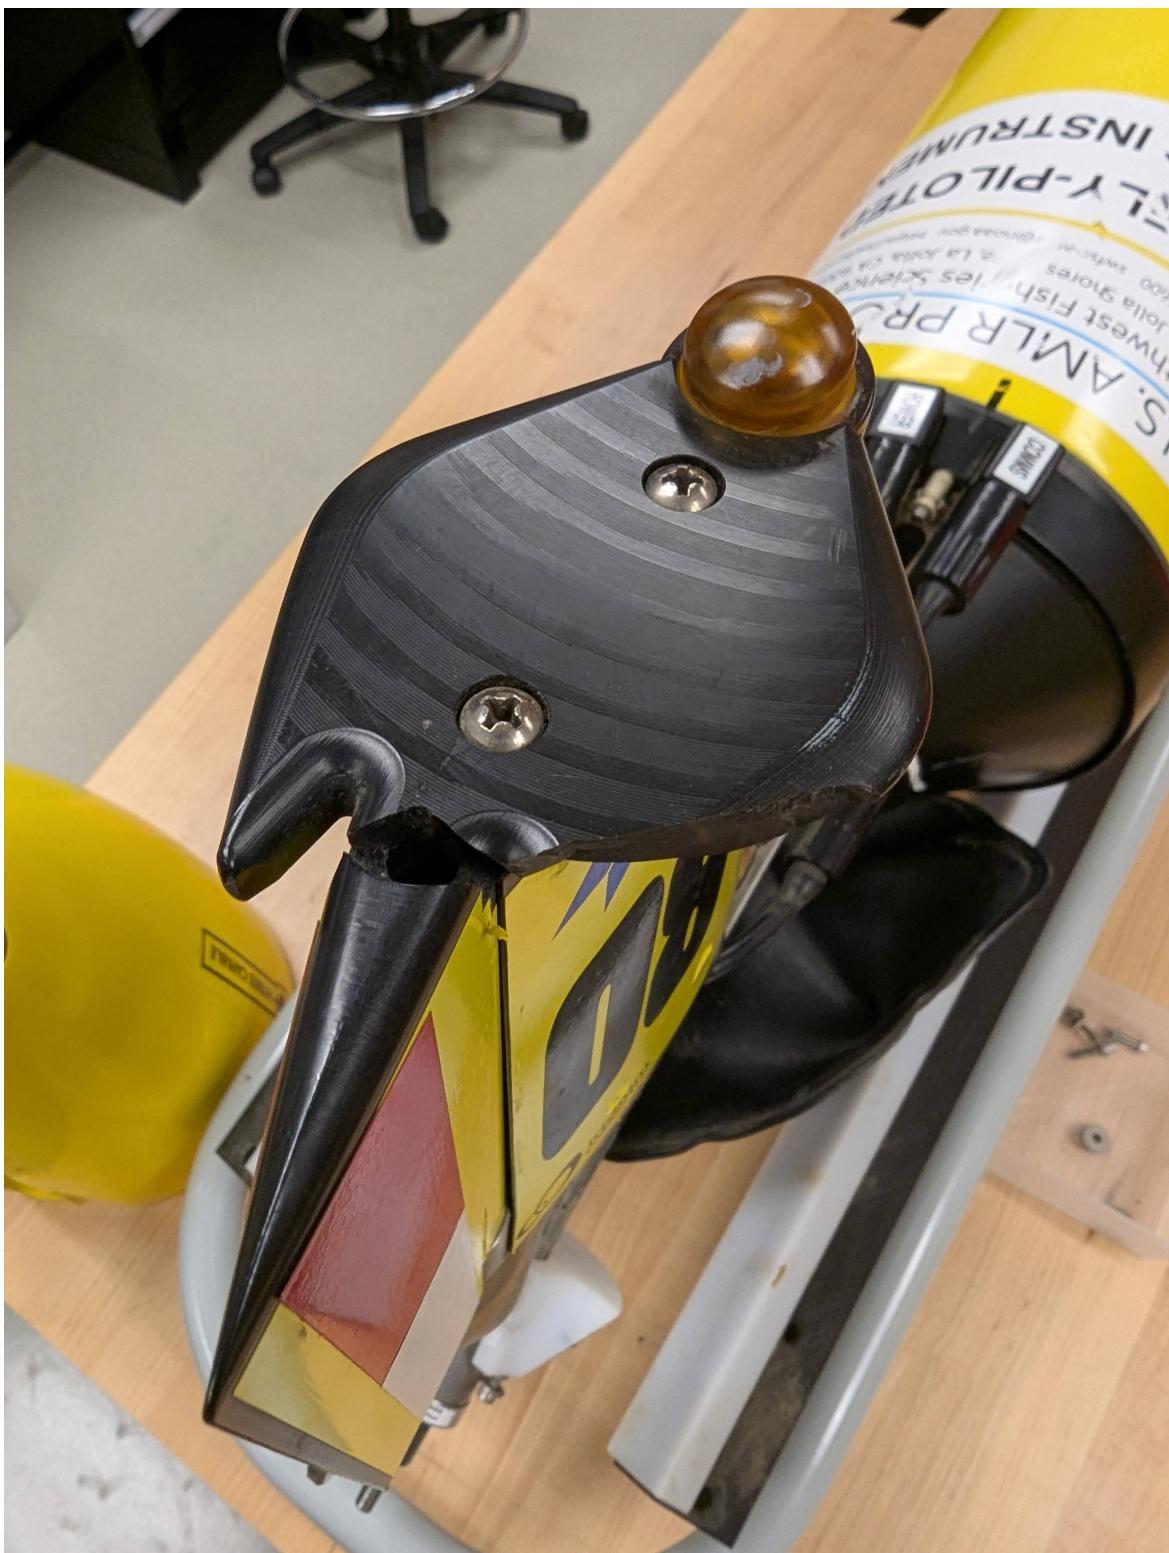
The glider was received in La Jolla on 2024-06-12, where it was inspected, cleaned, batteries were removed, and data were downloaded and archived on NOAA's Google Cloud Platform. External damage noted included a ejection weight tube assembly, a bent digifin assembly, a broken Iridium antenna, a broken wing rail, a chipped digifin, a loose and twisted MCBH connector on top of the science bay, a broken tail cowling, and multiple deep scratches on the hulls of the aft section, the science bay, and the energy bay. The glider was returned to Teledyne Marine Systems for evaluation and repair. Data will be quality checked and analyzed at a later date.

Damage to glider AMLR08 cause during emergency recovery. (A) Glider ‘AMLR08’ post-recovery in Punta Arenas, Chile. (B) Aft end of AMLR08 back at the Southwest Fisheries Science Center in La Jolla, CA. (C) Scratches along the aft, science, and energy bays of the glider. (D) Broken section of the Iridium antenna. (E) Broken wing rail.
