Glider Deployment Report: AMLR08

(November 20, 2024)

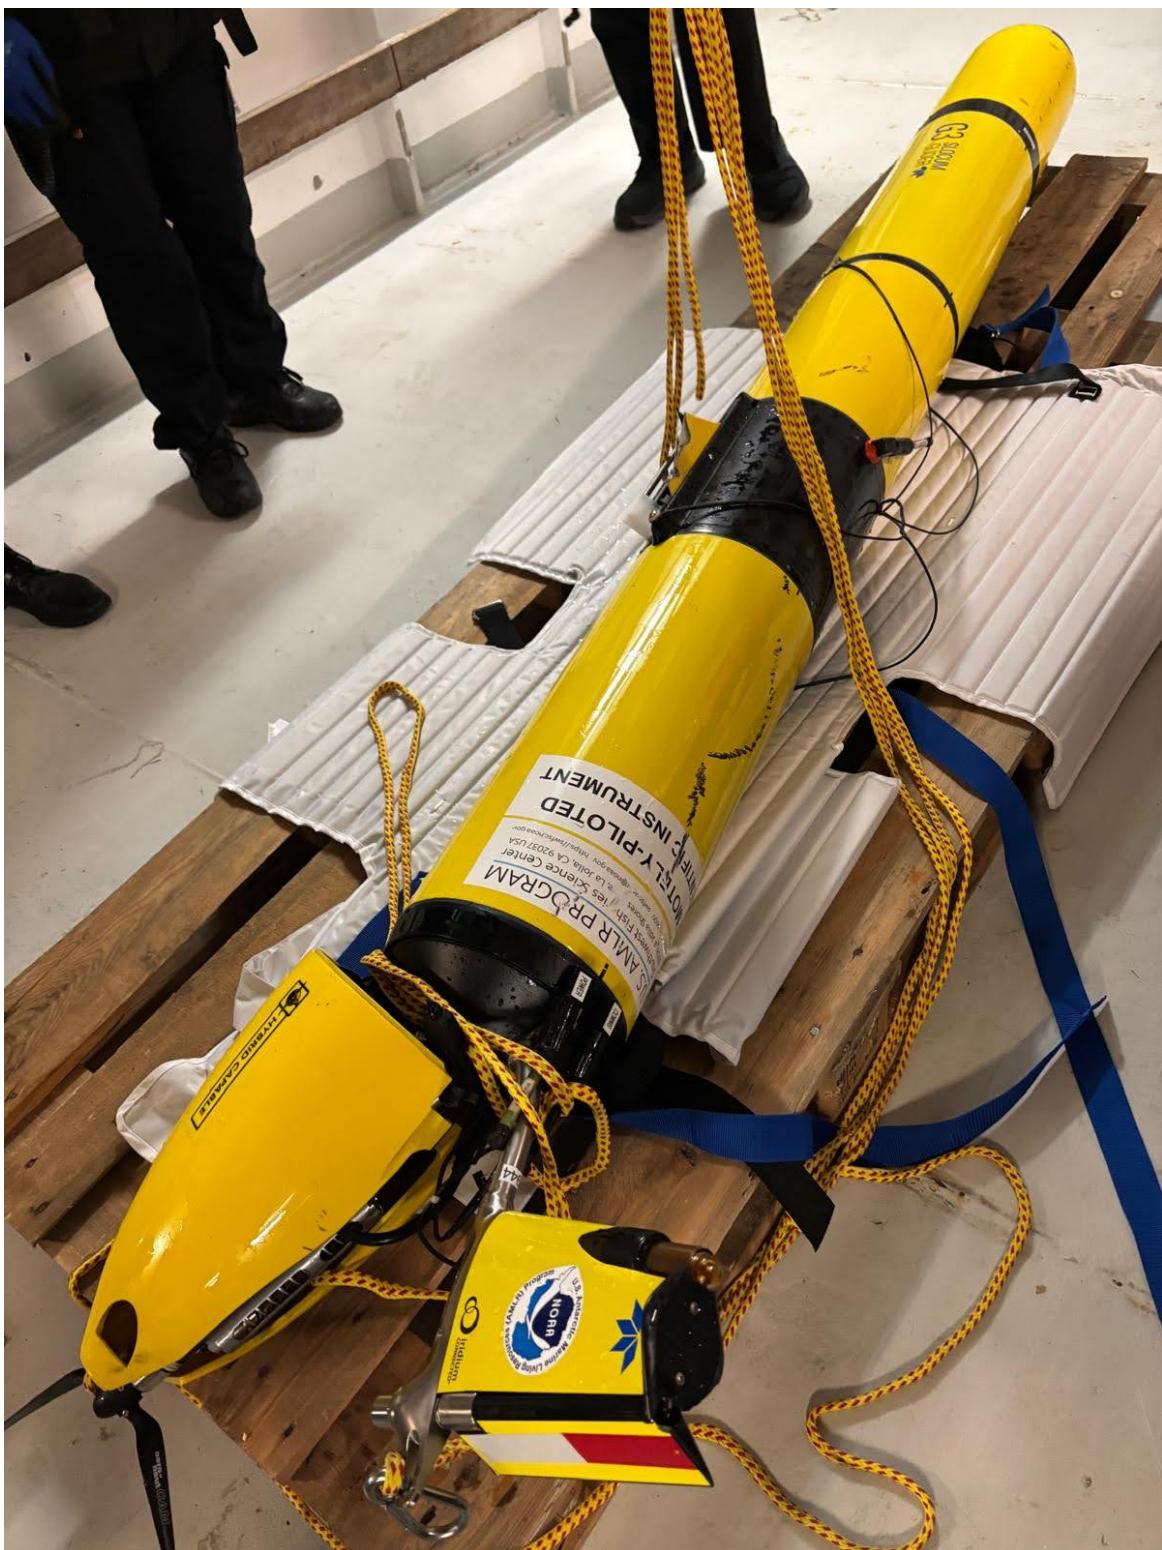
A

We reached out to multiple entities within the Antarctic scientific and tourism communities for possible recovery options, and a tour ship in the area was able to recover the glider approximately 12 hours after the emergency weight was ejected (MS *Fram*). The glider was transported back to Punta Arenas to our port agent (Agencias Universales S.A., “AGUNSA”) warehouse in Punta Arenas, Chile, where it remained until March 2025, when it was loaded into a shipping container and returned to our laboratory in La Jolla, CA, USA. The aft end of the glider suffered extensive damage during the recovery process. In late December, a team of U.S. AMLR Program scientists deploying to Antarctica inspected the glider in Punta Arenas and noted that oil was leaking from the front section.

Figure 2: Damage to glider AMLR08 cause during emergency recovery. (A) Glider ‘AMLR08’ post-recovery in Punta Arenas, Chile. (B) Aft end of AMLR08 back at the Southwest Fisheries Science Center in La Jolla, CA. (C) Scratches along the aft, science, and energy bays of the glider. (D) Broken section of the Iridium antenna. (E) Broken wing rail.
