Glider Deployment Report: AMLR08

(November 20, 2024)

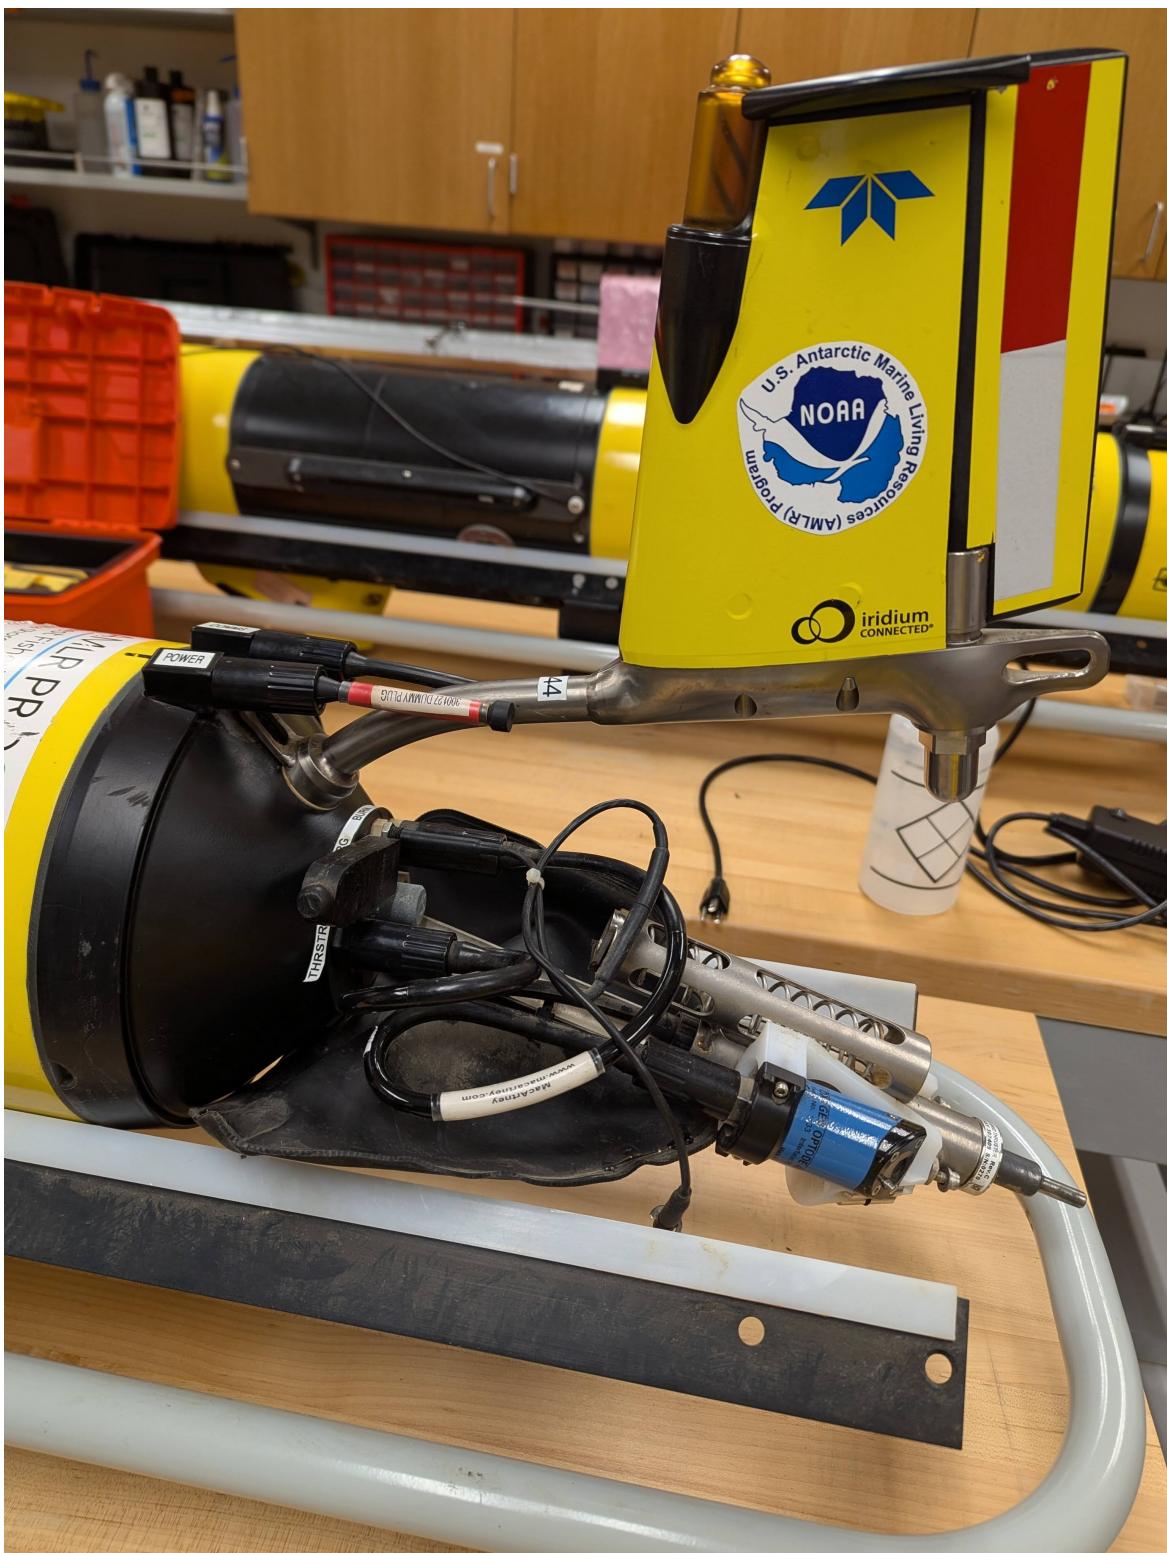
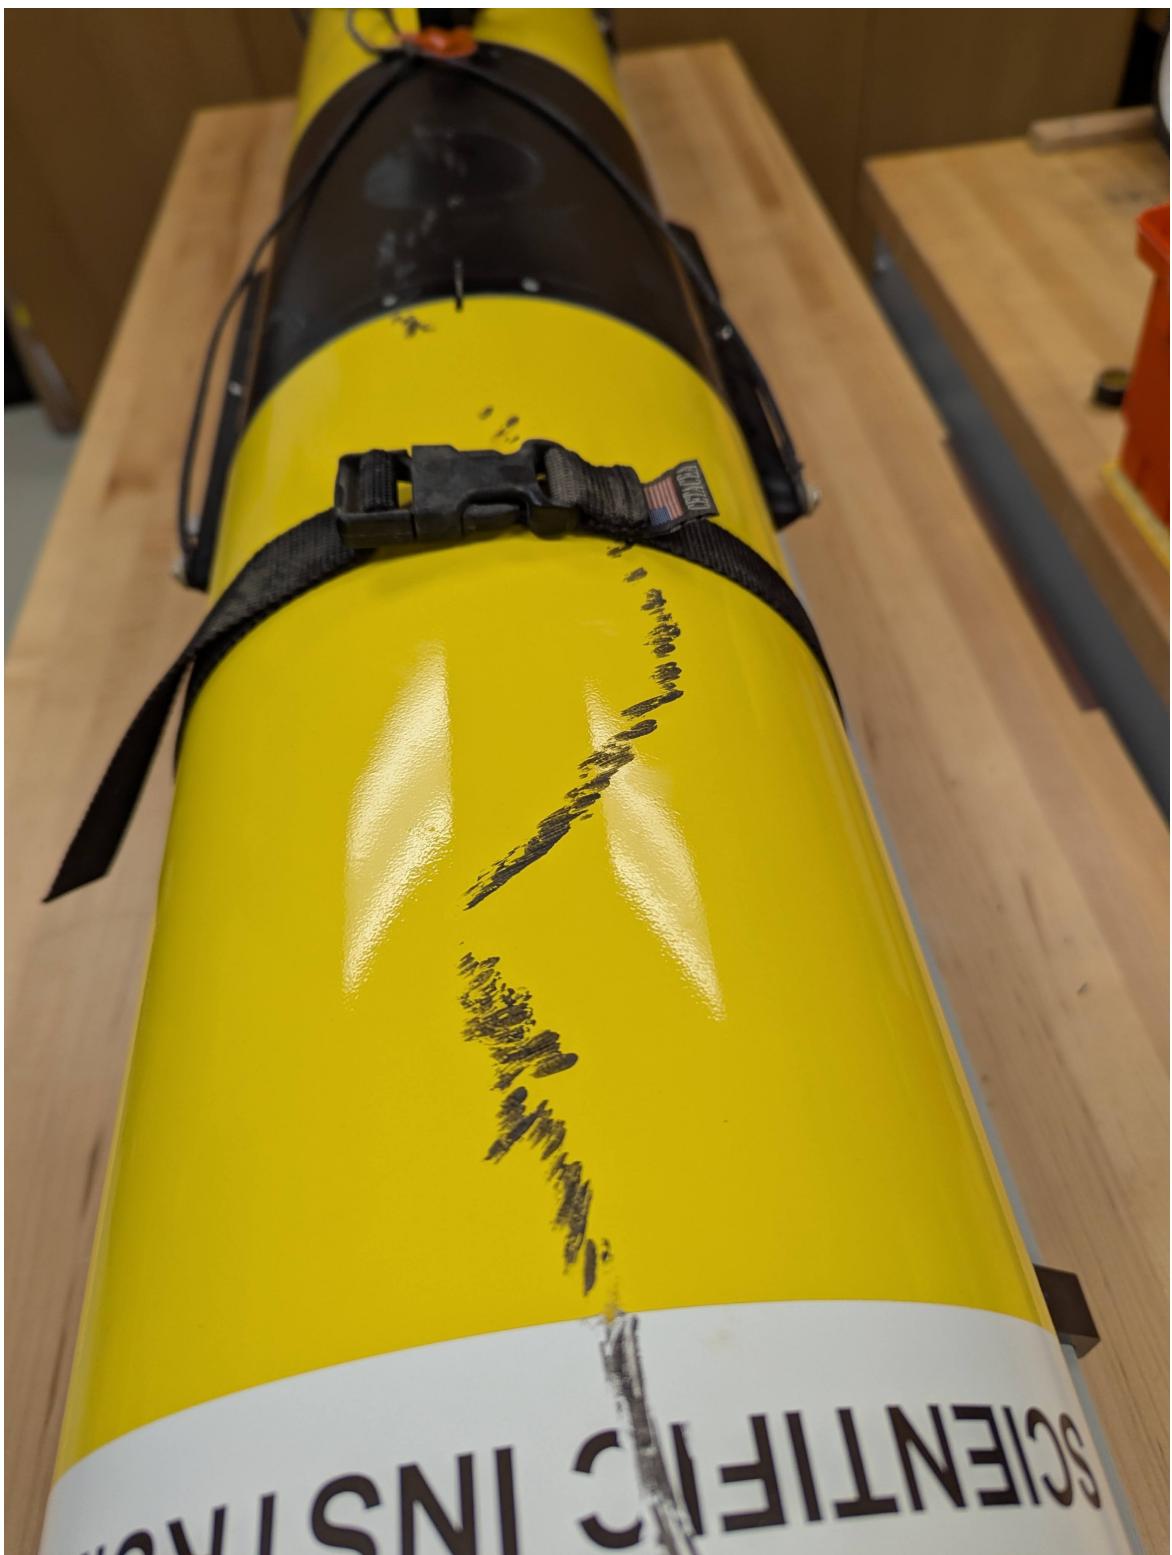
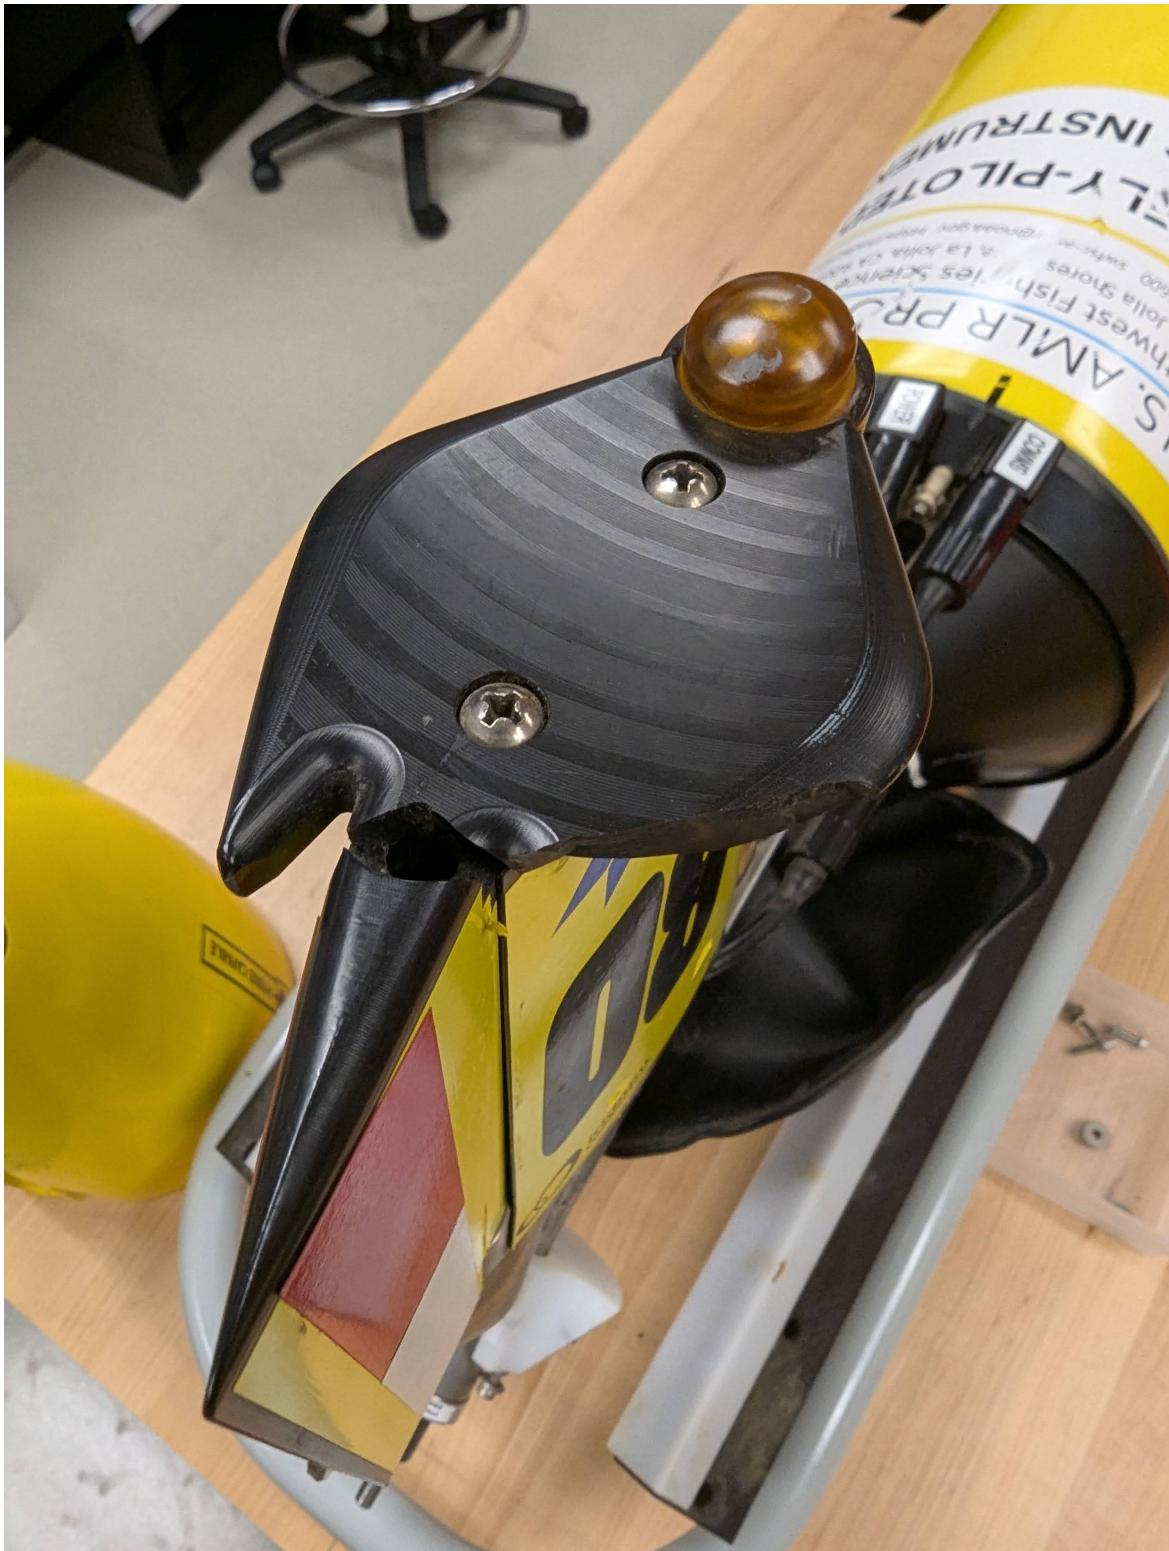
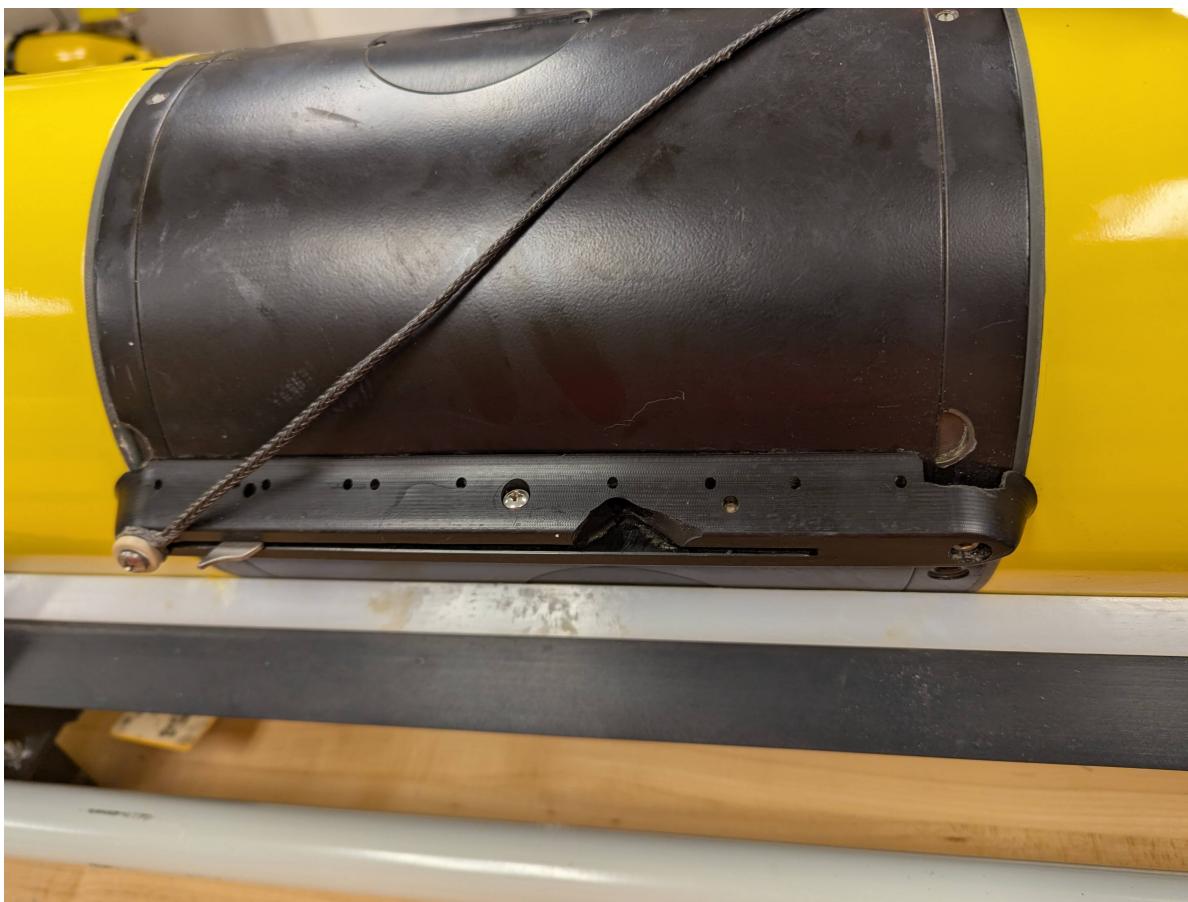
We reached out to multiple entities within the Antarctic scientific and tourism communities for possible recovery options, and a tour ship in the area was able to recover the glider approximately 12 hours after the emergency weight was ejected (MS *Fram*). The glider was transported back to Punta Arenas to our port agent (Agencias Universales S.A., “AGUNSA”) warehouse in Punta Arenas, Chile, where it remained until March 2025, when it was loaded into a shipping container and returned to our laboratory in La Jolla, CA, USA. The aft end of the glider suffered extensive damage during the recovery process. In late December, a team of U.S. AMLR Program scientists deploying to Antarctica inspected the glider in Punta Arenas and noted that oil was leaking from the front section.

The glider was received in La Jolla on 2024-06-12, where it was inspected, cleaned, batteries were removed, and data were downloaded and archived on NOAA's Google Cloud Platform. External damage noted included a ejection weight tube assembly, a bent digifin assembly, a broken Iridium antenna, a broken wing rail, a chipped digifin, a loose and twisted MCBH connector on top of the science bay, a broken tail cowling, and multiple deep scratches on the hulls of the aft section, the science bay, and the energy bay. The glider was returned to Teledyne Marine Systems for evaluation and repair. Data will be quality checked and analyzed at a later date.

Figure 2: Damage to glider AMLR08 cause during emergency recovery. (A) Glider ‘AMLR08’ post-recovery in Punta Arenas, Chile. (B) Aft end of AMLR08 back at the Southwest Fisheries Science Center in La Jolla, CA. (C) Scratches along the aft, science, and energy bays of the glider. (D) Broken section of the Iridium antenna. (E) Broken wing rail.
