## *Report on Working Condition of Streetlights and Sidewalks Near and Under the Hebbala Flyover*

Date of audit: 18, 19 November 2022

Date of publishing: 24 December 2022

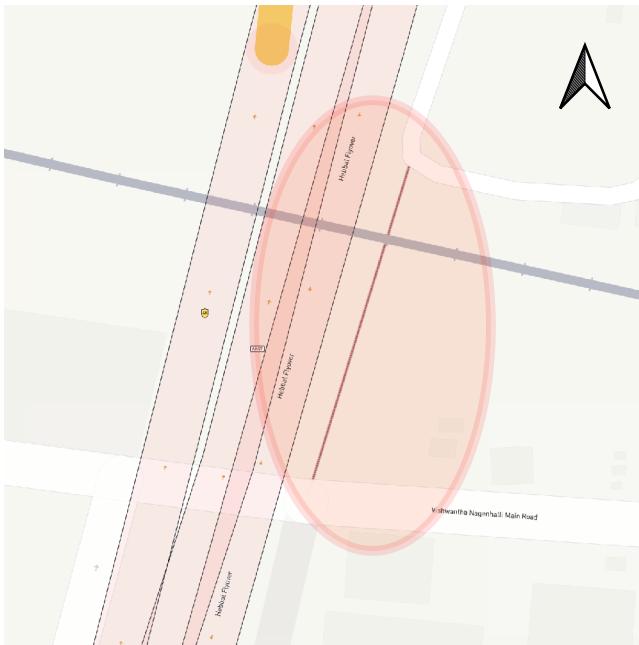
**Level Crossing with no protection,**  
Hundreds of people cross these tracks which is not  
manned.

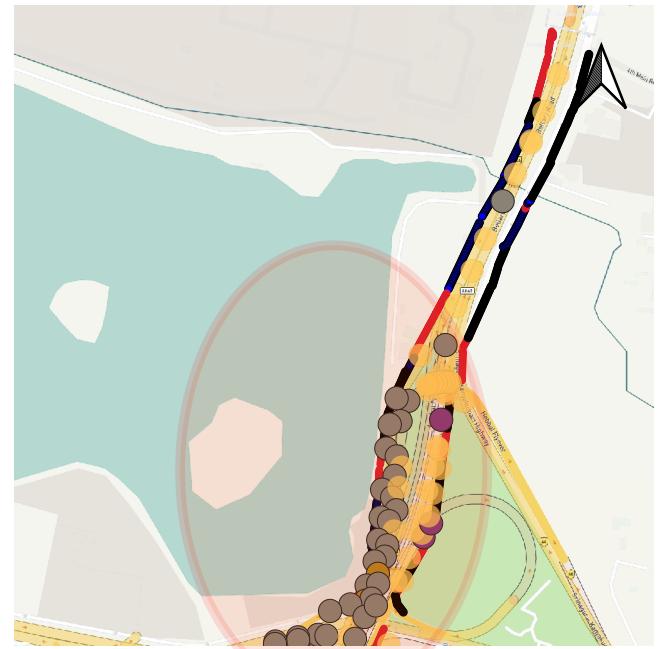
**Lack of sidewalk and lighting near the Hebbal Lake  
leading to Esteem Mall Bus Stand**

On the day of the audit, all lighting on the side of the lake was off while advertisement bill boards were on.

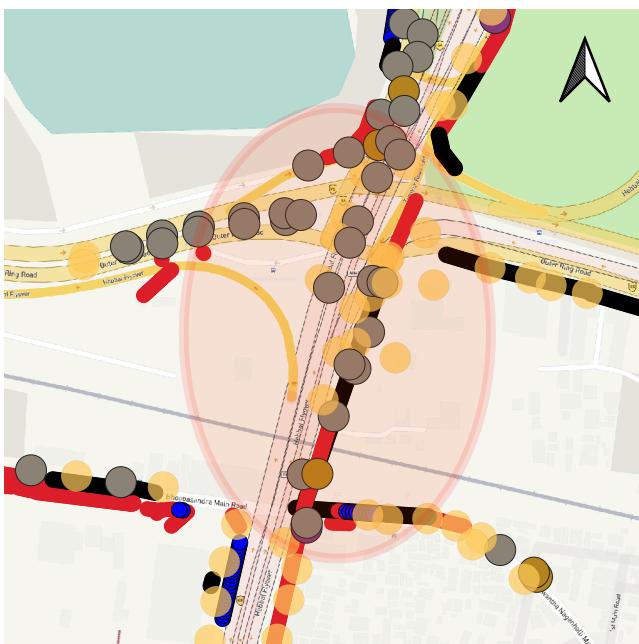
**Lighting and space under the flyover leading to the bustands on the ORR**

Lighting on the green spaces and path from the track to the BusStand is very low and women avoid these spaces after sundown

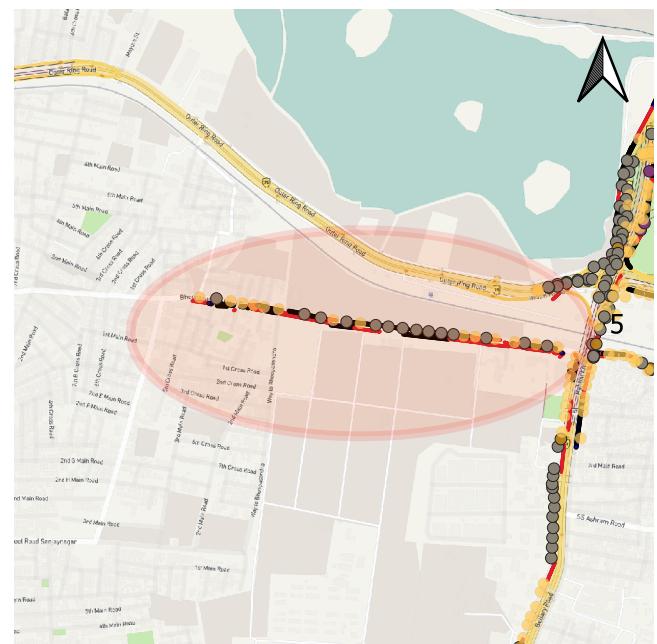
**Lighting and sidewalk width leading to Bhoopsandra road**

Both sides of the road are filled with large, unused complexes, this combined with spotty lighting and tiny sidewalks make it dangerous. The only light on the road is from vehicles
