## *Streetlights and Sidewalks Near and Under the Hebbala Flyover: Are they Safe for Women?*

Date of audit: 18, 19 November 2022

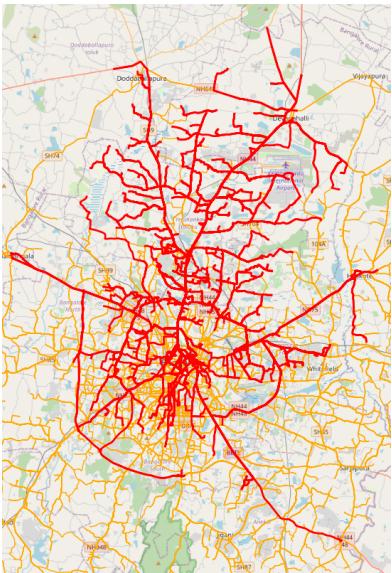
Image of the bus routes that pass through Hebbal

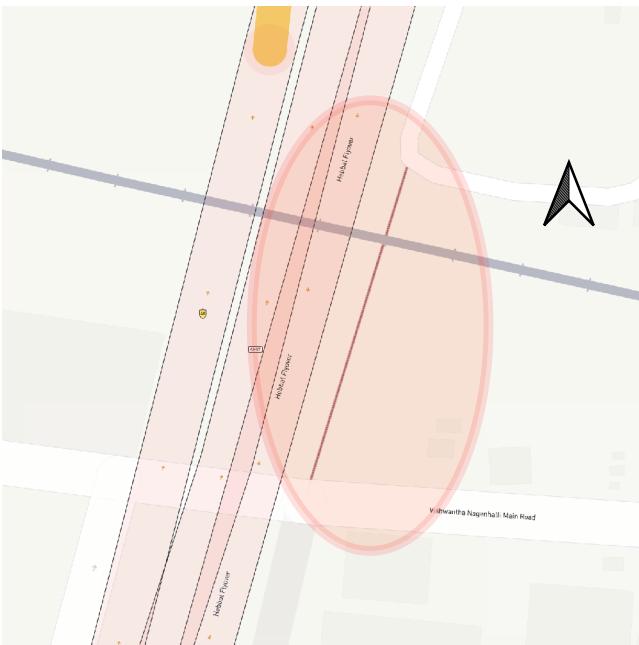
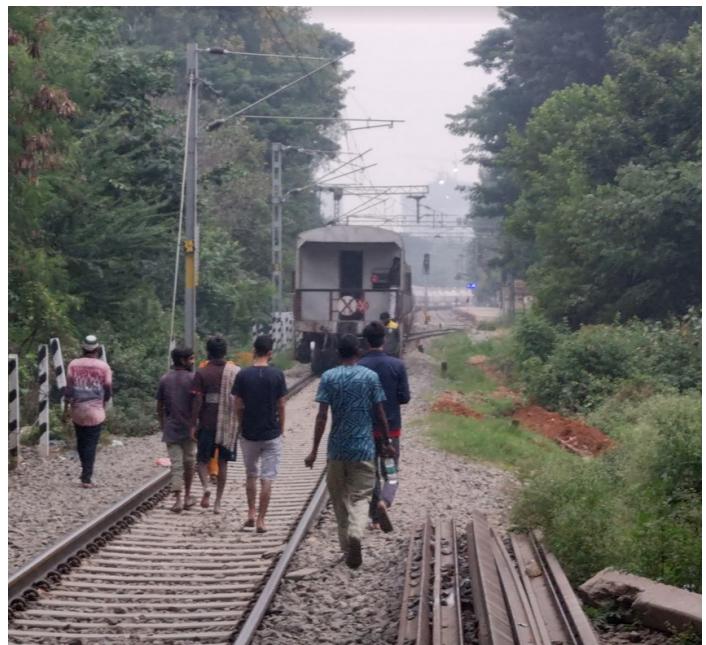
*Level Crossing with no protection,*

Vehicles, Cattle and People cross this track in groups through the day. In the evenings, there is insufficient lighting to cross comfortably. This is a safety hazard.

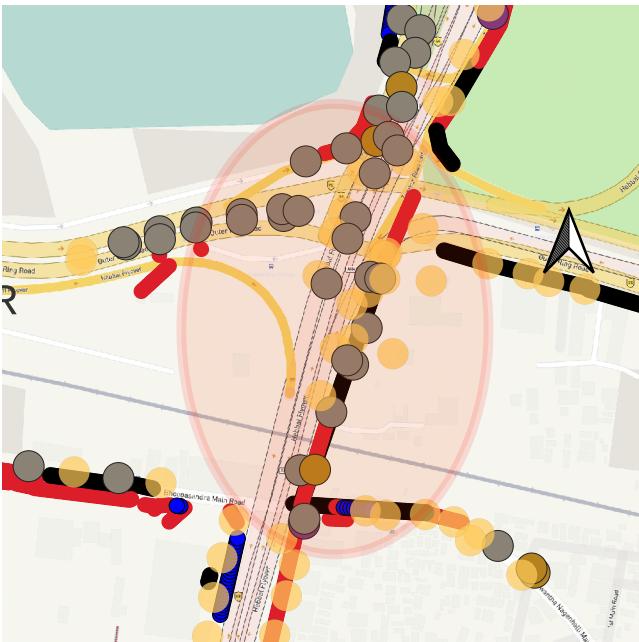
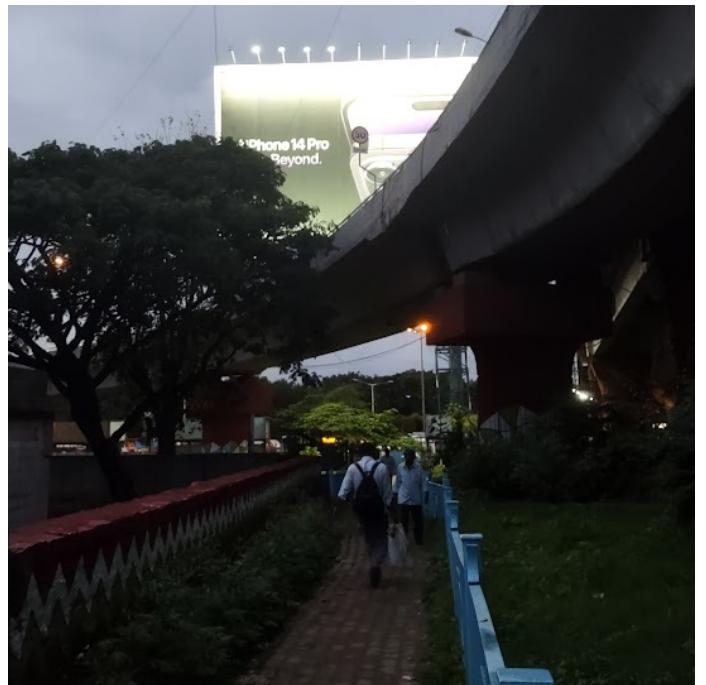
*Lighting and space under the flyover leading to the bustands on the ORR*

Lighting on the green spaces and path from the track to the BusStand is very low and women avoid these spaces after sundown. The green spaces under the flyover are not lit at all and present a daunting task to walk next to. Especially when the path crossing through has garbage and is used to urinate in.

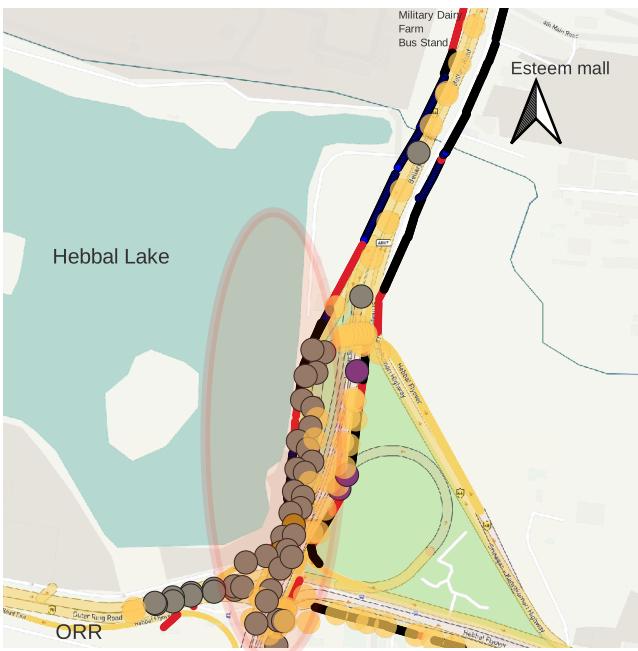
*Lack of sidewalk and lighting near the Hebbal Lake leading to Military Dairy Farm Bus Stand*

On the day of the audit, all lighting on the side of the lake was off while advertisement bill boards were on. There are also no sidewalks leading to the Military Dairy Farm Bus Stand.

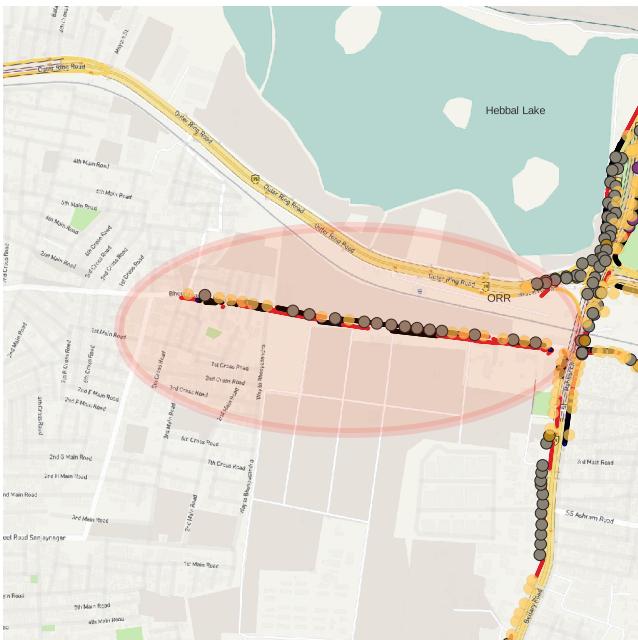
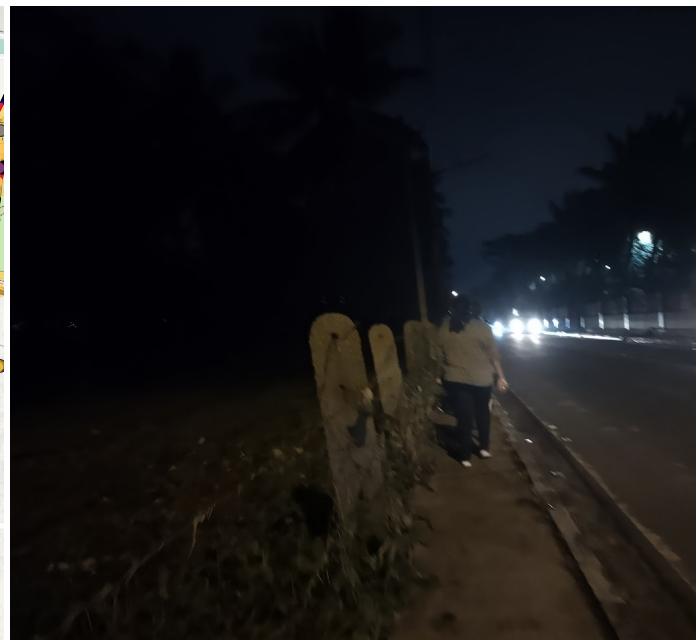
*Lighting and sidewalk width leading to Bhoopsandra road*

Both sides of the road are filled with large, unused complexes, this combined with spotty lighting and tiny sidewalks make it dangerous. The only light on the road is from vehicles moving toward Hebbal.
