## *Report on Working Condition of Streetlights and Sidewalks Near and Under the Hebbala Flyover*

Date of audit: 18, 19 November 2022

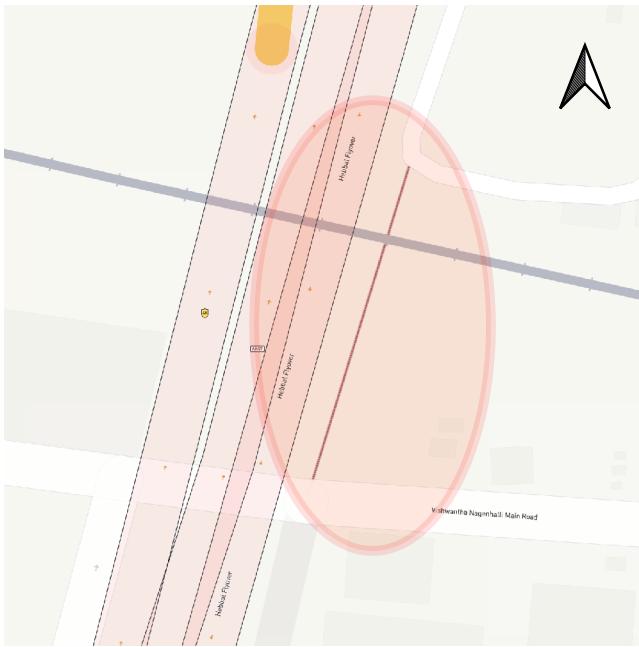
**Level Crossing with no protection,**  
Hundreds of people cross these tracks which is not  
manned.

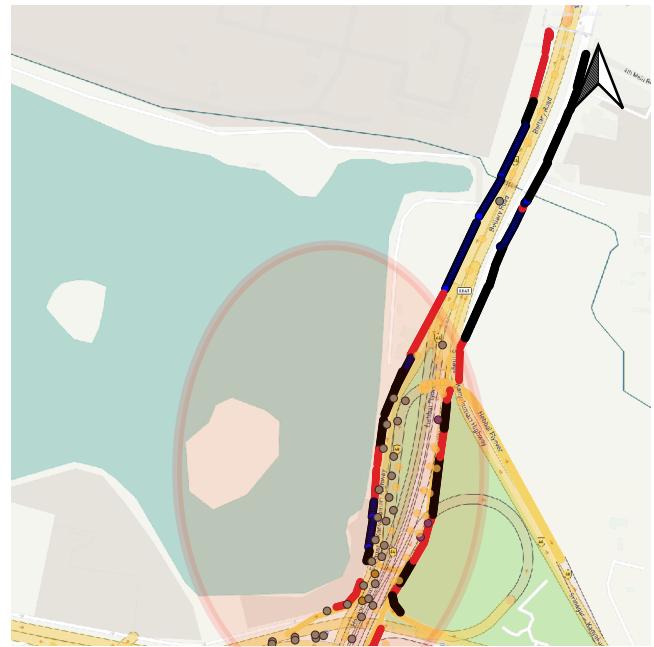
**Lack of sidewalk and lighting near the Hebbal Lake leading to Esteem Mall Bus Stand**

On the day of the audit, all lighting on the side of the lake was off while advertisement bill boards were on.

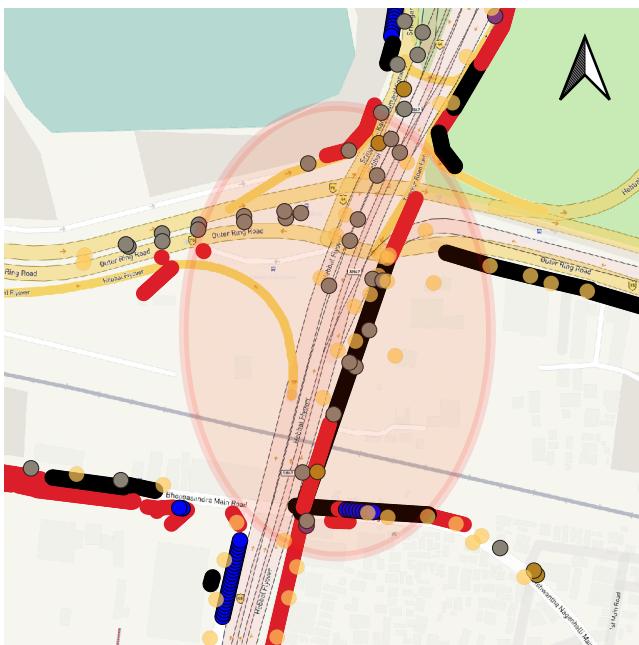
**Lighting and space under the flyover leading to the bustands on the ORR**

Lighting on the green spaces and path from the track to the BusStand is very low and women avoid these spaces after sundown

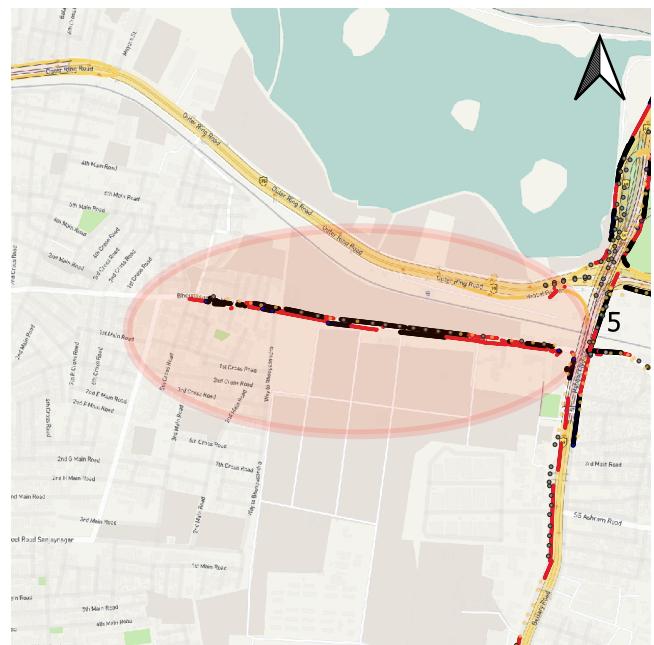
**Lighting and sidewalk width leading to Bhoopsandra road**

Both sides of the road are filled with large, unused complexes, this combined with spotty lighting and tiny sidewalks make it dangerous. The only light on the road is from vehicles
