## Case Study – Three Mile Island

The Biggest Nuclear Accident in the US

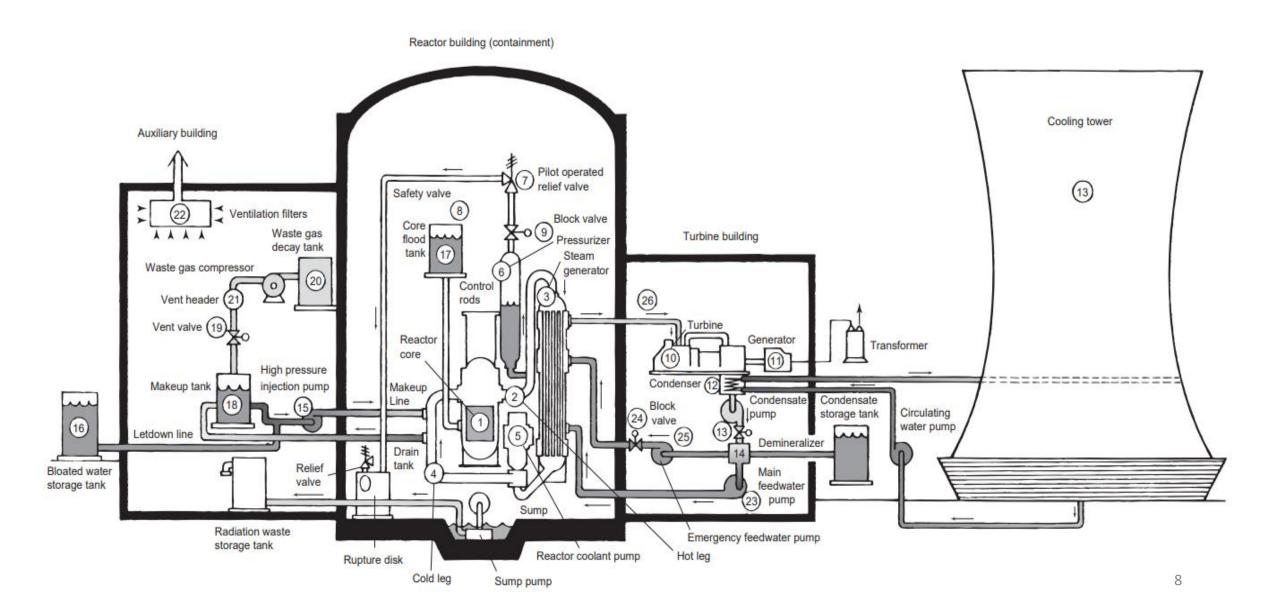
# Three Mile Island nuclear power plant Unit 2

- A mechanical or electrical maintenance interrupted the water flow in the secondary loop.
- As a result one of the condensate booster pumps turned off. That caused the main feedwater pumps (23) and the turbine (10) to shut down as well.
- An automatic emergency system started up the auxiliary feedwater pumps (25).

- But with the turbines inoperative, there was little outlet for the heat generated by the fission process in the reactor core.
- The pressure in the reactor rose to more than 2,200 pounds per square inch, opening a pressure relief valve (7).
- Moreover, the control rods were lowered into the reactor core to stop the main fission process.

- To control pressure, a pilot-operated relief valve (a valve located at the top of the pressurizer) opened.
- The valve should have closed when the pressure fell to proper levels, but it became stuck open.
- Staff was unaware that cooling water was pouring out of the stuckopen valve.
- As coolant flowed from the primary system through the valve, other instruments available to reactor operators provided inadequate information.

- Apart from this failure everything else had proceeded automatically as it was supposed to.
- Except for one other serious omission: The auxiliary pumps (25) that had been started automatically could not supply the auxiliary feedwater because block valves (24) had inadvertently been left closed after maintenance work done on them two days earlier.

- As the emergency feedwater valves were still closed no heat was being taken out of the steam generators.
- This in turn led to a temperature rise in the primary loop.
- The staff didn't realize why, as they didn't know that the valves were closed.
- Without feedwater in the loop (26), the steam generator (3) boiled dry.
- The reactor had not yet cooled down, and even with the control rods shutting off, the main fission reaction was still generating energy.
