Insured/Applicant Name:	Mr. ABC	Appli	cation / Policy #:	6293CGg267				
Address Inspected: 1345	Marseille Dr, Miami Beach FL 33141							
Actual Year Built: 1949		Date Inspected:	12/20/2021					
Minimum Photo Requirements ☑ Dwelling: Each side ☑ Roof: Each slope ☑ Plumbing: Water heater, under cabinet plumbing/drains, exposed valves ☑ Main electrical service panel with interior door label ☑ Electrical box with panel off ☑ All hazards or deficiencies noted in this report								
A Florida-licensed inspector must complete, sign and date this form.

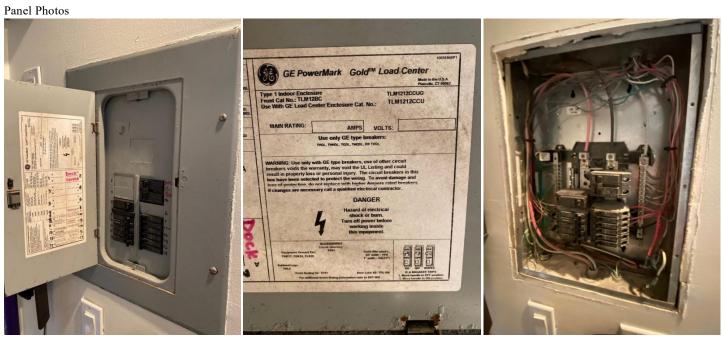
Electrical System

Double tap the breaker and secondary electric panel
