# **Project Deliverables:** Improvement of Reliability of 220 KV Power Transmission network

**Project Name:** Improvement of reliability of 220kV power transmission network

**Name of the Department:** Electrical Power Systems (EPS)

## JSP Raigarh

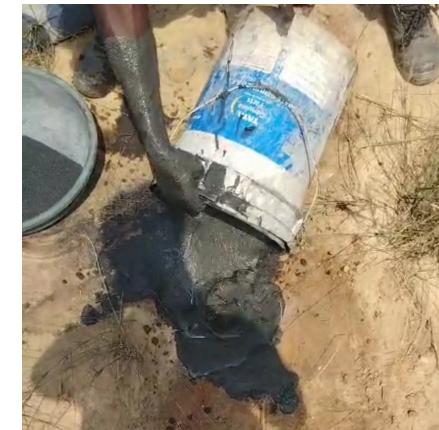
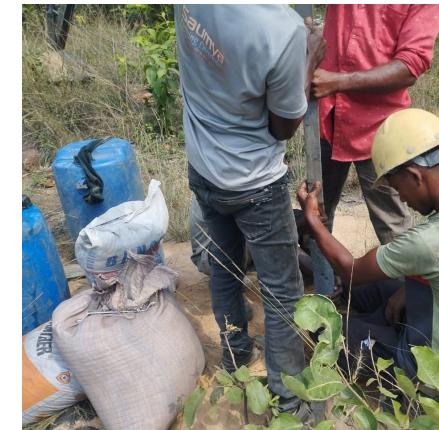
## Conductive Concrete Earthing (Marconite Earthing)

Concrete conductive earthing is a specific method for improving the grounding system of structures like 220 kV transmission line towers. It utilises conductive concrete to create a low-resistance path for fault current to dissipate into the ground.

**Marconite:Cement:Water** ratio is **3:1:1** by weight  
It is also available as premix of standard 25kg

Marconite has resistivity of **0.001 ohm m**. The final mixture has a resistivity of **0.1 ohm m**.
