# Case Study: Poor PC Board Layout Causes Radiated Emissions

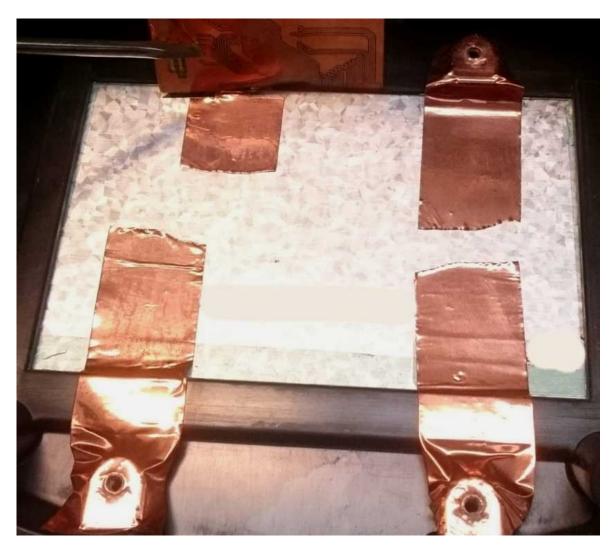
Figure 7: A crude but effective copper tape modification

So how was this achieved in practice? Figure 7 shows the crude implementation during development. The conductive adhesive copper tape extends from the mounting bosses in the front panel plastic moulding (onto which the PCB mounts) and onto the metallised panel with sufficient area to form a good RF contact. Note that the capacitance of the two surfaces (tape and panel) in close proximity can be just as significant to the impedance as the actual resistance through the adhesive. Also, the top left piece of tape passes under the LCD control flexi PCB through a gap which is a bit of a fiddle to place but all part of the effective solution.

This modification also necessitated scraping away the solder resist on the PCB around the PCB mounting holes and tinning the pads to provide a reliable electrical contact back to the PCB. This is easily achieved with a small hand held grinding tool like a Dremel running at low speed.
