Effect on RC buildings of 6 February 2023 Turkey earthquake doublets and new doctrines for seismic design

Murat Ozturk ^a, Musa Hakan Arslan ^{a,*}, Hasan Hüsnü Korkmaz ^b

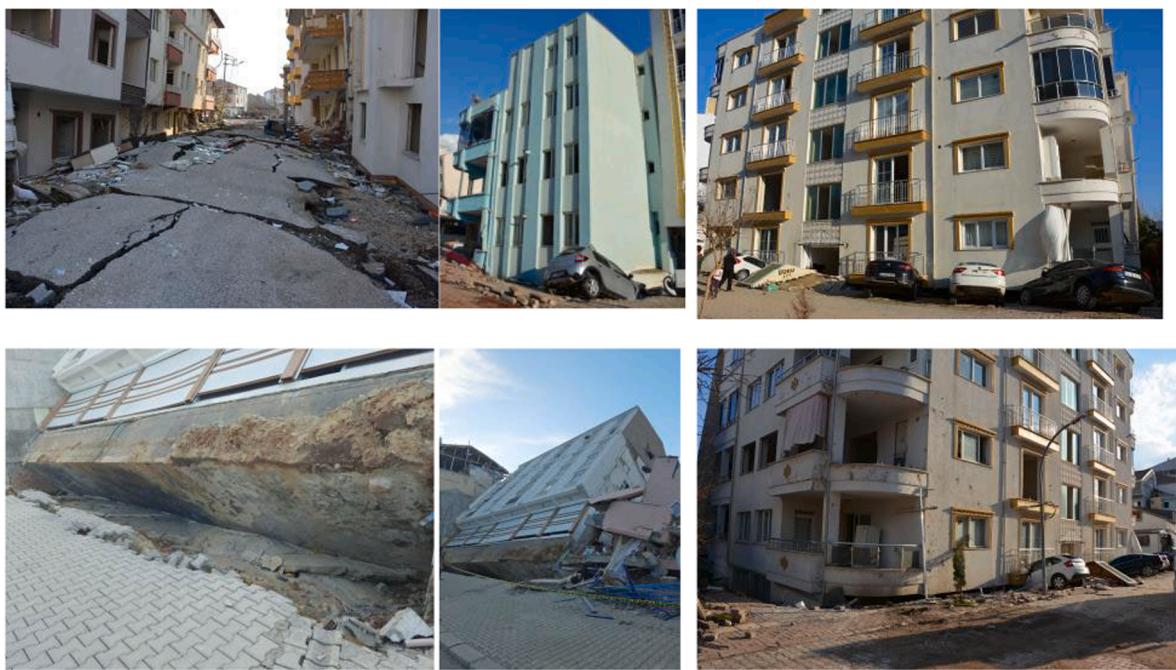
One of the geological effects of earthquakes is the ground behavior that develops at shallow depths due to the vibrations caused by the earthquake. During an earthquake while seismic waves, especially shear waves, propagate through saturated (below groundwater level) loose soils, causing an increase in pore water pressure. The increased pressure destroys the contact forces that hold the soil grains together, causing the grains to move away from each other and the soil to lose its strength. As the liquefied sand rises to the surface, it weakens the soil, so the soil that loses its strength becomes unable to bear the loads transferred by the structure. Therefore, structures above the ground either lean forward or backward or sink into the ground [98]. Such structural damages due to liquefaction occurred widely, especially in the Gölbaşı district of Adiyaman, which was established by the lake, except for the province of Hatay. Due to the soil liquefaction in Gölbaşı, some buildings were tilted to the side while most of them sank into the soil (Fig. 18).

Fig. 18. Effects of ground liquefaction in some regions during earthquakes.

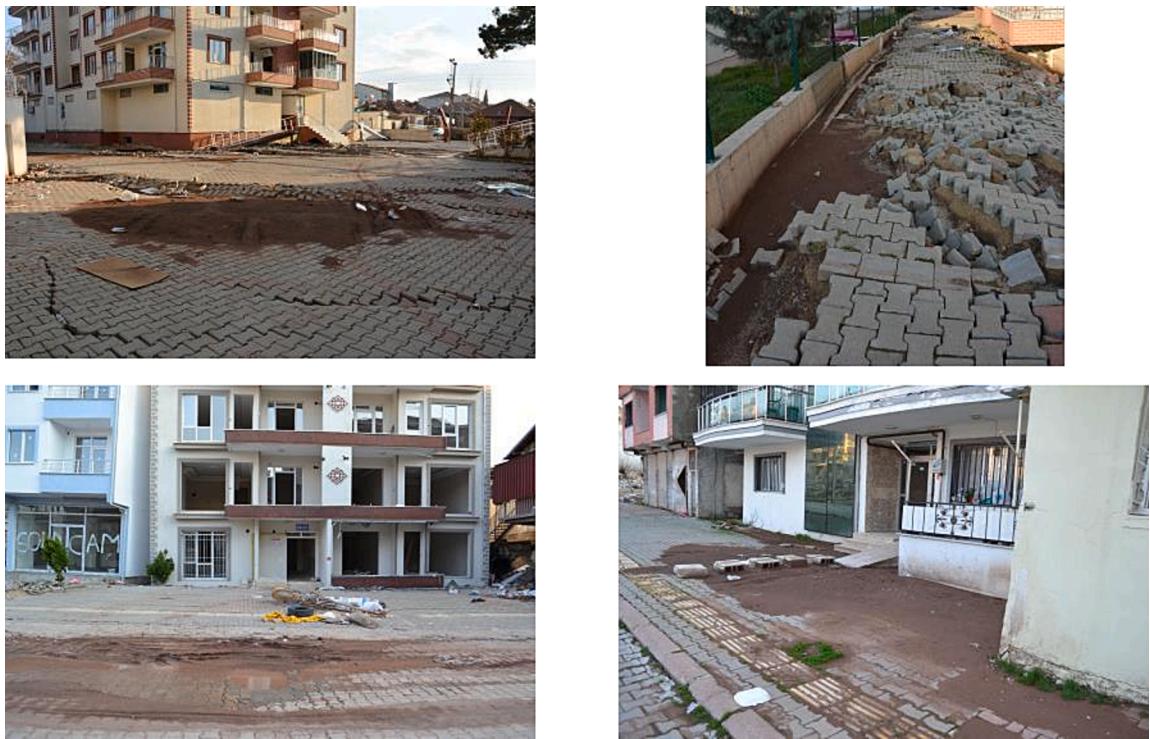
Fig. 19. Sand deposits formed by soil liquefaction.

Liquefaction is observed at the surface alone or in the form of tandem sand volcanoes and deposits of sand along crevices (Fig. 19). Sand volcanoes occur as the liquefied soil rises to the surface, pushing the surface soil layer to the sides and forming a chimney.

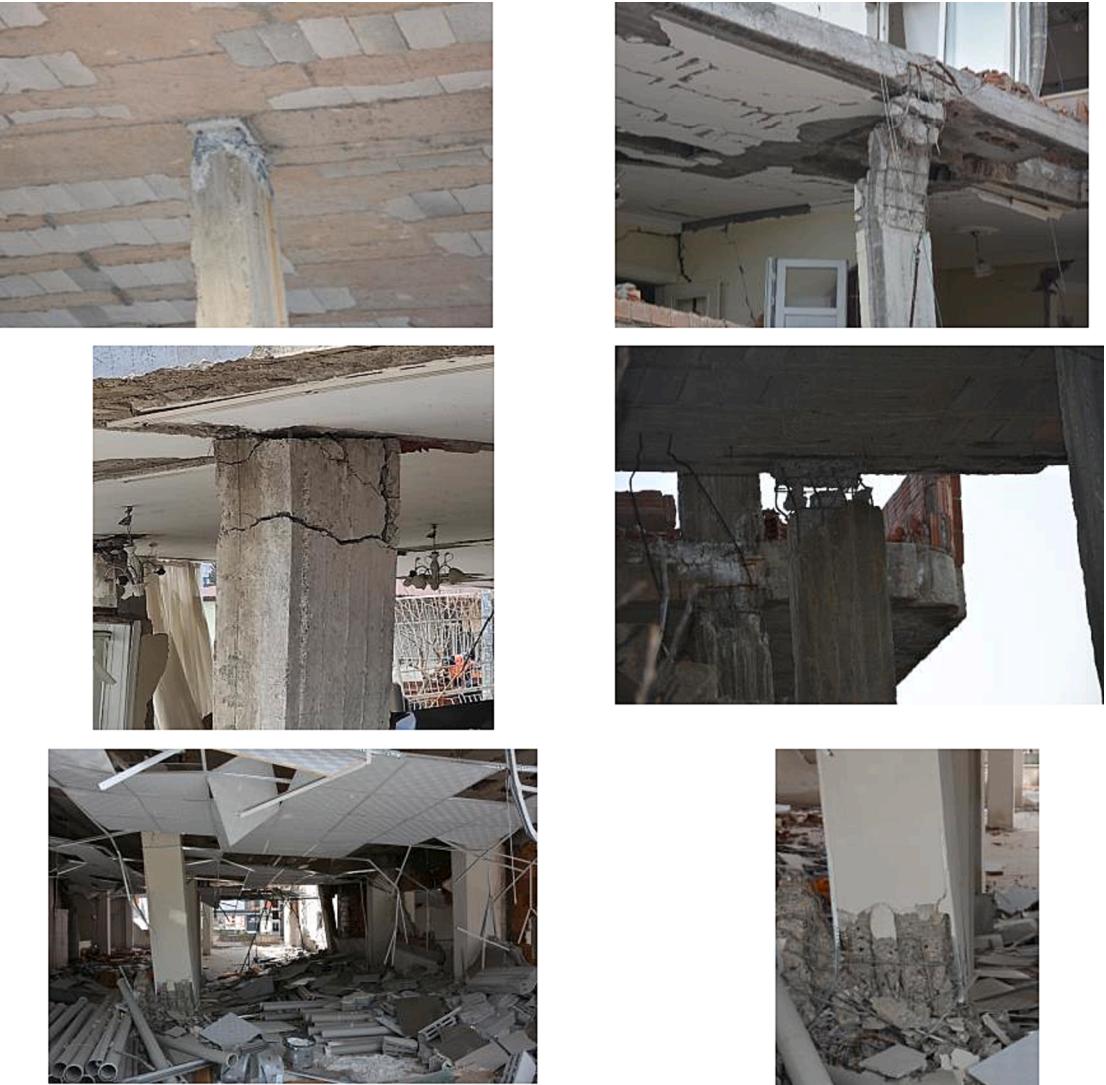
Fig. 20. Heavily damaged infilled ribbed slab RC buildings in Nurdağı and İslahiye.

case of using such slabs, if there is not enough shear walls in the load-carrier system, the ductility level should be taken as limited. In such slab systems, flat beams with very low h/b ratio ((height / width) usually 35/65 cm) are wider than columns and a design contrary to capacity design emerges. However, due to the lack of sufficient torsional rigidity of flat beams, the joint area cannot reach the capacity. In addition, as can be seen in Fig. 20, the narrower columns than the flat beams cause the beam reinforcements to lay outside the column. This situation also creates a bonding problem in connection region.

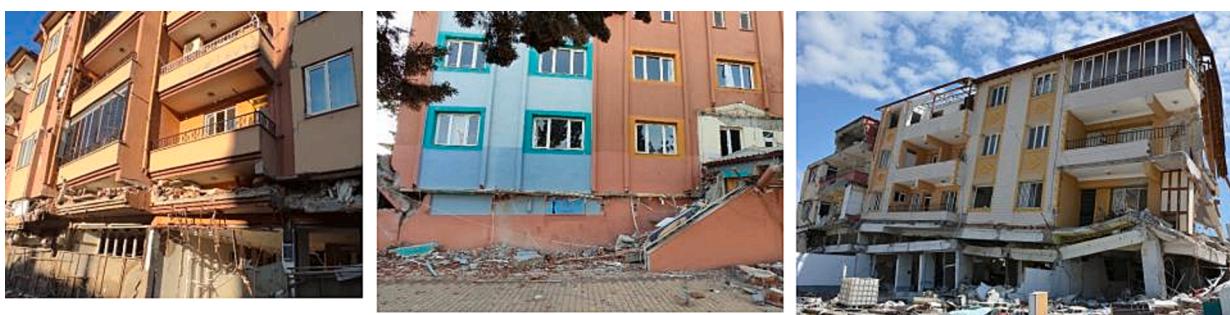
One of the main reasons that cause collapse and damage in reinforced concrete structures during earthquakes, both in Turkey and around the world is the soft / weak storey behaviour of a critical storey [7,100–102]. In Turkey, a significant part of the buildings built on both sides of the main streets are likely to have soft storey behaviour in case of earthquakes. In these buildings, the ground stories are generally used for commercial purposes and glass walls are made for presentation instead of brick infill walls. Especially the buildings where the ground storey heights are higher than the other storeys are at much greater risk. In addition, parking garages can cause soft storey formations due to the need for large and free area.

Fig. 22. Collapses due to weak and/or soft storey in reinforced concrete buildings.

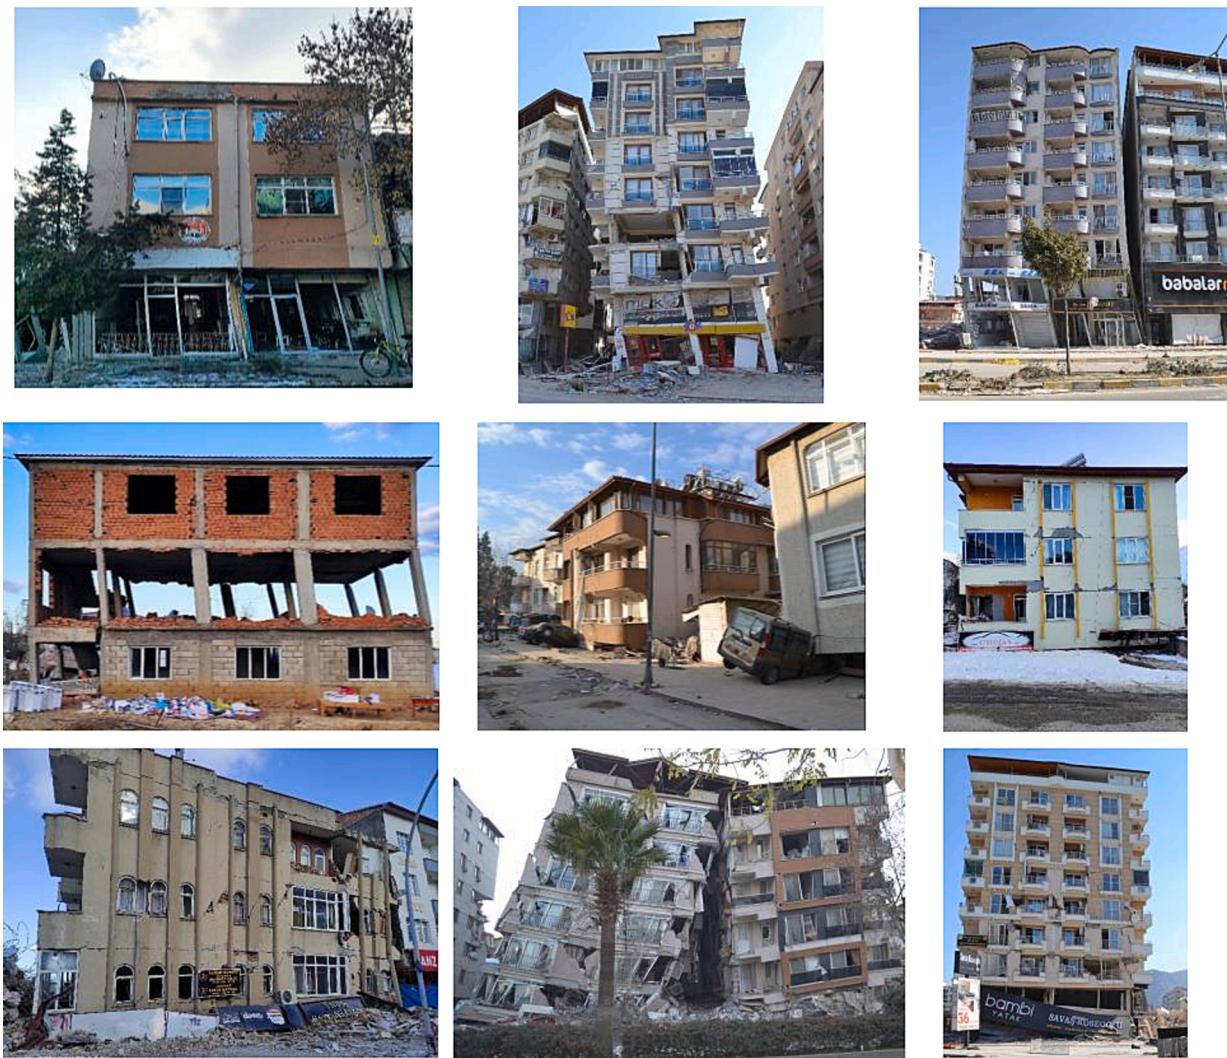
Fig. 23. Damages and collapses observed in some structures due to soft storey behavior.

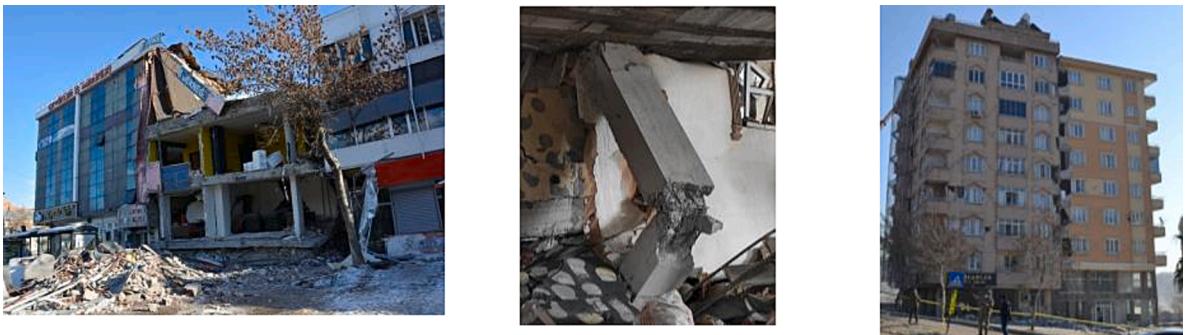
Especially in cities with high population density, there are many structures that are in contact with each other, despite having different dynamic characteristics, due to economic concerns such as maximum land usage requirements. TEC-1998 [18] seismic codes did not give precise guidelines to preclude pounding. For this reason, structures with different vibration characteristics during earthquakes may cause heavy damage and fractures in the columns, especially if the floor levels are not aligned (Fig. 25).

Fig. 25. Pounding Effect / Damage and collapses in adjacent buildings.

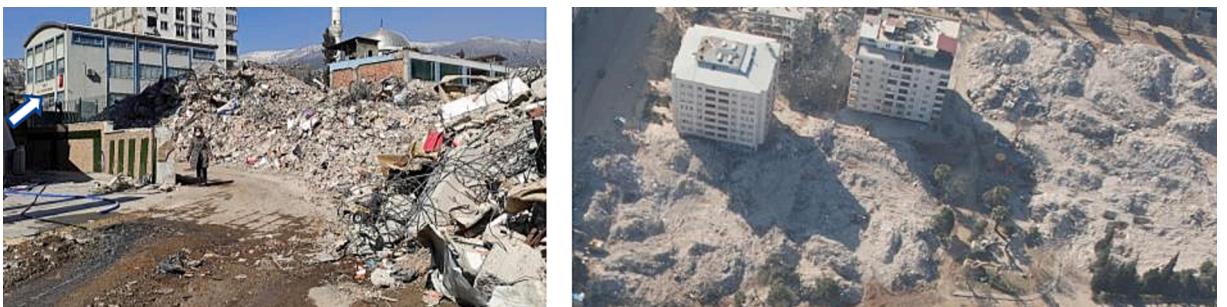
Fig. 26. Building wreckage resembling a sand pile.

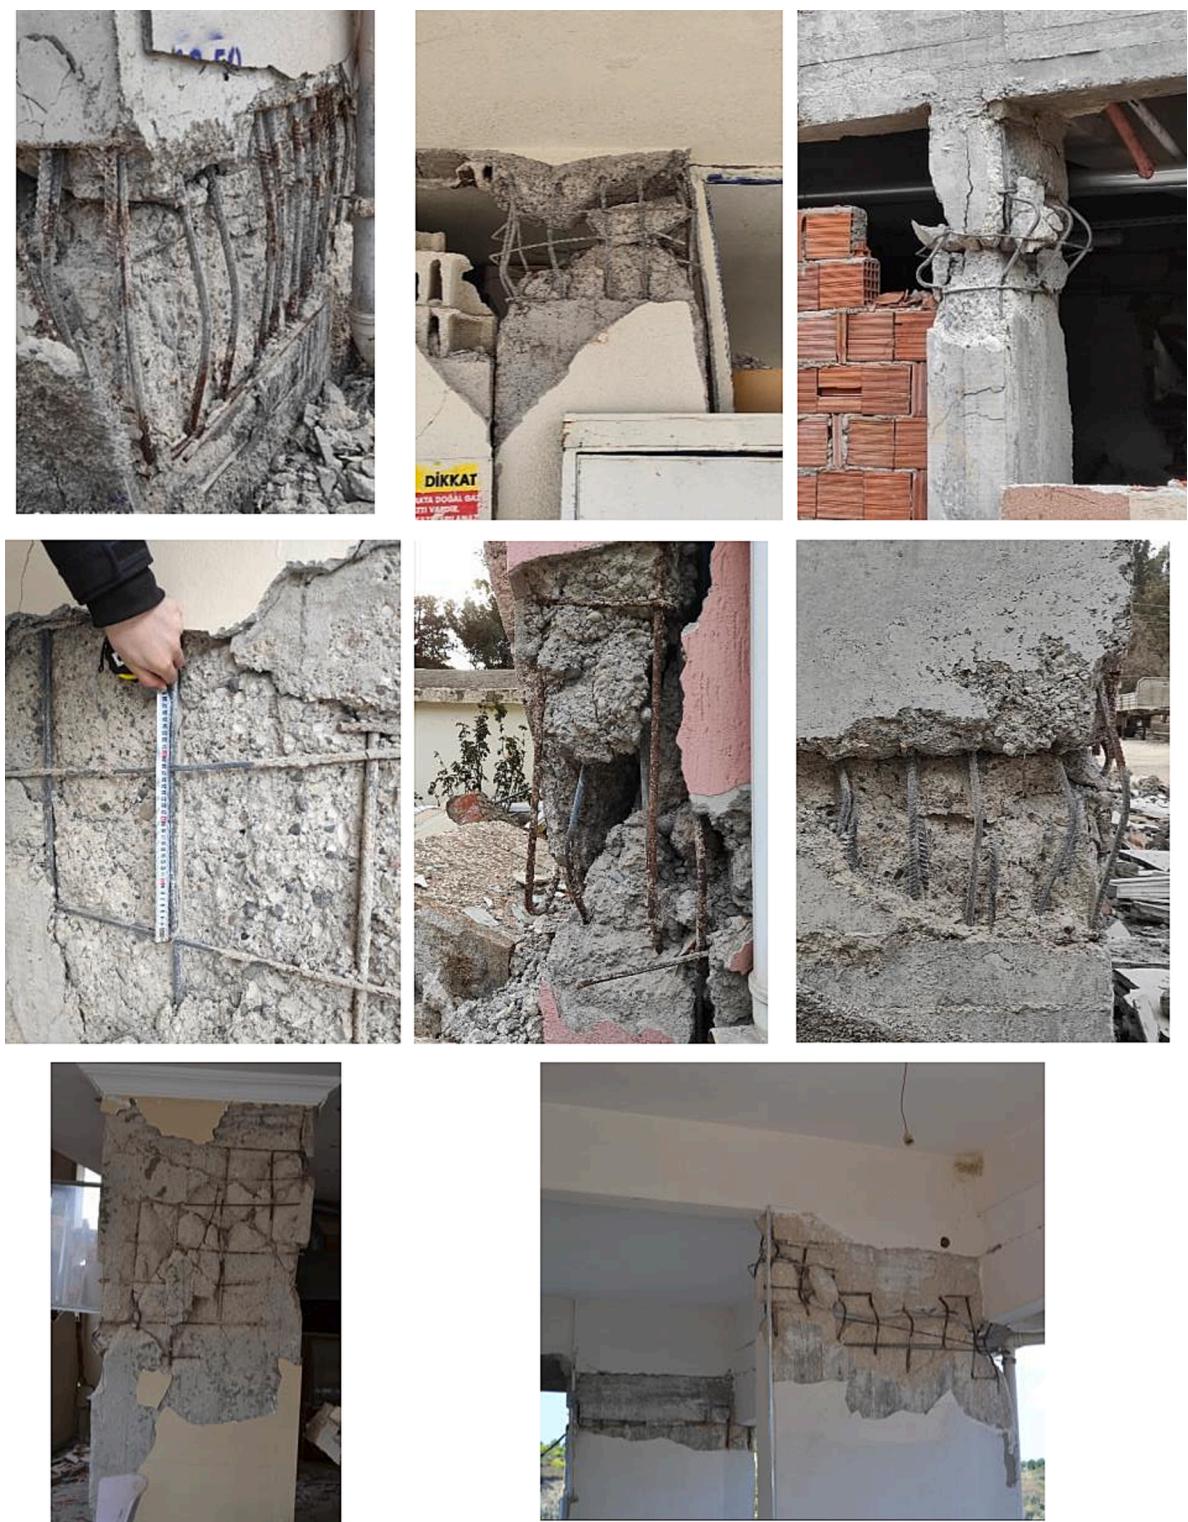
While increasing the shear strength of the transverse reinforcement in concrete columns is the main task, it also has important functions such as limiting the longitudinal reinforcement against buckling and improving the deformability by confining the concrete core. According to TBEC-2018 [20], the transverse reinforcement spacing in the confinement zones of the columns cannot exceed 150 mm and 1/3 of the small dimension of the column, and 200 mm in the middle zone. It has been observed that the stirrup spacing in most of the heavily damaged buildings is well above the maximum value allowed by the design codes. For this reason, heavy shear damages occurred on the columns and the reinforcements were buckled (Fig. 28). As seen in the Fig. 28 while the distance between the stirrups in the column is about 280 mm, no stirrup densification was made in the plastic hinge regions of any column.

Fig. 28. Some examples of damage caused by insufficient transverse reinforcement and incorrect end hook angles.

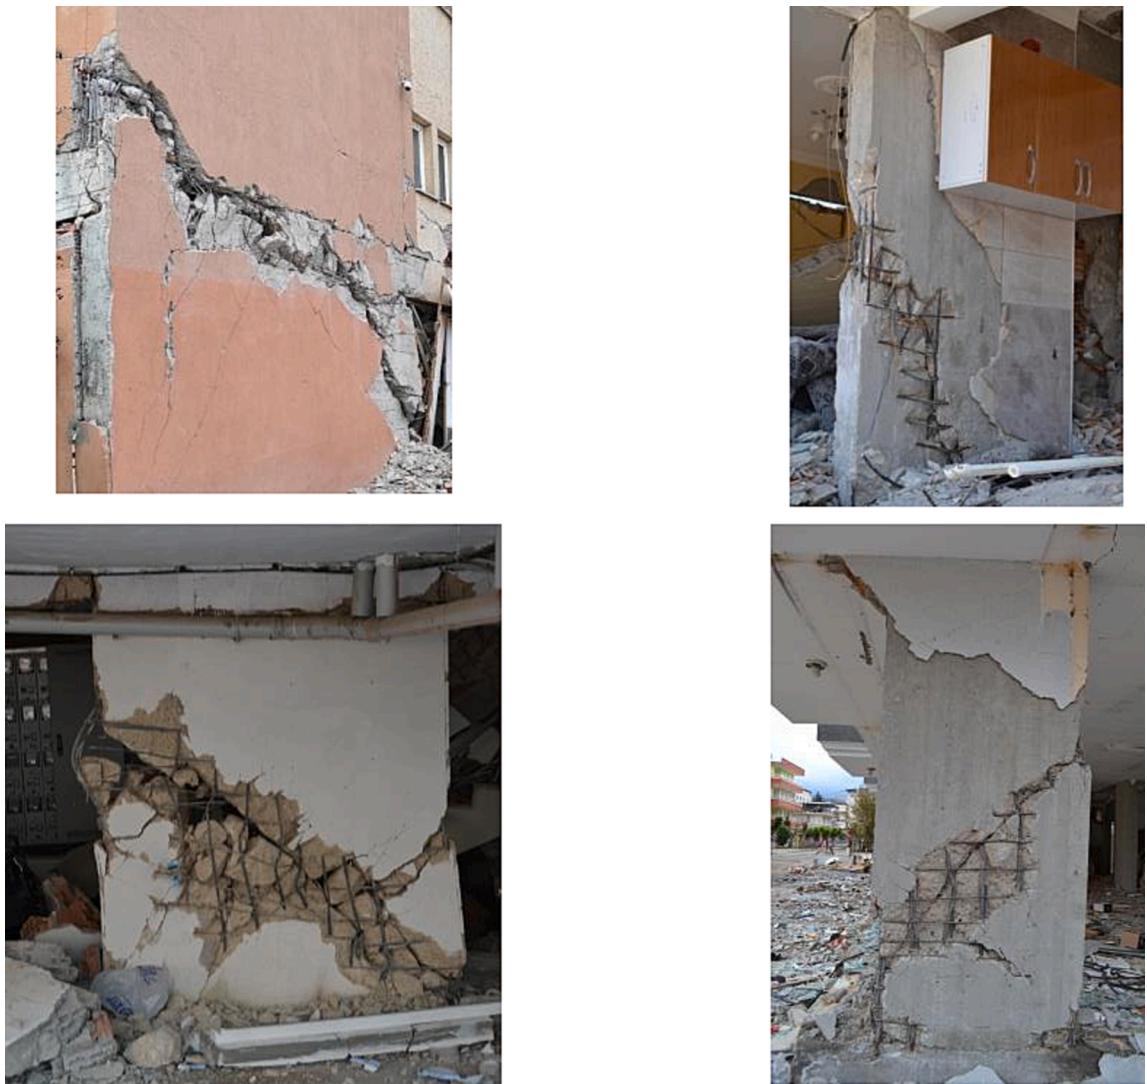
Although there are heavy design rules on this subject in TEC-1998 [18] and later, in the field survey made by the authors after the earthquakes in question, the double-sided 135-degree hook and crossties applied to prevent the buckling of the longitudinal reinforcement, especially used in order not to open the stirrup arms, were not encountered in the relatively new reinforced concrete buildings. It is extremely interesting. This shows that this section of the code are only a book source and that they are not fully implemented / or not applied. TBEC-2018 [20] defines shear walls with $H_w / L_w \geq 2.0$ as bending shear wall and requires special reinforcement detail requirements. Here, H_w is the height of the shear wall and L_w is the length of the shear wall in plan. The code

Fig. 29. Damages caused by insufficient shear capacity in shear walls.

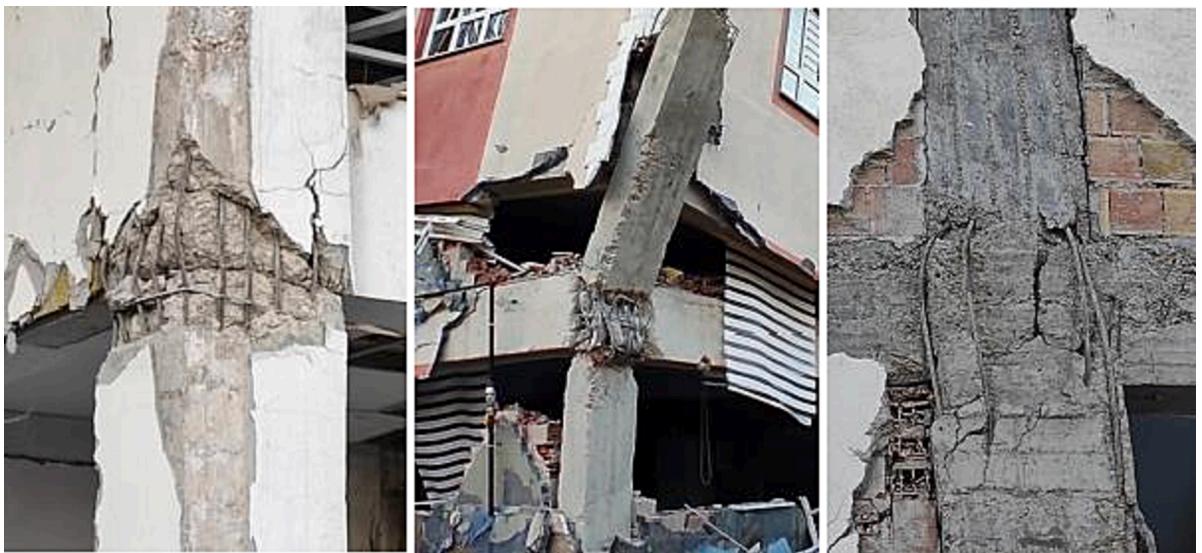
Fig. 31. Failure of beam-column joints.

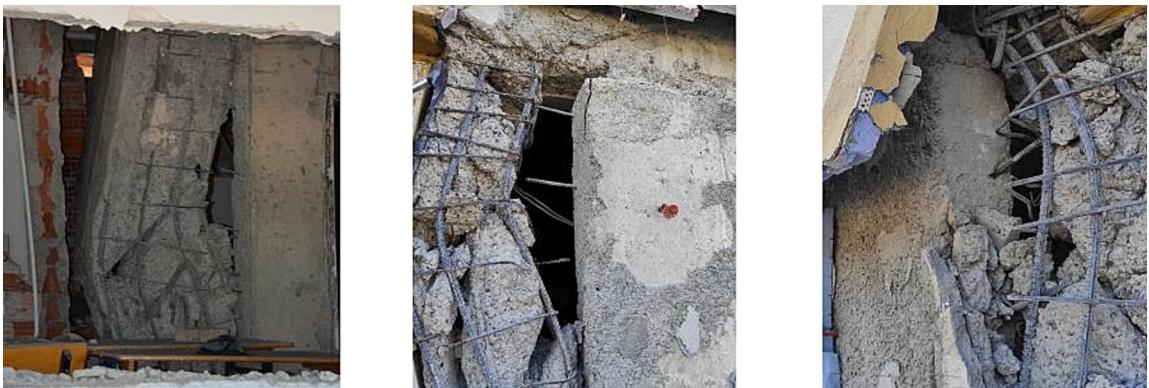
For example, Fig. 32 shows a high school building located in Kahramanmaraş-Türkoğlu, 10 km from Nurdagi, and the damage caused by the earthquakes. As can be seen from the response spectra given for Nurdagi and Kahramanmaraş in Fig. 7, it is understood that the damages occurred in the first earthquake of magnitude 7.7 (M_w 7.7). Shear walls that comply with the code requirements are placed on the interior and exterior axes of the building. However, due to the lack of anchorage reinforcements and insufficient anchorage lengths, which will enable the existing columns and beams to work together with the newly added shear walls, the shear walls were stripped from the columns and beams, shear force could not be transferred to the shear walls, so the existing structure with insufficient strength and ductility came to the verge of collapse. As can be seen from Fig. 32, only 1 or 2 anchor reinforcements were placed in the upper part between the columns and the shear walls on the outer axes, but no anchorage was made afterwards. Also, it is seen that these anchors were placed carelessly too close to the outer surface of the shear walls. It is seen that the anchorage lengths are insufficient at the shear wall-column interfaces on the interior axes. A striking point in the building is that some of the columns have

Fig. 32. Damage caused by earthquakes in a strengthened high school building in Kahramanmaraş.

very heavy torsional shear damages. It is understood that during the magnitude 7.7 earthquake (M_w 7.7), the shear walls were stripped from the existing structural elements at different times, therefore, due to the change in the centre of rigidity and also depending on the magnitude of the earthquake a large torsional moment occurred in the structure. As a result heavy torsional shear damage occurred in 2 columns near the entrance door. This damage to the column can be seen in the bottom middle picture.

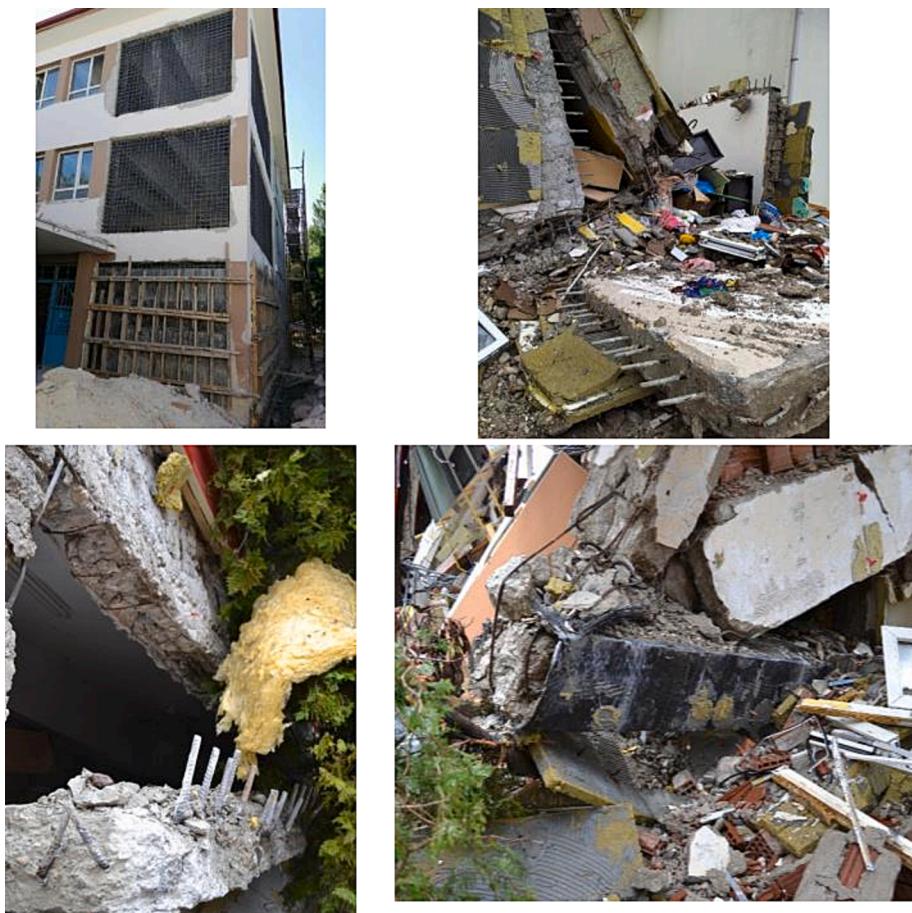
In addition, it is understood that only the column is wrapped without increasing the strength and rigidity of the beam-column joints, therefore, the joint areas with insufficient shear and ductility capacity could not respond to the demands of strong earthquakes after the shear walls lose their effect. Also, with the loss of the effect of the shear walls, the formation of short columns due to architectural factors was effective in the collapse.

Fig. 33. Collapse caused by earthquakes in a strengthened secondary school in Malatya-Akçadağ.

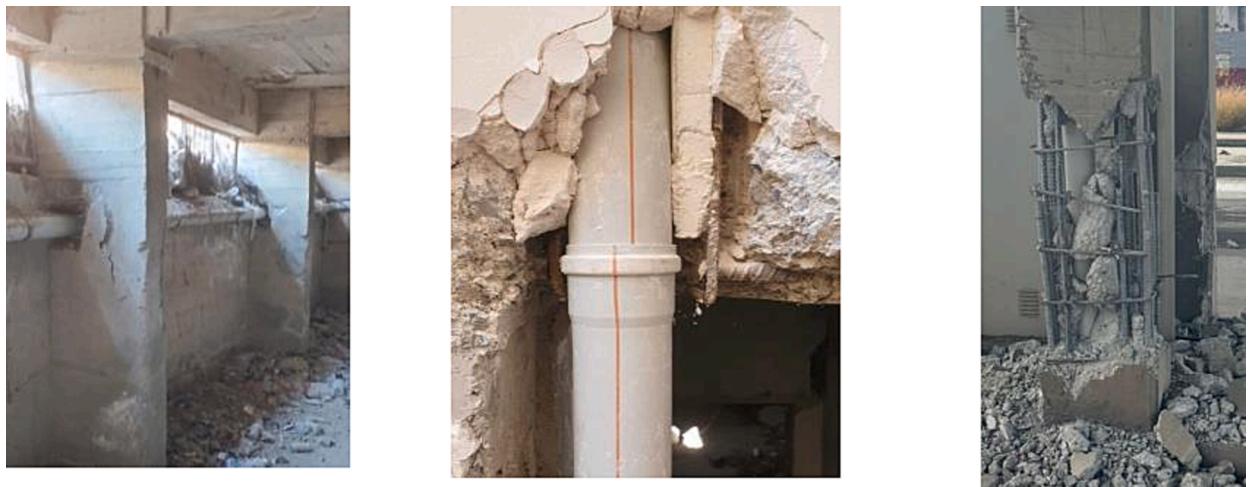
In the field post-earthquake observations, it is seen that the structures with especially weak earthquake performance are mostly old buildings. The main reason for this was stated in the previous section that the old structures were not designed to provide sufficient

Fig. 34. Damages caused by users to the load-bearing elements during the use of the building.
