**RE: Portable Fire Equipment Asset Defect Report- October 2025**

**Subject:** Portable Fire Equipment Asset Defect Report- October 2025

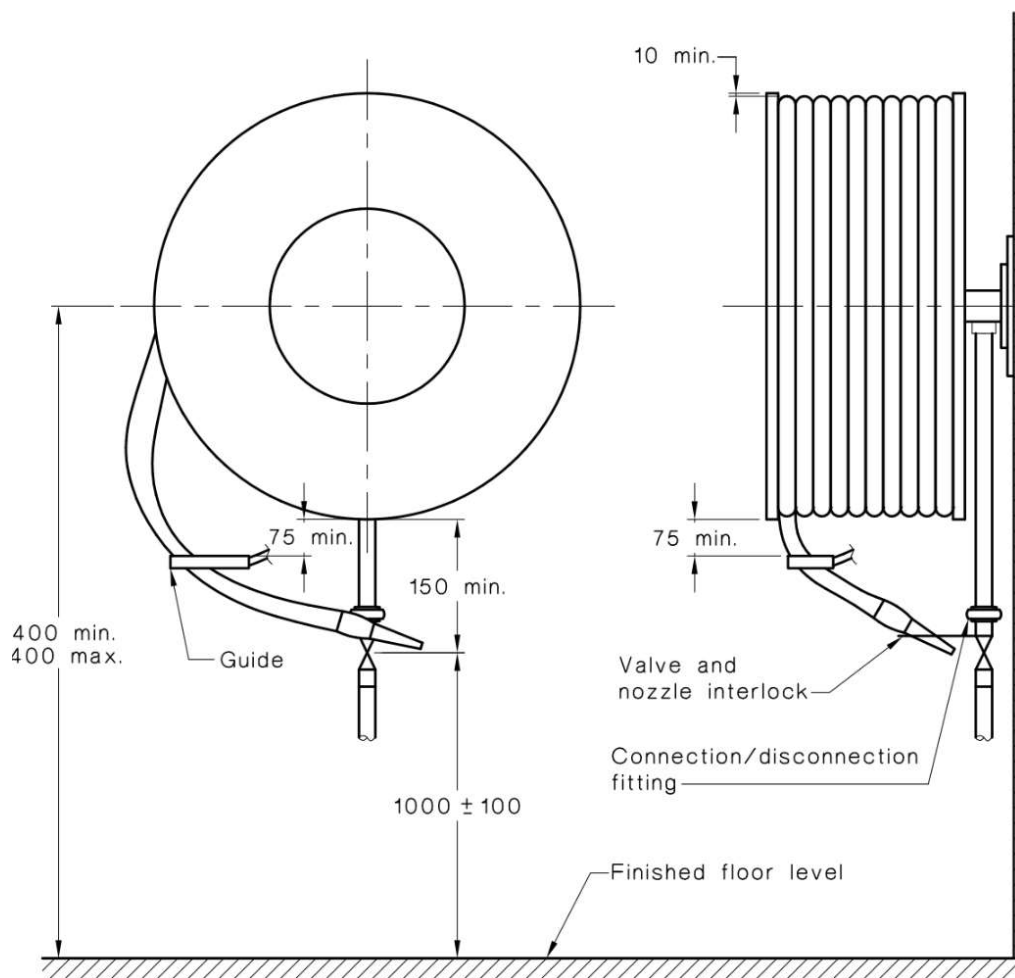
## **6.2 Metered water supply**

- (c) Any valve that can prevent flow of water to the hose reel shall be secured and padlocked in the open position. It shall be marked on an attached corrosion-resistant and durable tag, with the following in nominal 8 mm upper case text:
