FIELD OBSERVATION REPORT

PROJECT: Dana Point - Balcony Rehabilitation

PROJECT #: 10145.02

May 15, 2013

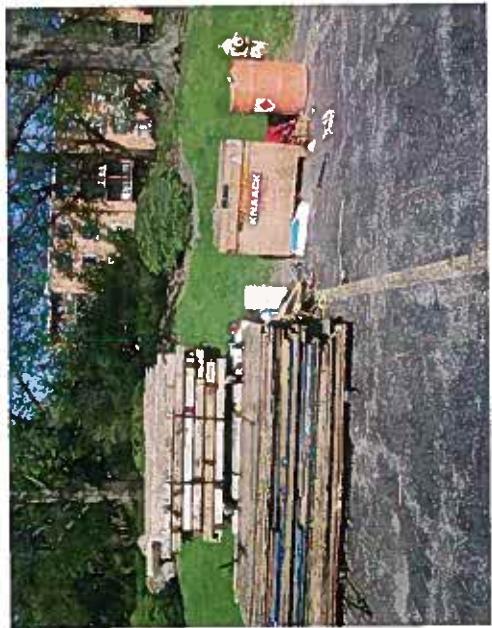
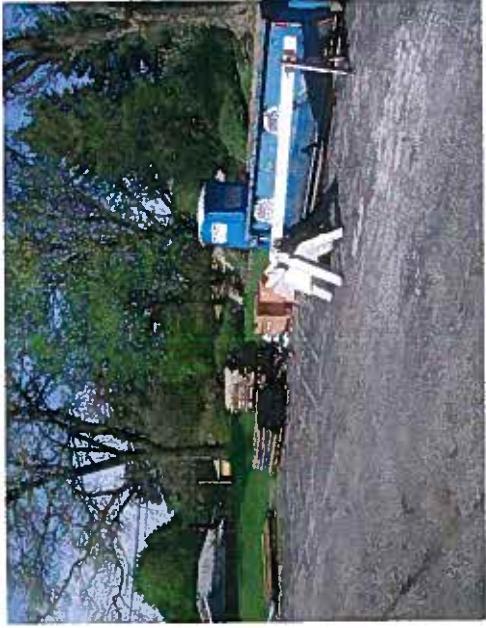
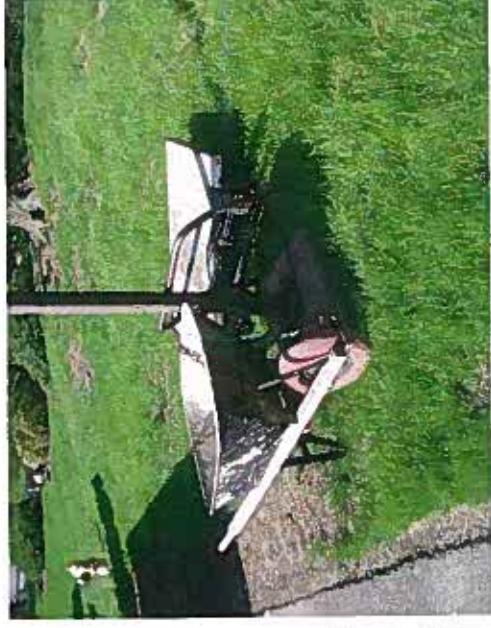
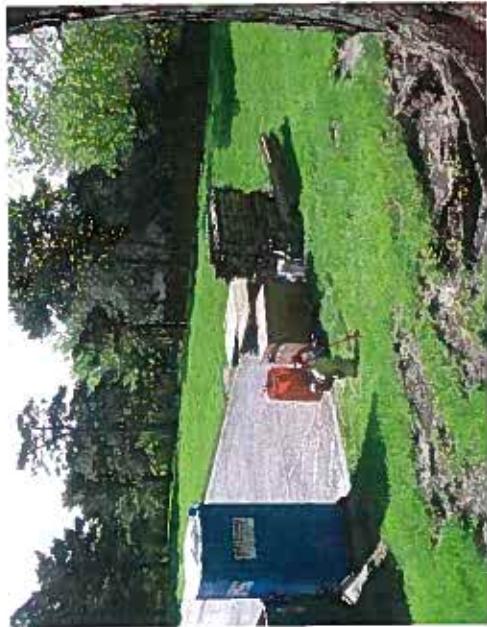
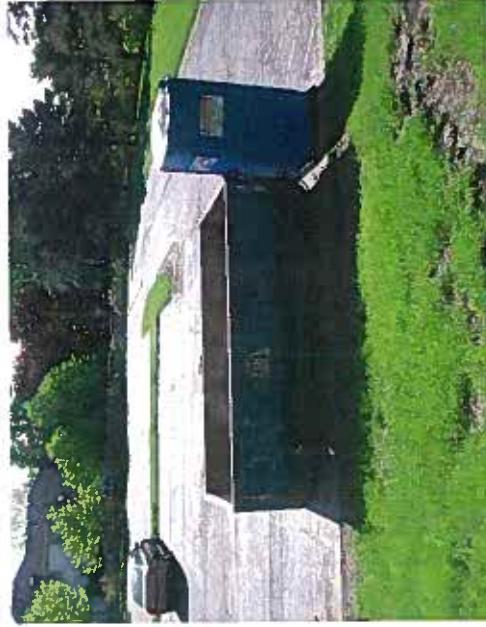
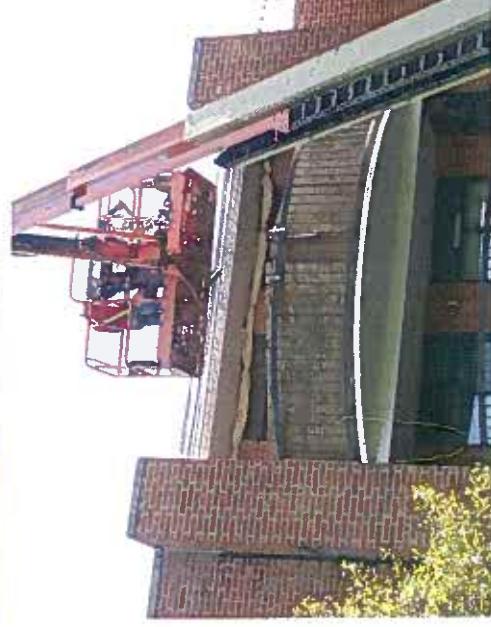
Work performed today:		Weather	<u>Partially Cloudy</u>	
<p>Crew will continue to sandblast existing rebar at 1605-410B</p> <p>They have a new technique for protecting sliding doors. Tarp is being used. When they are not working the tarp is rolled up so that the unit owners have light Good method.</p> <p>Rick called and said they will be ready to pour concrete (most likely this Friday).</p> <p>He will give me 15 Balconies to notify on May 20th. Then the rest of the Balconies on May 28th (for Membrane installation only)</p> <p>Finished sandblasting. Cleaning up demo debris. Getting formwork ready.</p>		Temp.	AM	PM
		75		
		Work force:	No.	
		Postl-Yore	<u>Mayne</u>	
		Project Manager		
		Foreman	<u>Leo</u>	
		Laborer	<u>Guy Benny</u>	
		LMS		
		Others		
		Equipment:		
		Fork Lift	1	Hrs.
		Boom lift	1	
Extra work:		Authorized by:	Approx. price	
Signature of Architectural Representative:				Report No. : <u>219</u>
