FIELD OBSERVATION REPORT

PROJECT: Dana Point - Balcony Rehabilitation

PROJECT #: 10145.02

May 29, 2013

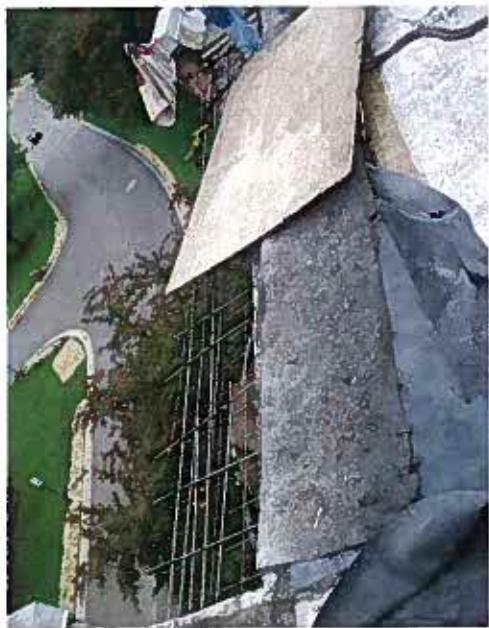
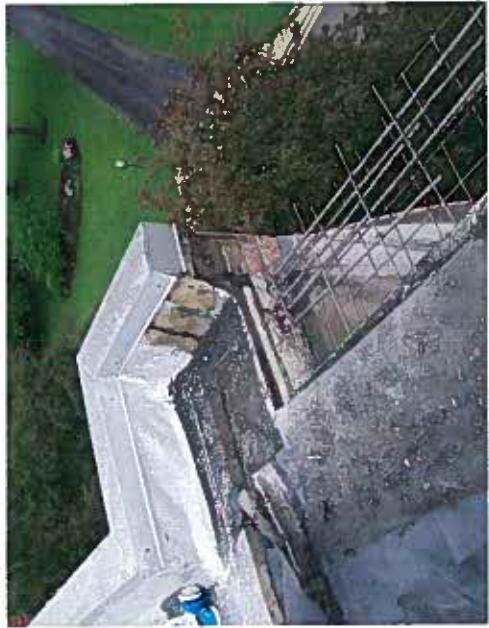
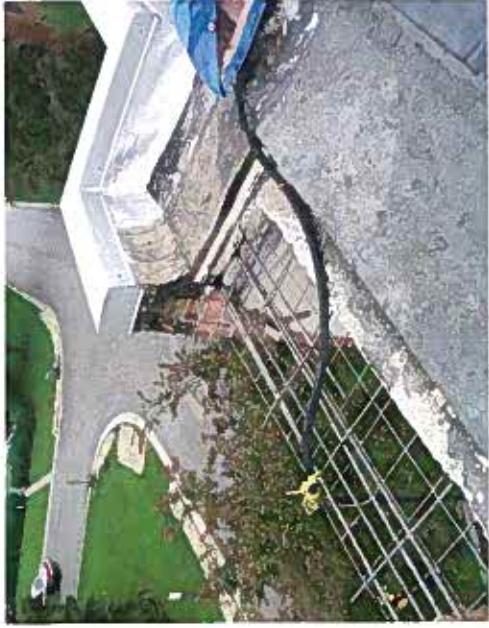
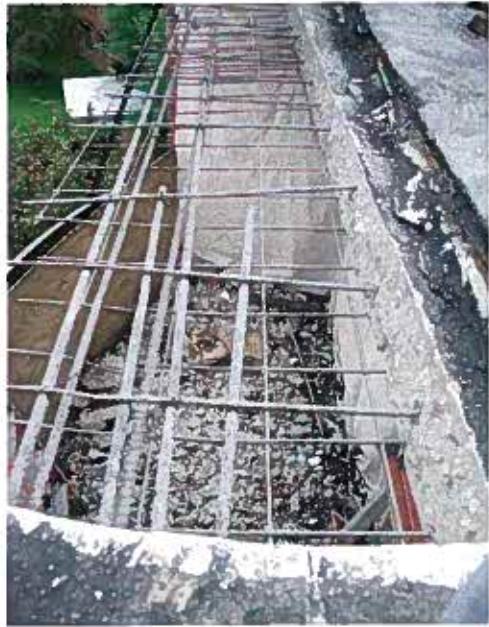
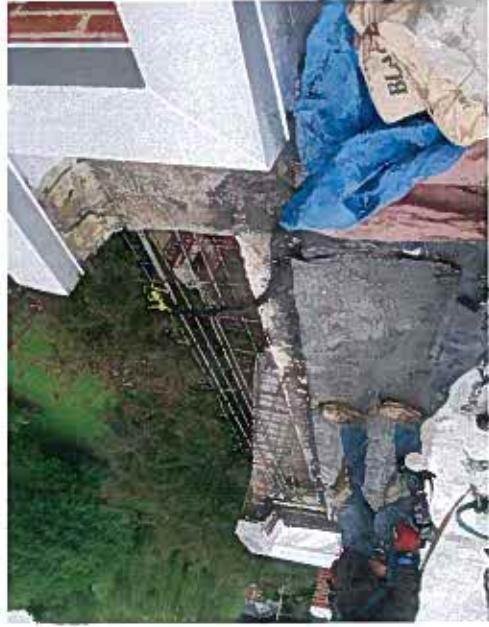
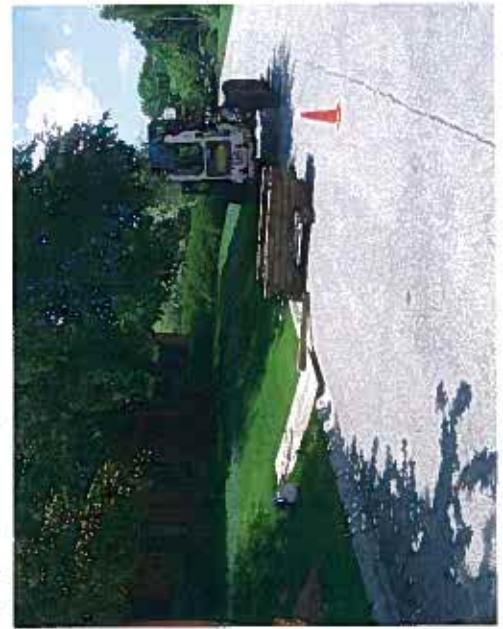
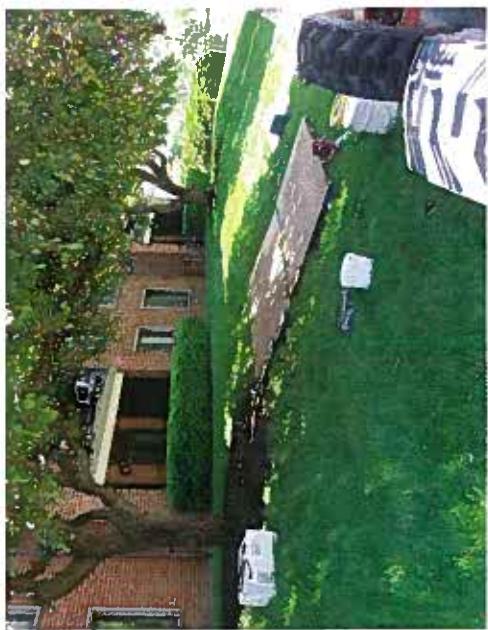
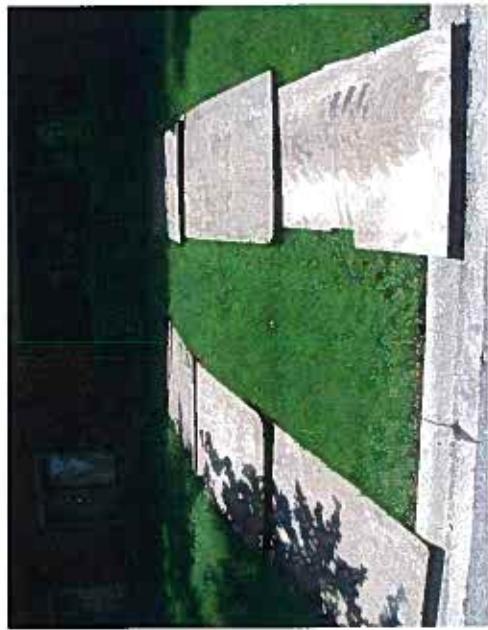
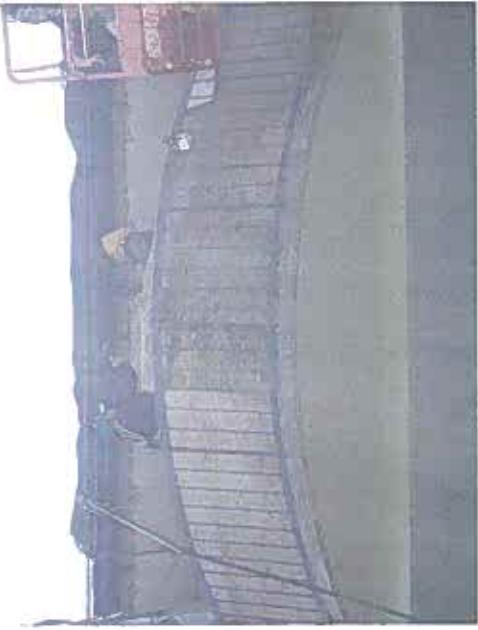
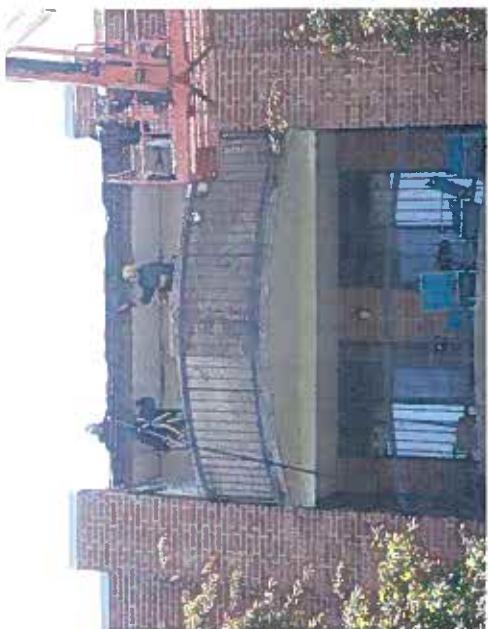
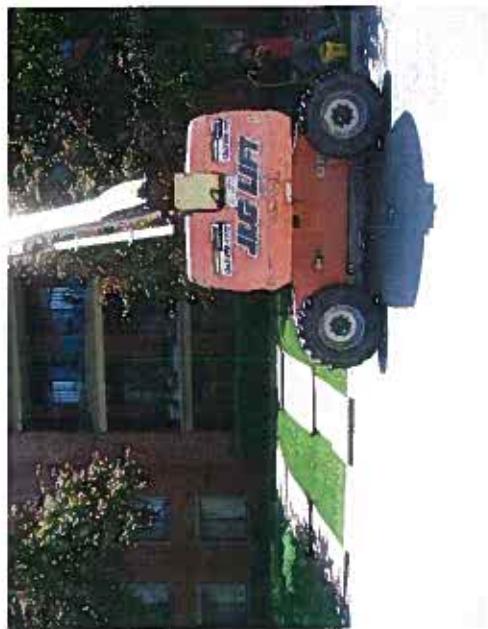
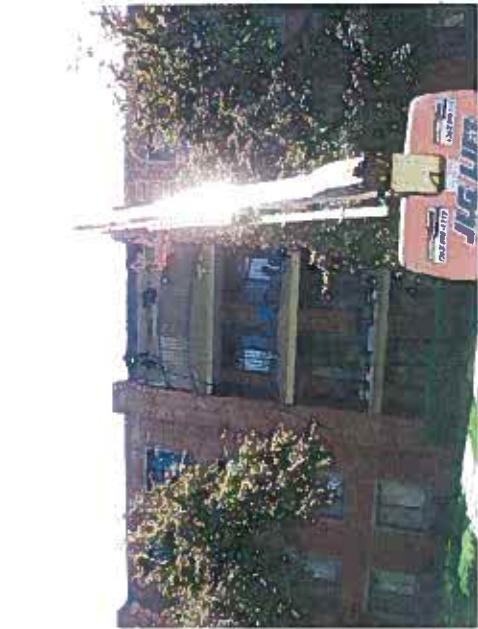
Work performed today:		Weather	Overcast
<p>Crew continues to sandblast existing rebar.</p> <p>There is a good amount of existing rebar. Adding in a few more pieces where there are gaps or the existing has rusted substantially.</p> <p>Crew has formwork ready to be installed as soon as sandblasting & priming is completed.</p> <p>Crew priming rebar.</p> <p>If weather is good, they will most likely pour the concrete by this Friday.</p>		Temp. AM	73 P.M.
		Work force:	No.
		Postl-Yore	Maggie
		Project Manager	
		Foreman	Lee
		Laborer	Craig & Bonny
		LMS	
		Others	
		Equipment:	Hrs.
		Fork lift	1
		Broom lift	1
Extra work:		Authorized by:	Approx. price
Signature of Architectural Representative:		Report No.:	
Copies: Lisette Ray, CMCA		229
