Tank Inspection Report  
for  
Enva  
Tank CT-3  
at  
Shanbally, Co. Cork, Cork  
Inspection date 23rd July 2018

## TANK INSPECTION REPORT

| <b>REPORT NUMBER:</b> | 5675.10 |
| <b>SUBJECT:</b> | Tank CT-3 |

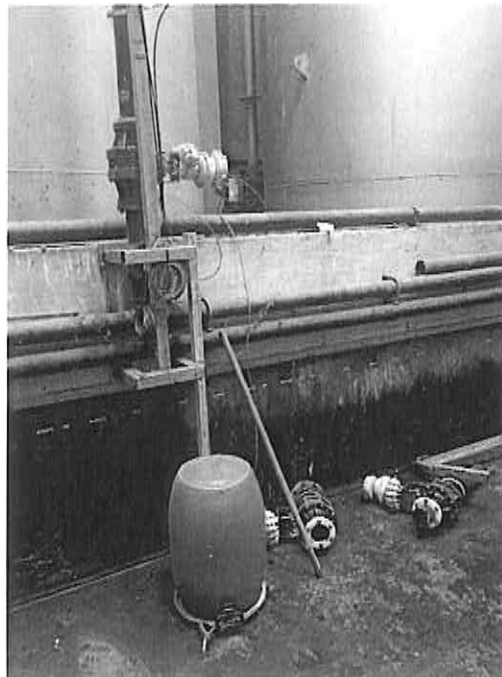
- Corrosion / Pitting band on the bottom of the shell around its perimeter
- approximately 50 mm wide and extending into the outer base rim, random areas were selected and the corrosion was removed, a pitting depth of 1.0 mm to 2.0 mm was measured at these locations.
- All of this corrosion would need to be removed to properly assess the depth of the overall pitting present.
- The handrails and platform appear to be in good condition.
- Note: No safe access to the top section of the shell.
- Ultrasonic thickness readings taken on the first 2 courses only,
- Note: Shell nozzles are numbered clockwise starting at the man way
- Debris litter in bund and surrounding areas
