**PRELIMINARY SURVEY REPORT**

| <b>Vessel/Carrier</b> | : | <vessel name> | <b>Voyage</b> | : | <voyage ID> |
| <b>Consignment</b> | : | <consignment details> | | | |
| <b>Date of Delivery</b> | : | <date of delivery> | <b>Cargo Exceptions:</b> | : | Wetting damages |

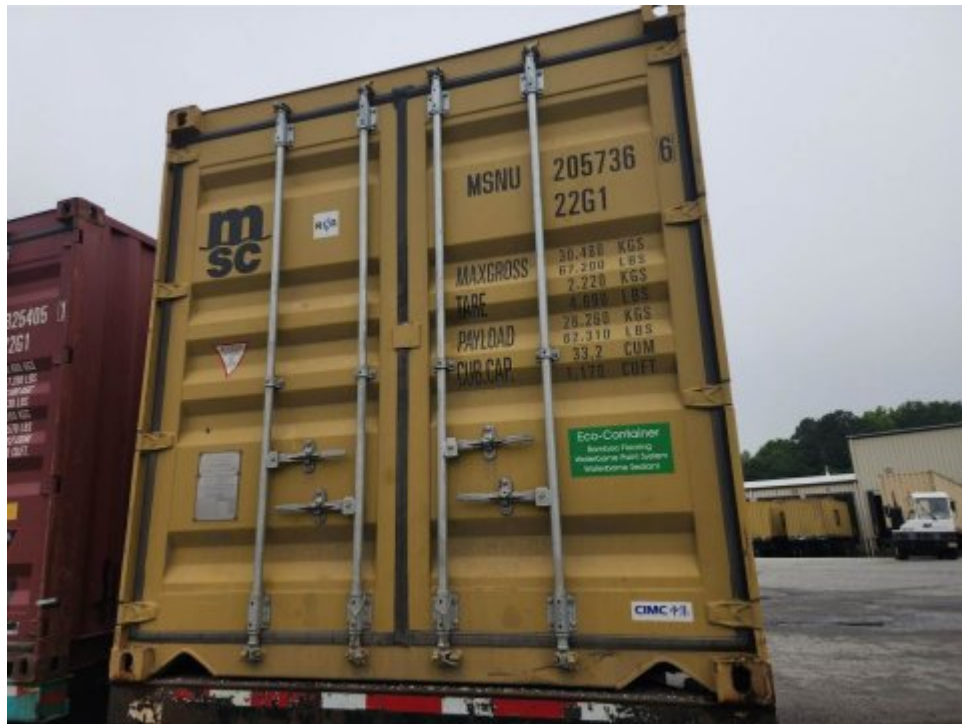
**Container MSNU2057366**

<container id1> is a 01/2024 mfd. 20ft standard dry van container with valid CSC safety approval. The container had four vents, and all were unobstructed. No holes or ruptures to the container were observed. Paper lining was stuck to the floor and container walls. The desiccant bags were not retained for inspection. The silver nitrate test was positive for chlorides. The silver Nitrate test on wet stained burlap bags was positive for chlorides.

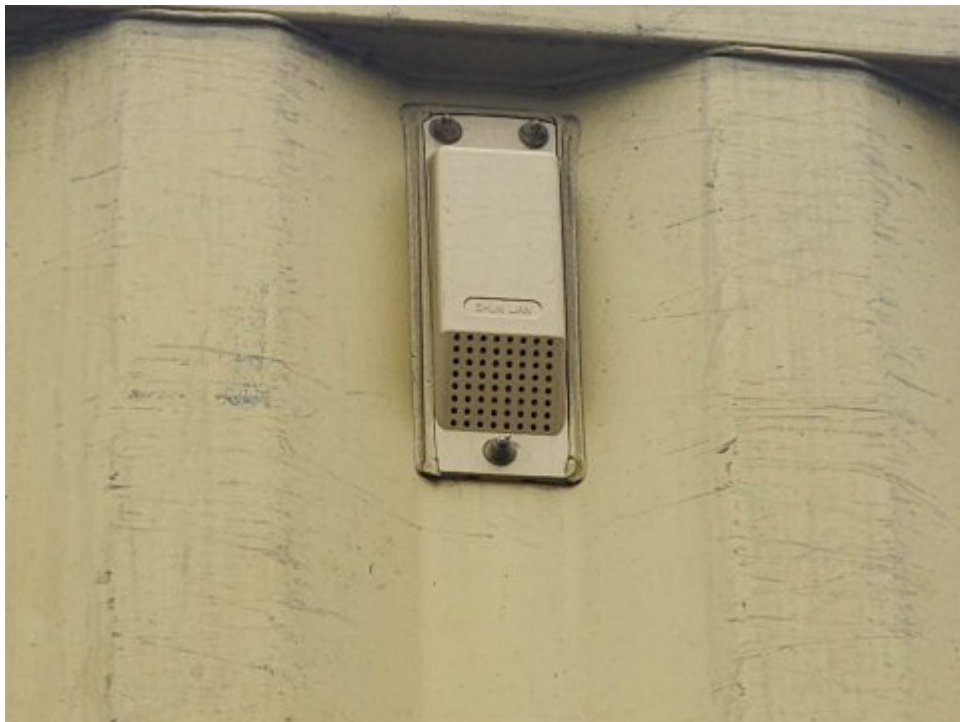
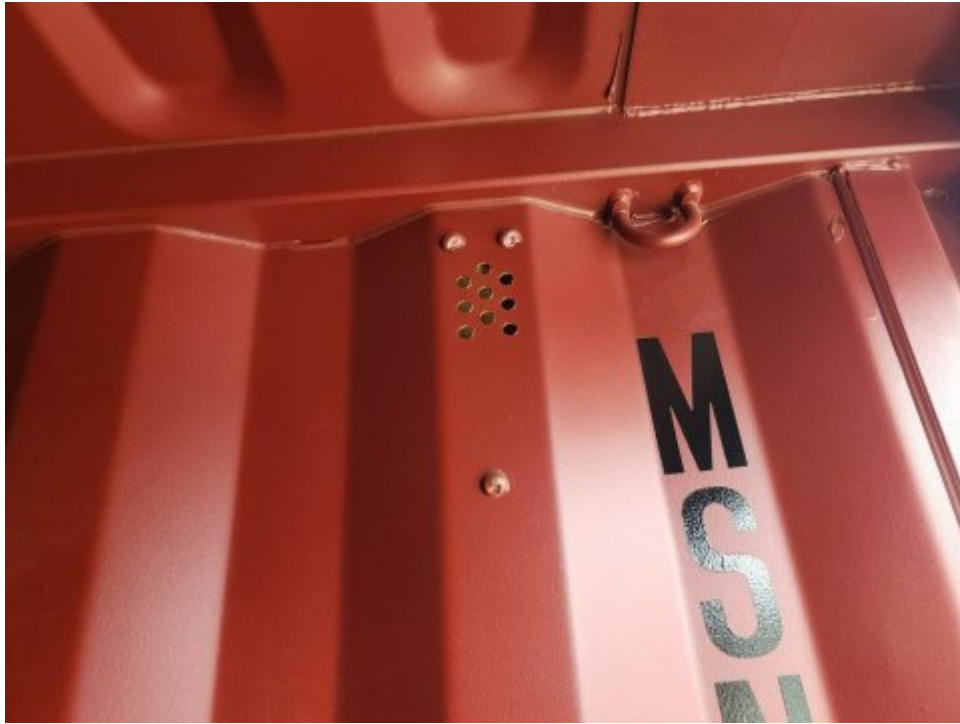
**Container MSNU2057366 – vent unobstructed**

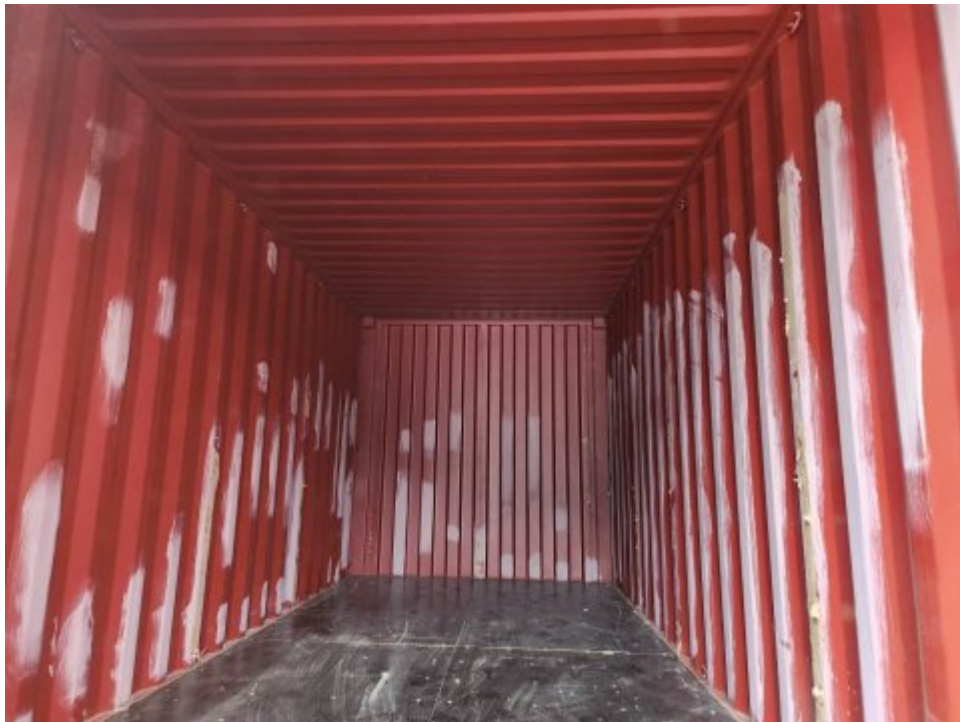
**Container MSNU2057366 – empty container**

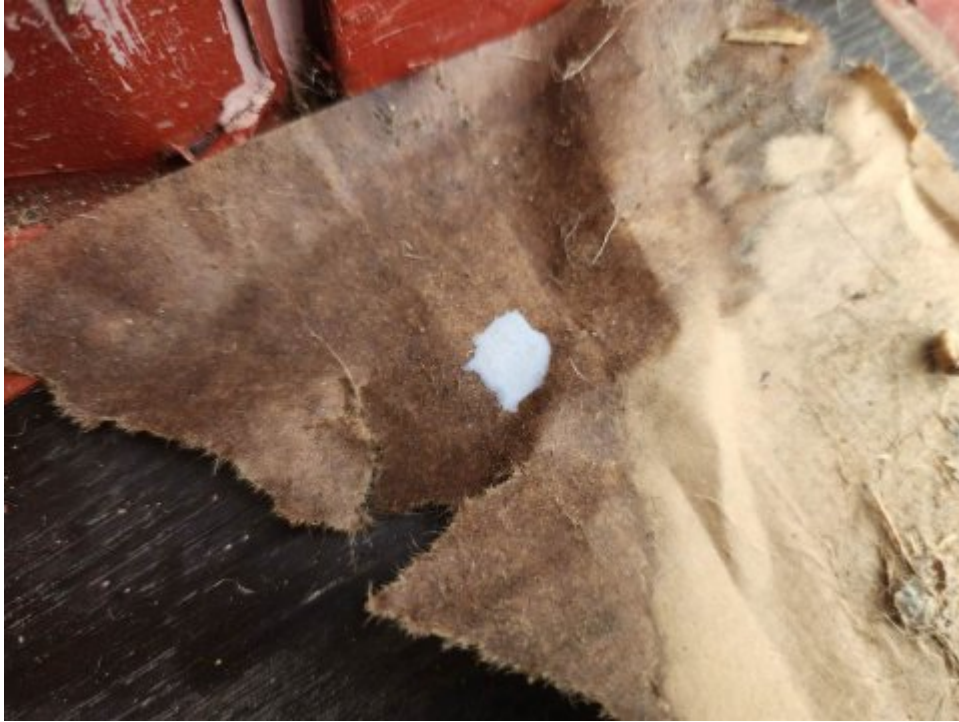
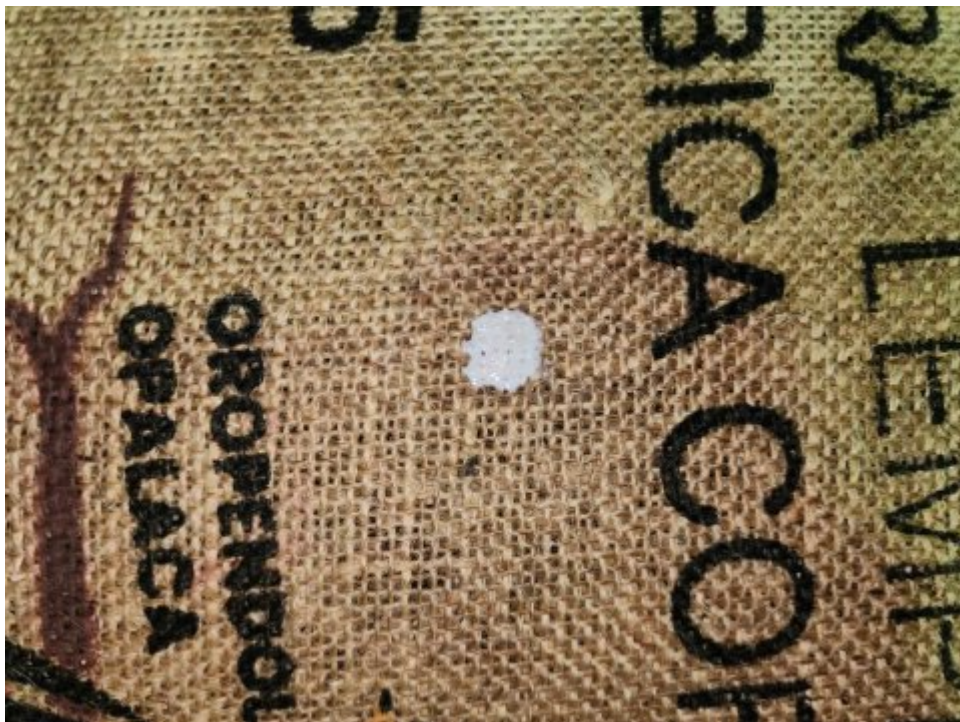
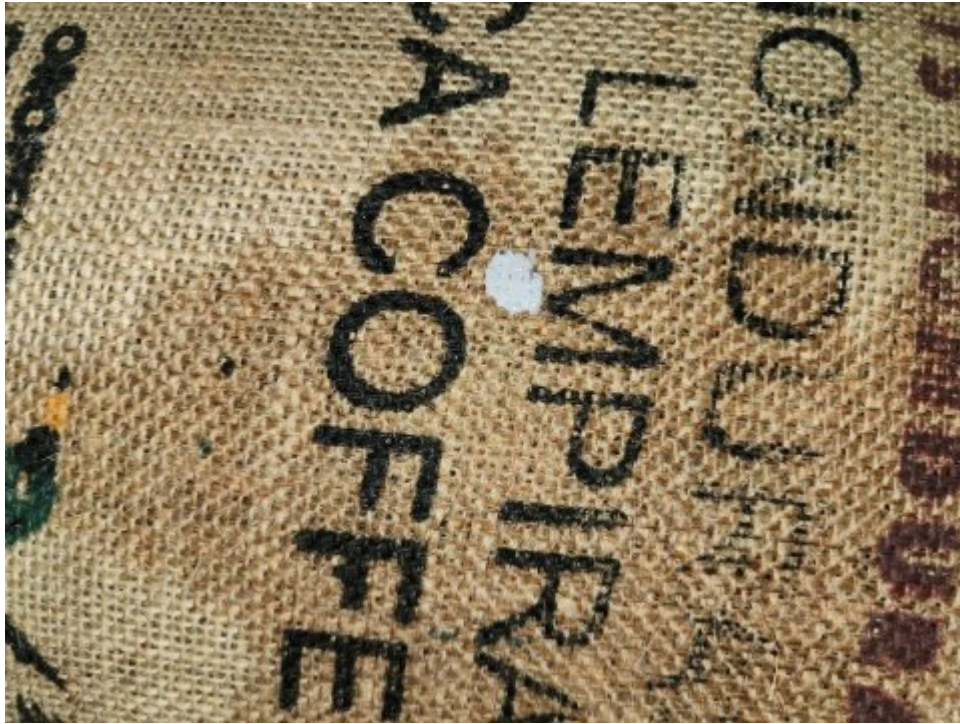
Container floor, paper lining and Burlap sacks were positive for chlorides. The test was likely positive due to reaction with calcium chloride used in desiccant bags.

**Container MSNU2057366 – silver nitrate test was positive for chlorides**

Container MSNU2057366 – silver nitrate test was positive for chlorides

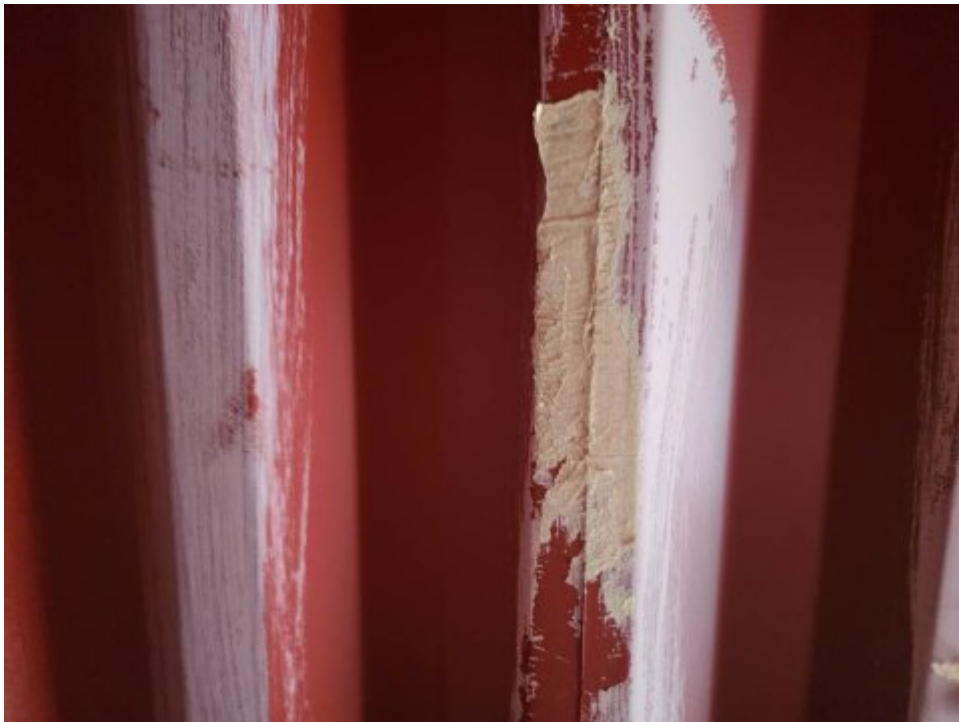
**Container MSNU2057366 – paper lining adhered to side panel**

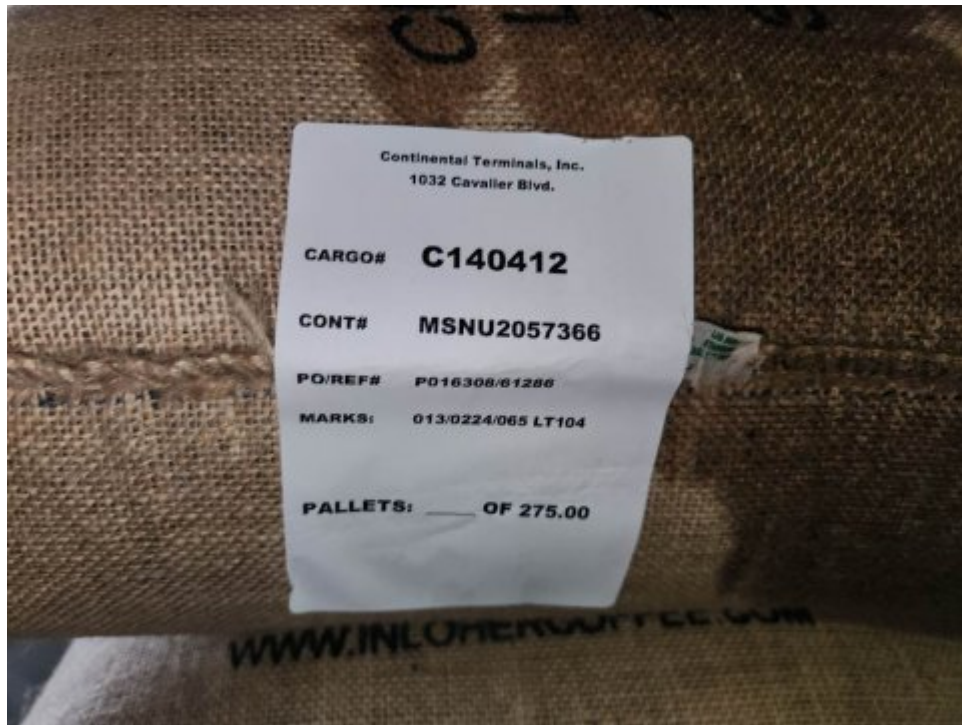
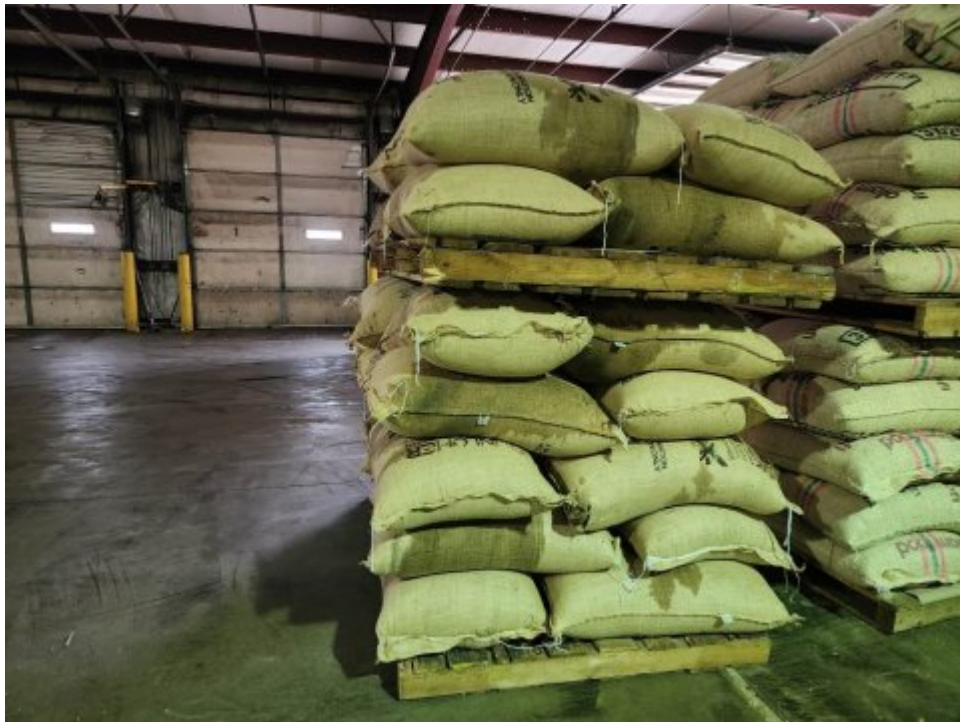
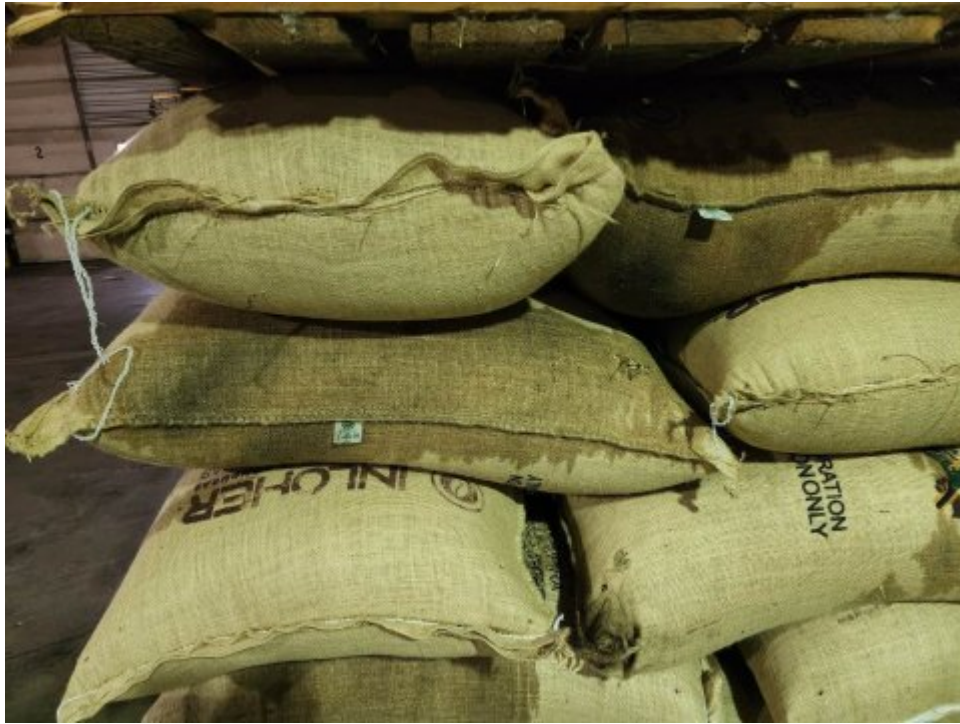
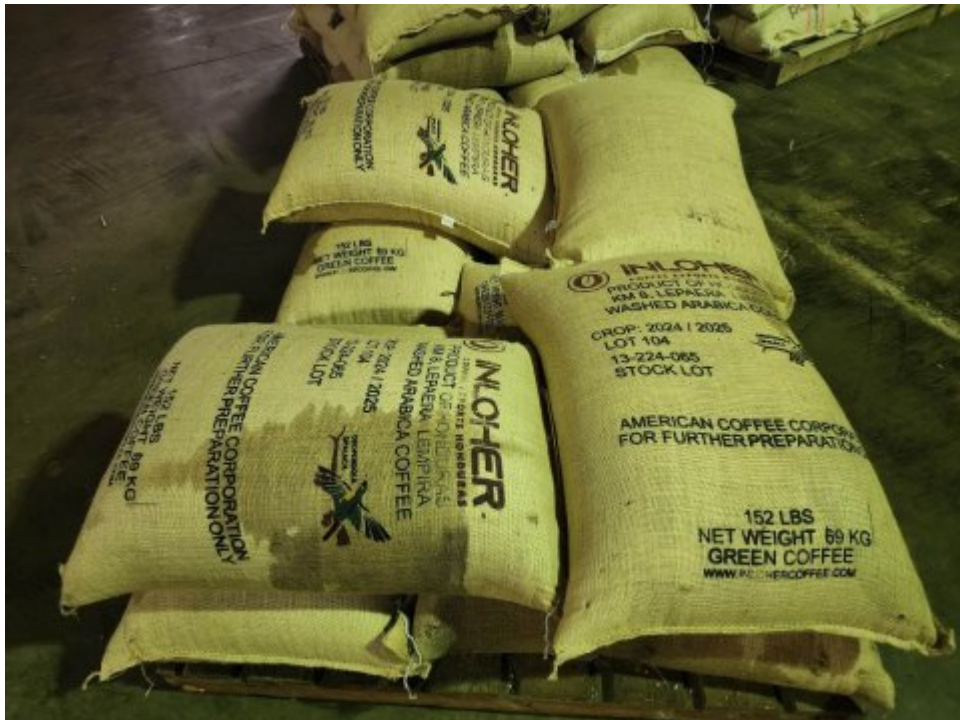
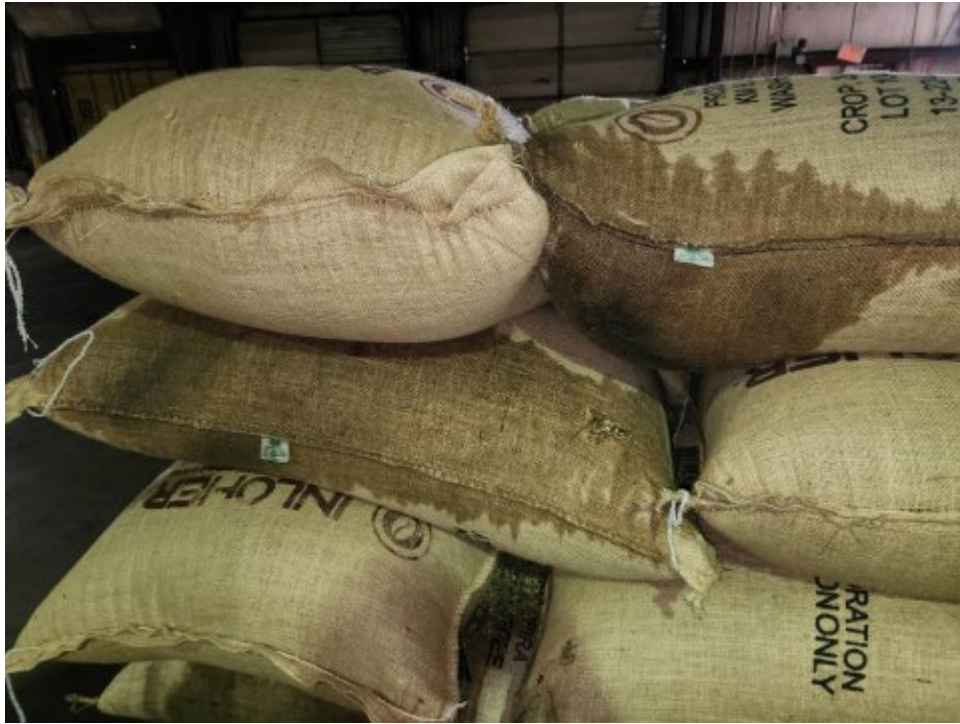
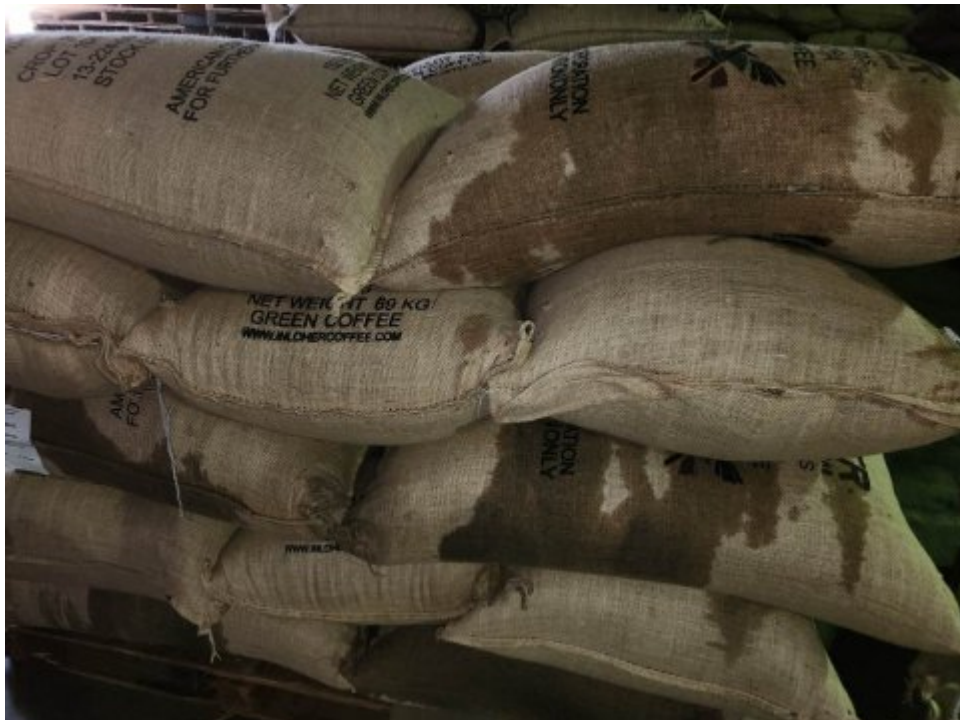
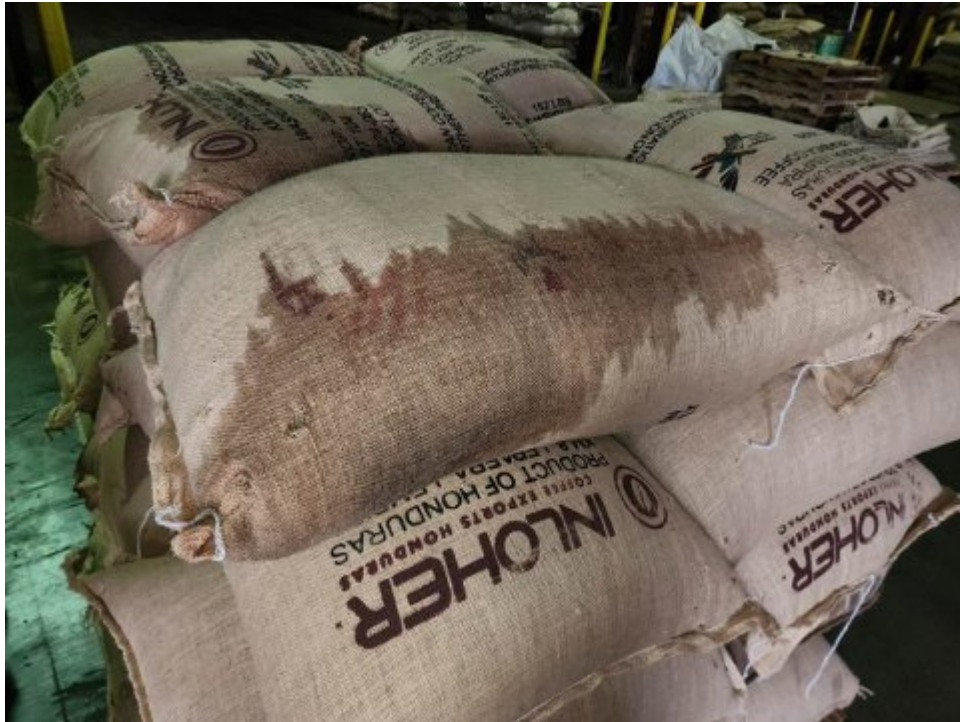
Two containers were delivered and unloaded on <unload date>, at which time damage was observed and reported. Per the warehouse, upon opening the containers, moisture was observed due to condensation. There were no breaches in the containers. The warehouse crew found the desiccant bags were heavily saturated with moisture absorption. The water leaked from the bags, ran down the containers side walls and onto the coffee bags. Wet bags were only found at and around the desiccant bags and only along the side panels.

Wetting could have likely been caused by condensation inside the container. No breaches to container were observed. As this wetting appears to be occurring on a regular basis, it appears the desiccant bags placed in the containers are either of poor quality or inadequate in number to the intended transit.

**Container MSNU2057366 – wet bags**

Merchandise can be reconditioned.

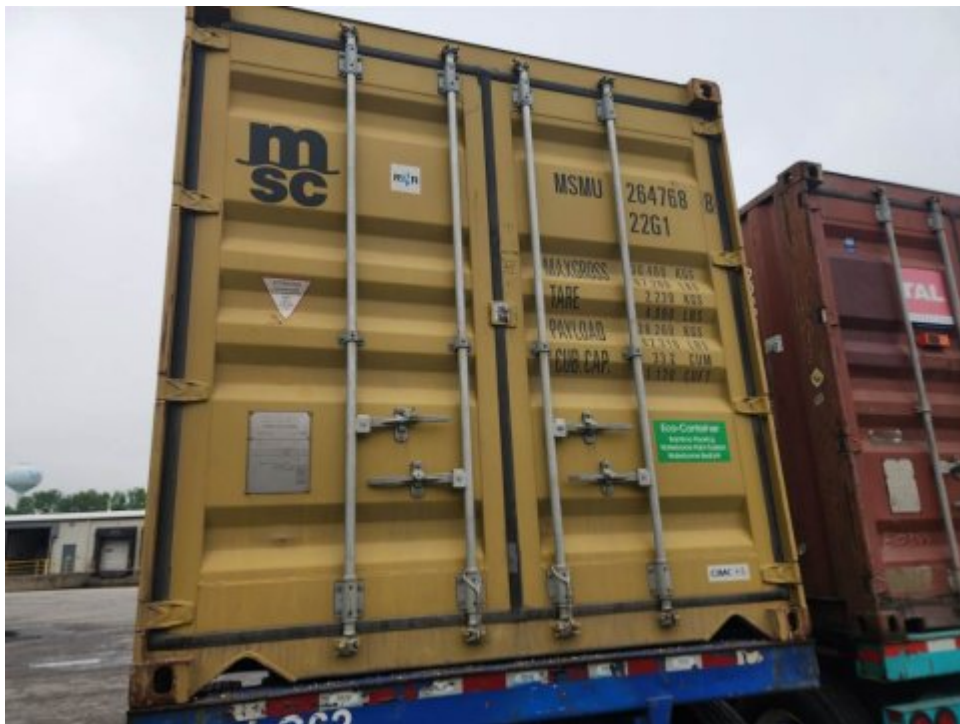
Container MSMU2647688

<constiner id2> is a 08/2022 mfd. 20ft standard dry van container with valid CSC safety approval. The container had four vents, and all were unobstructed. No holes or ruptures to the container were observed. Paper lining was stuck to the floor and container walls. The desiccant bags were not retained for inspection. The silver nitrate test was positive for chlorides. The silver Nitrate test on wet stained burlap bags was positive for chlorides.

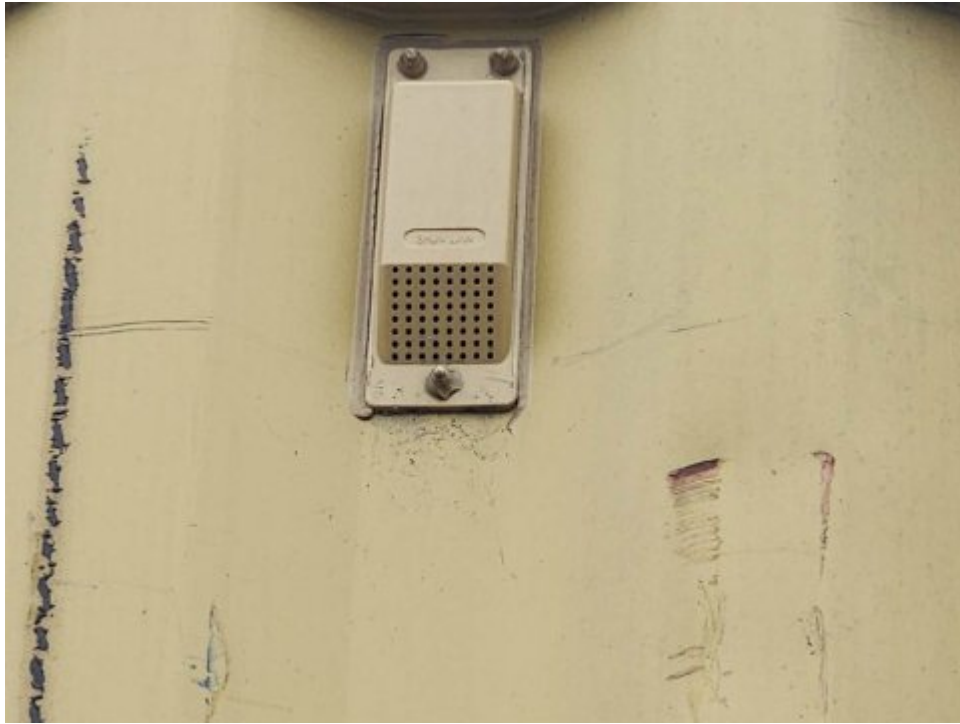
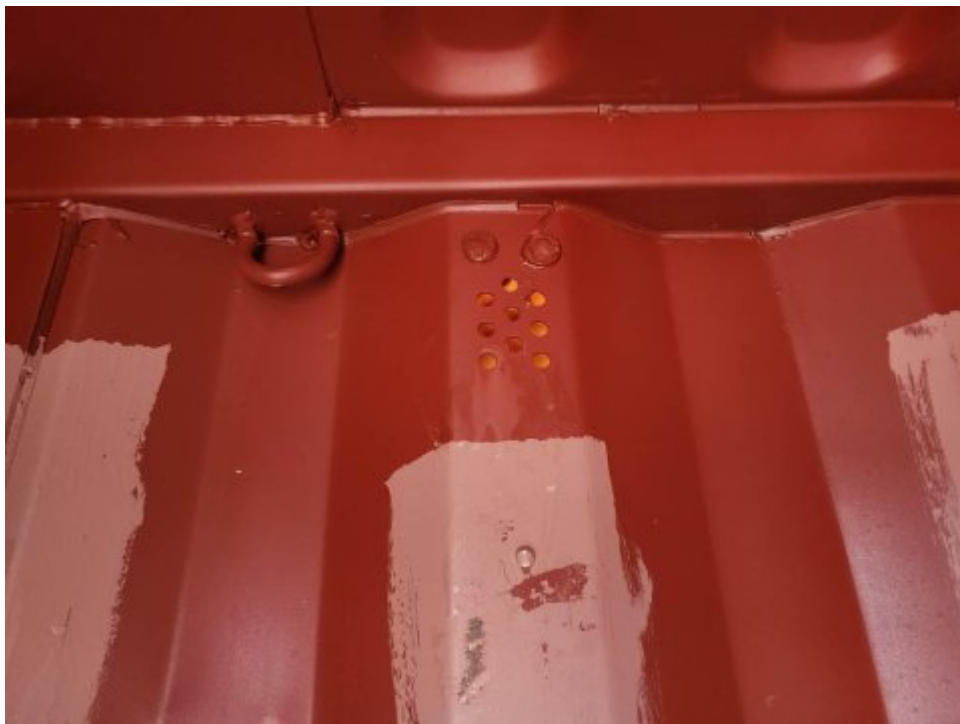
Container MSMU2647688 – vent unobstructed

**Container MSMU2647688 – vent unobstructed**

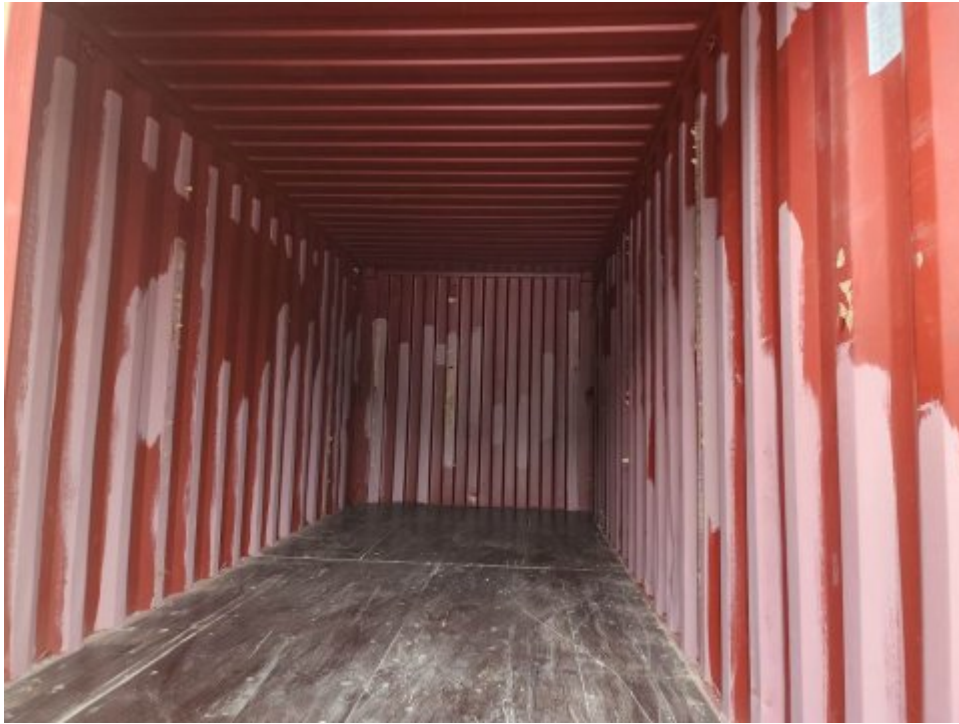
**Container MSMU2647688 – empty container**

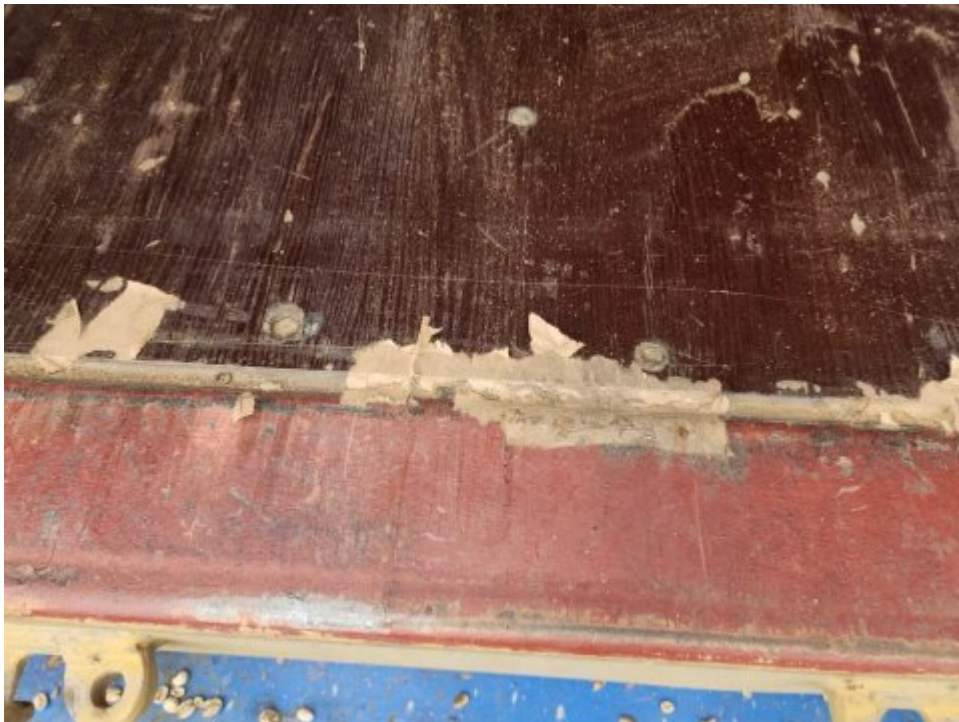
**Container MSMU2647688 – paper lining adhered to floor panel**

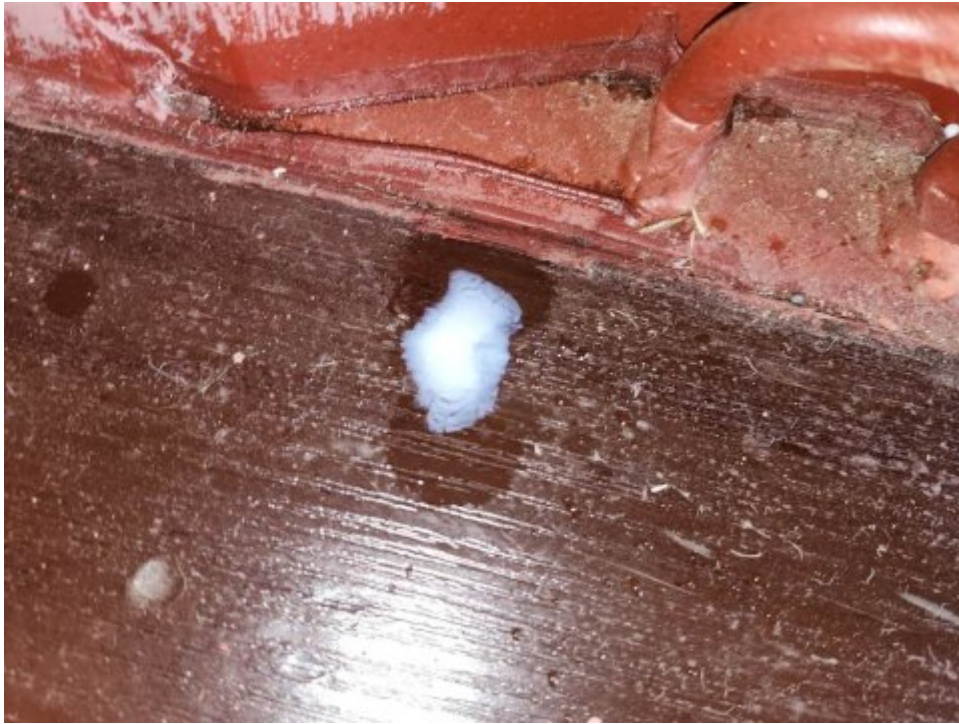
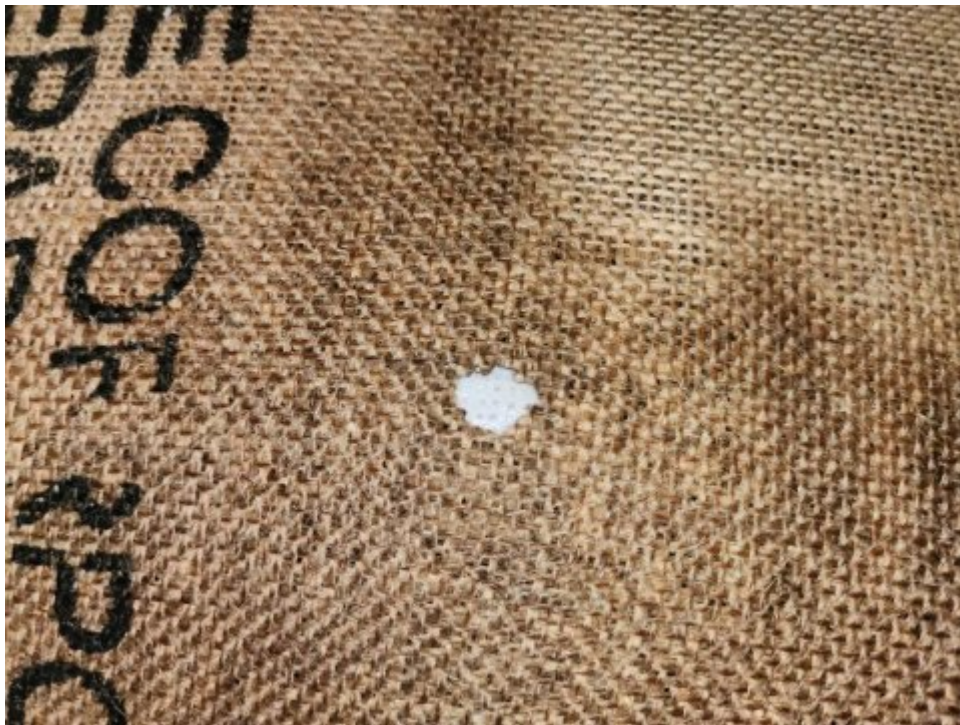
**Container MSMU2647688 – silver nitrate test was positive for chlorides**

Container MSMU2647688 – silver nitrate test was positive for chlorides

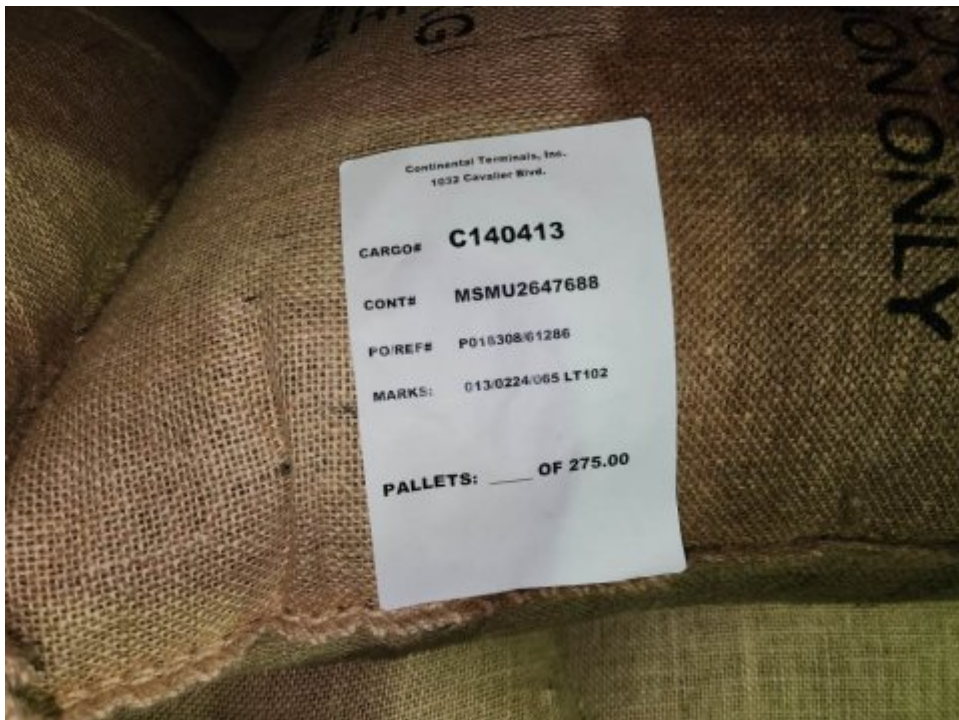
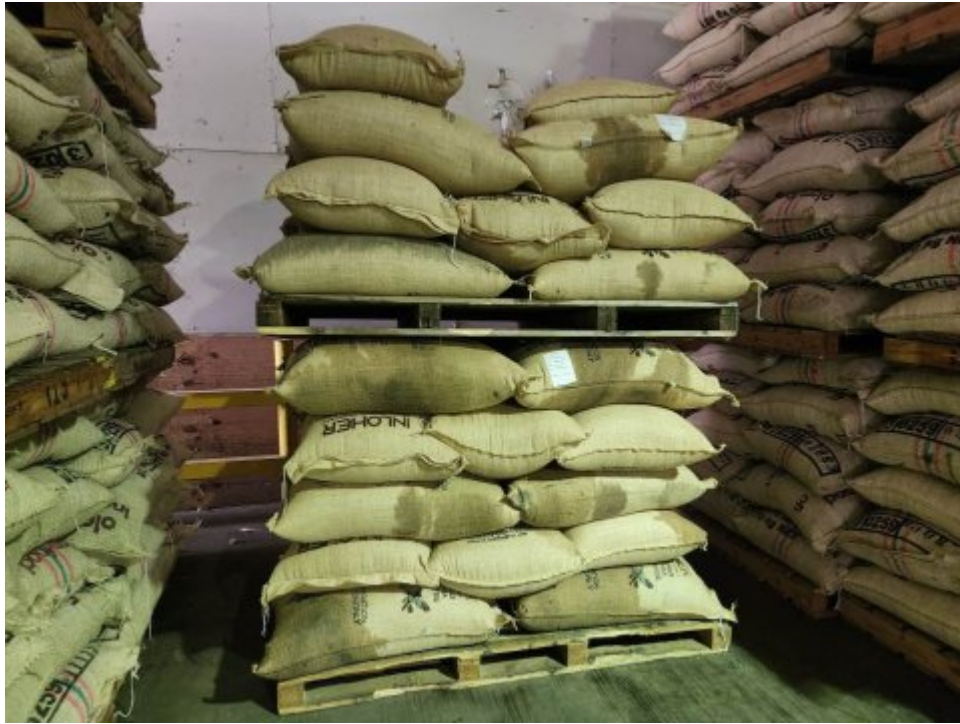
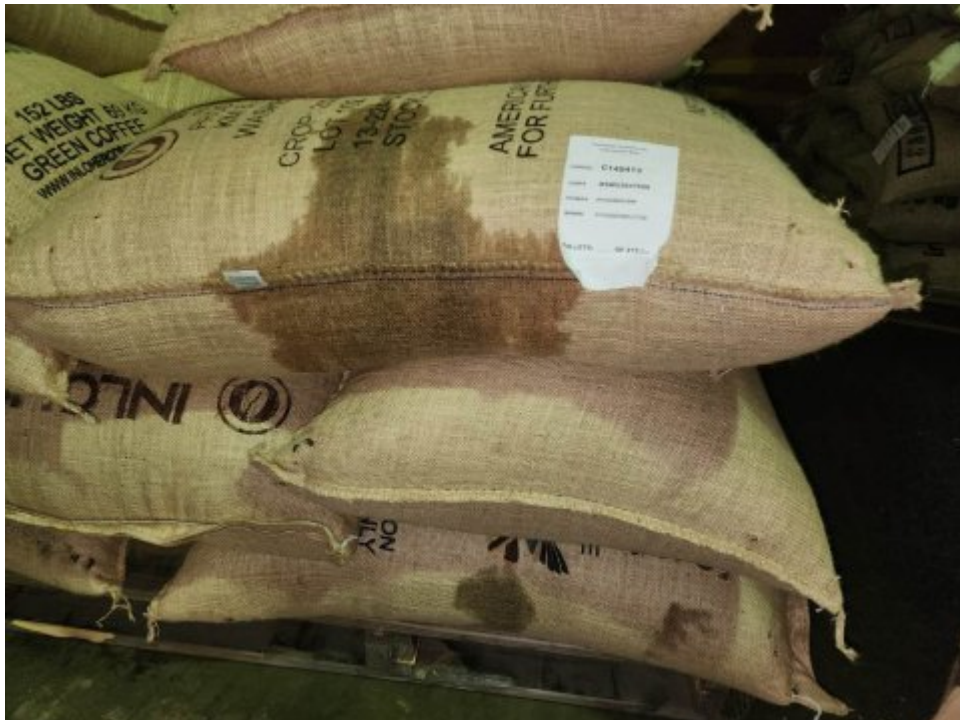
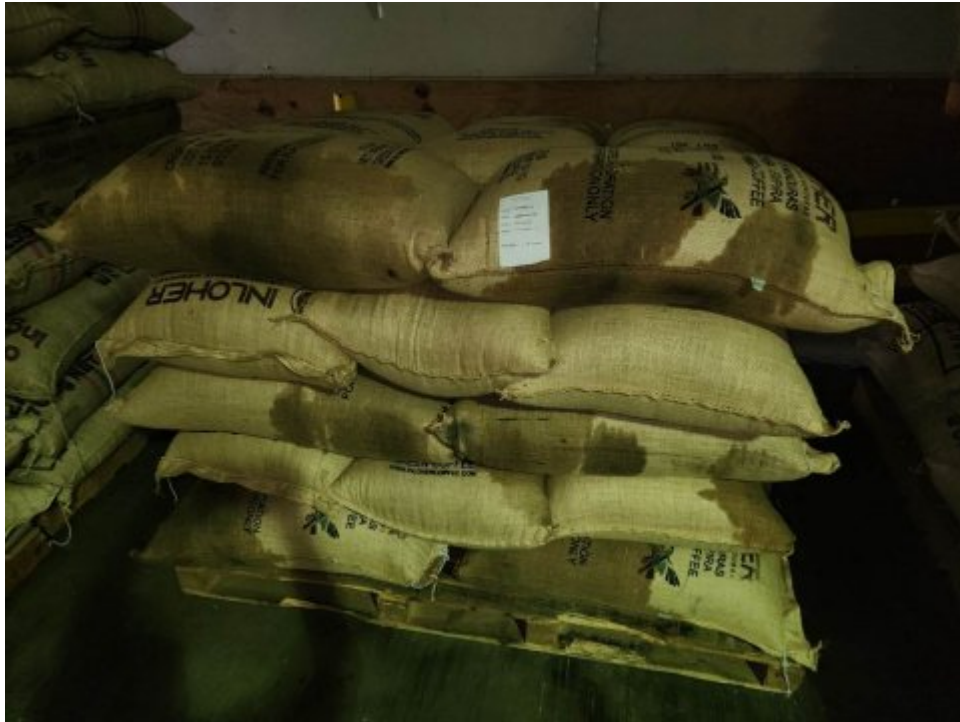
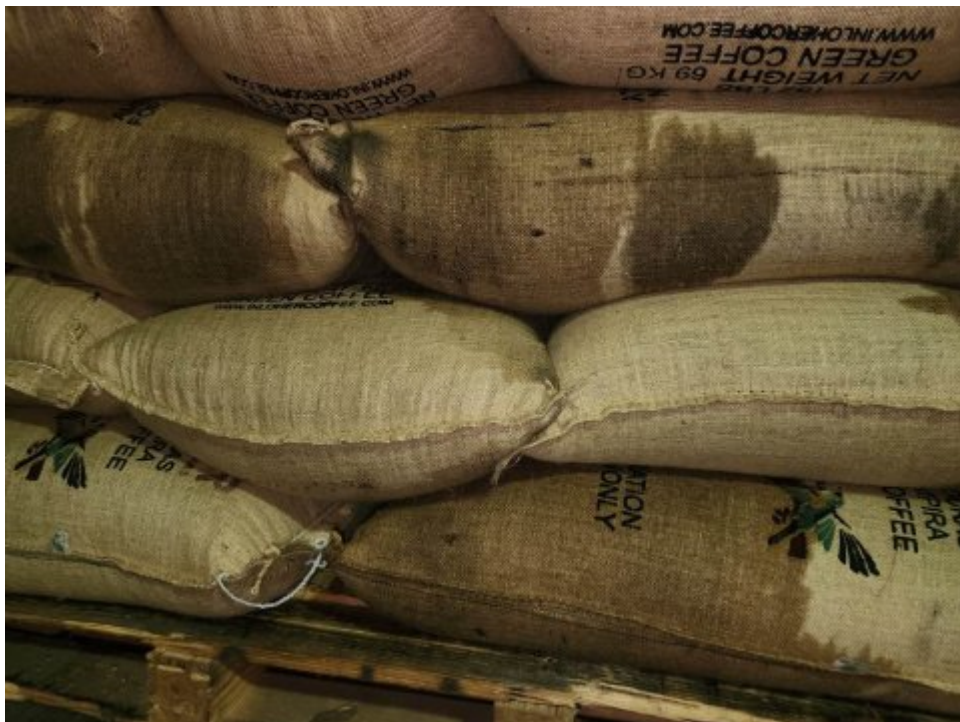
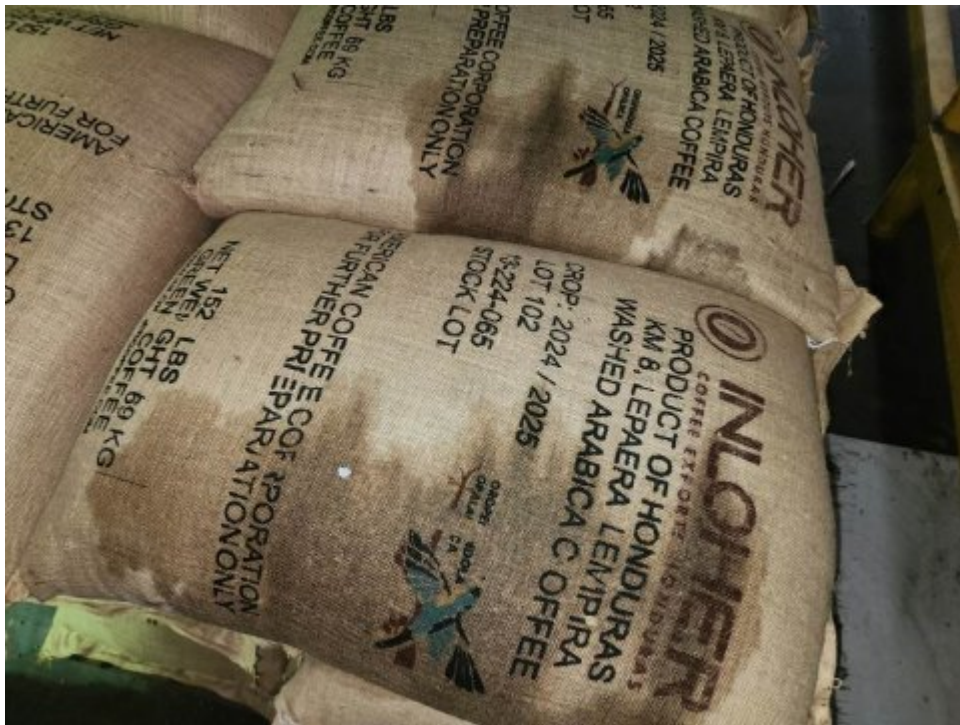
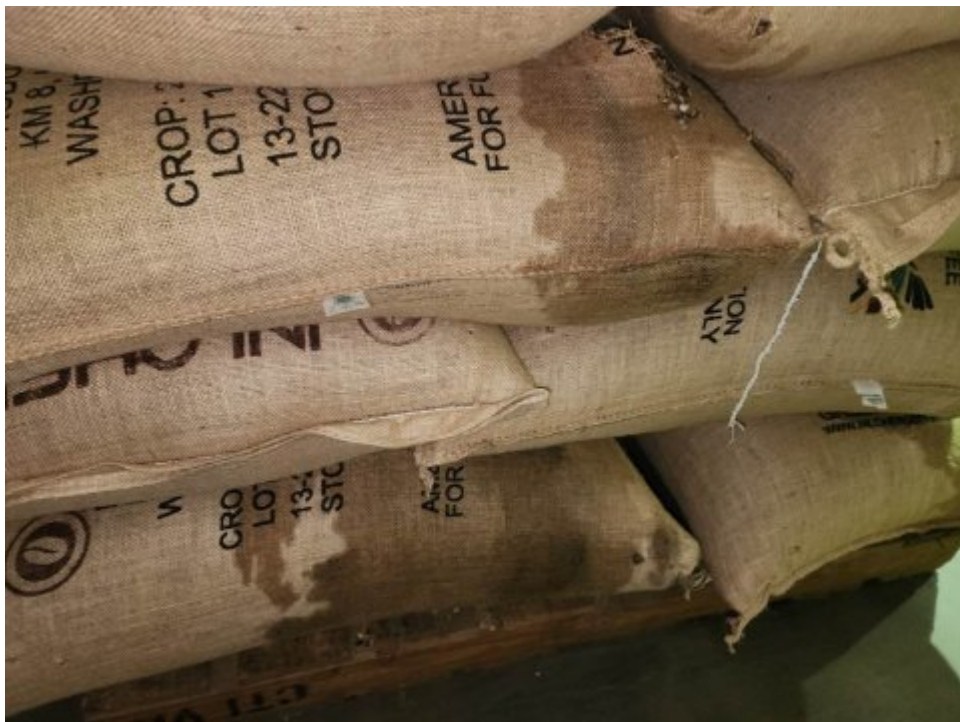
Container MSMU2647688 – wet bags

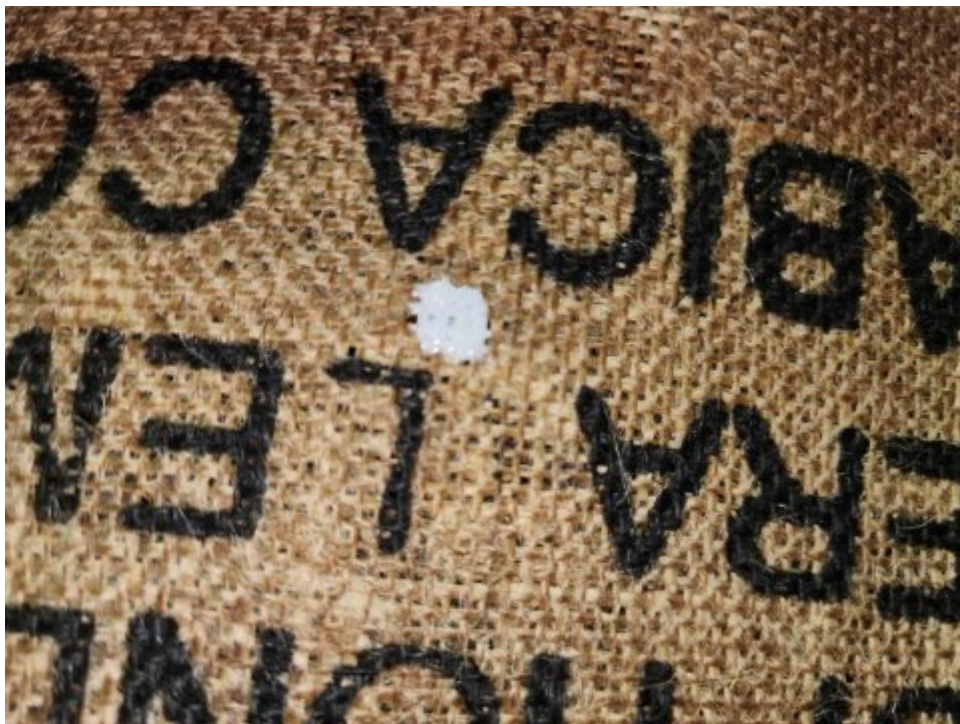
Container MSNU2057366 – silver nitrate test was positive for chlorides
