## SURVEY REPORT – <report number>

This is to certify that <survey company> surveyor, at the request of “Requested company” and their principals, visited <survey location> to document the condition of a shipment of “Pharmaceutical Products” shipped in one 40ft refrigerated container TEMU9839275.

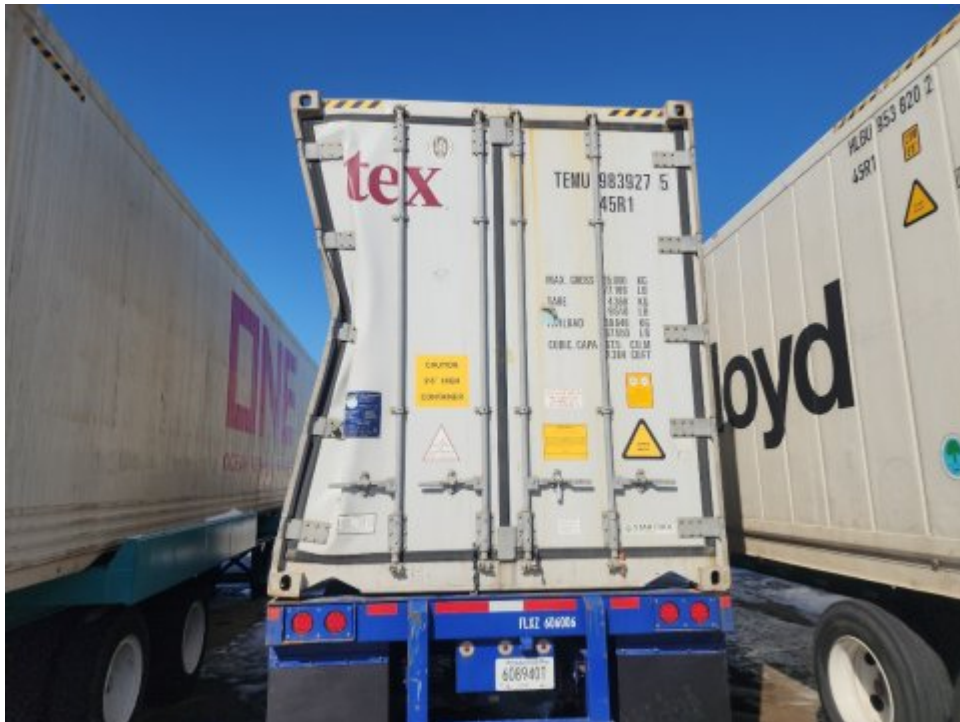
- 1) TEMU9839275 was a 01/2021 mfd. 40ft high cube refrigerated container. Container was in location 411-39 at Norfolk International Terminals. Left side panel was heavily pushed inwards over entire length of the container. Left front and rear corner posts were bowed, and left rear bottom corner casting was out of alignment. Bolt seals #HLG6171830 and #KLIK20829087 were on the doors. Reefer unit was operational with set point was +20deg C and return air was +20degC.

**Damaged container TEMU9839275 – left side**

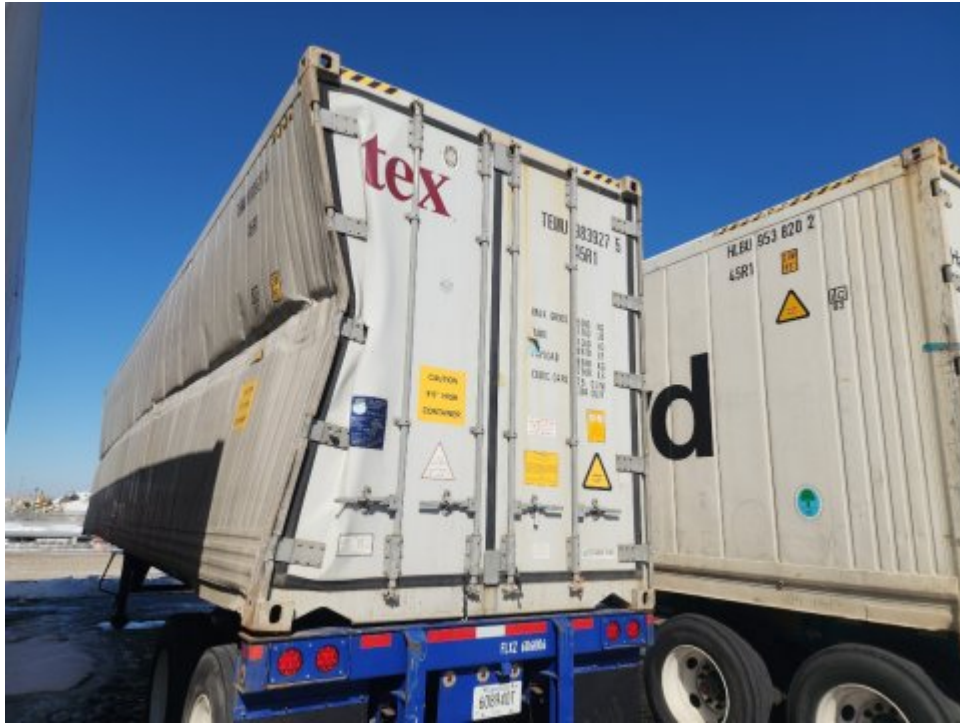
**Damaged container TEMU9839275 – left side**

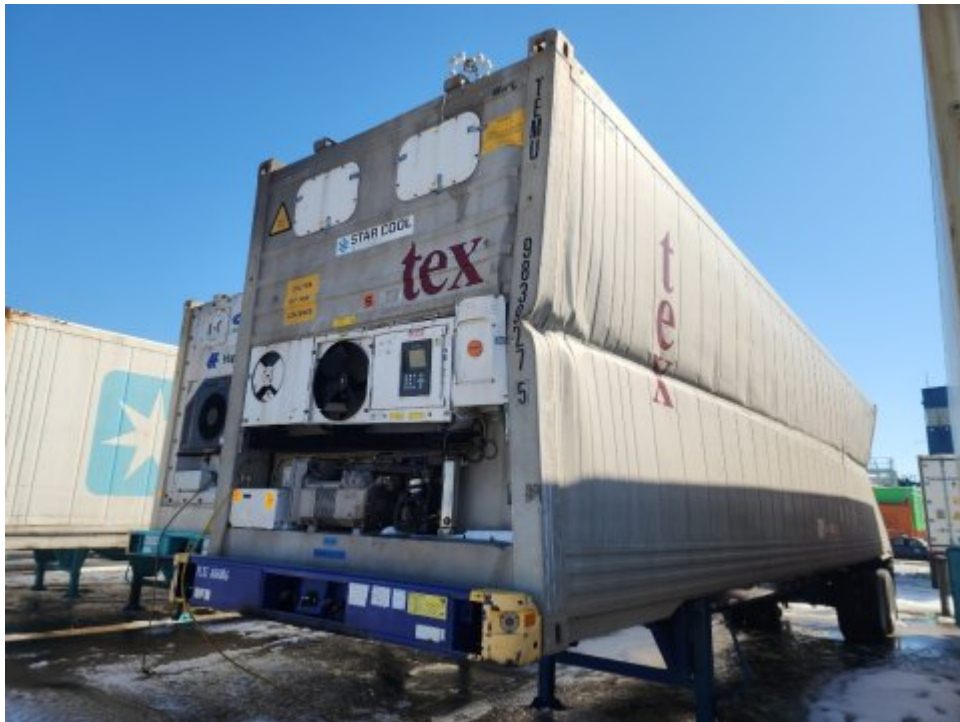
**Damaged container TEMU9839275 – front**

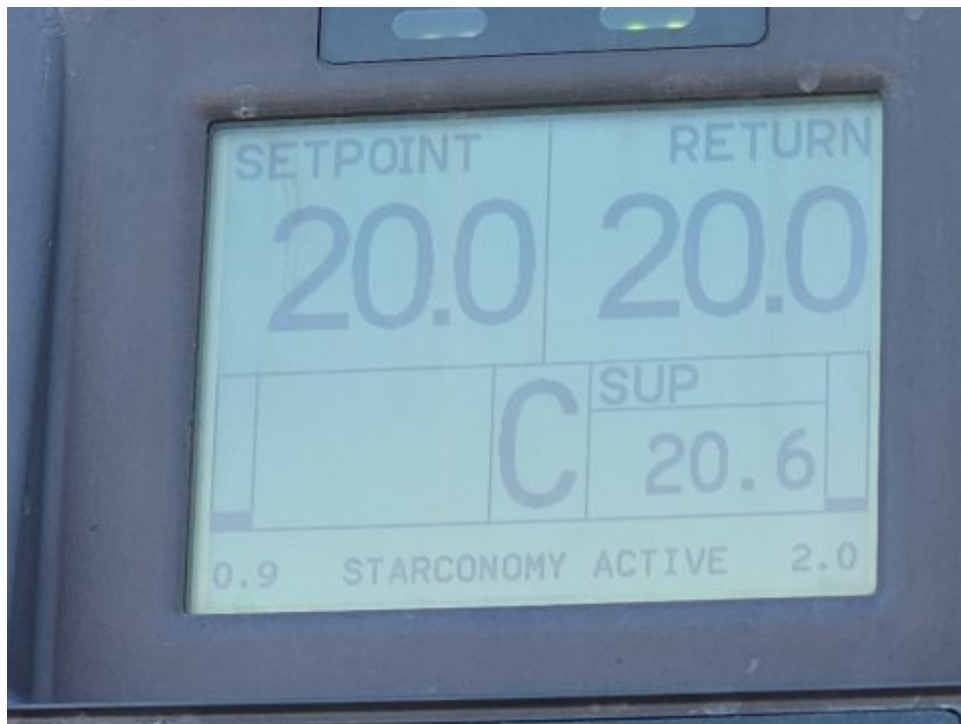
- 2) Damaged container was moved to Ocean Container Solutions facility for transload. Repair team cropped the left side door. Seals were broken and right-side door was opened.

**Damaged container TEMU9839275 – seal #HLG6171830**

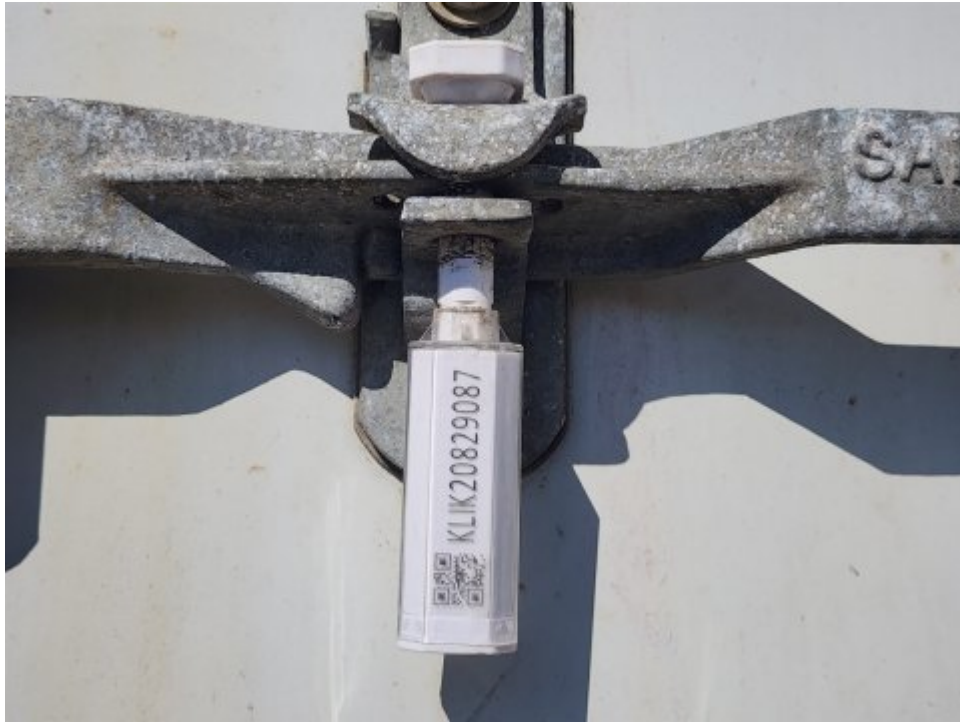
**Damaged container TEMU9839275 at Ocean Container Solutions yard**

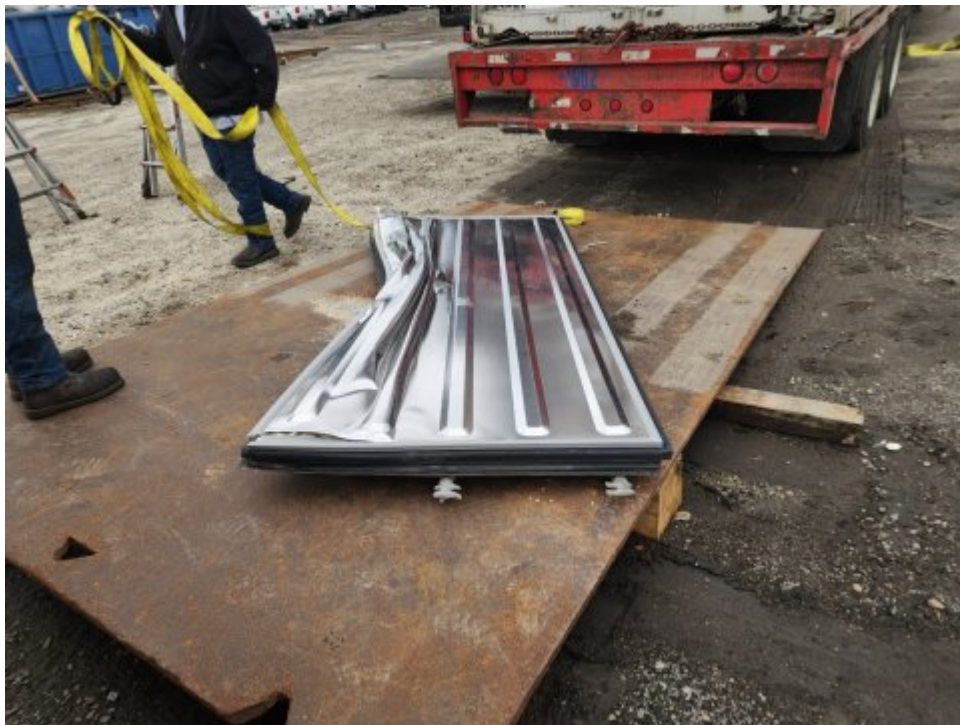
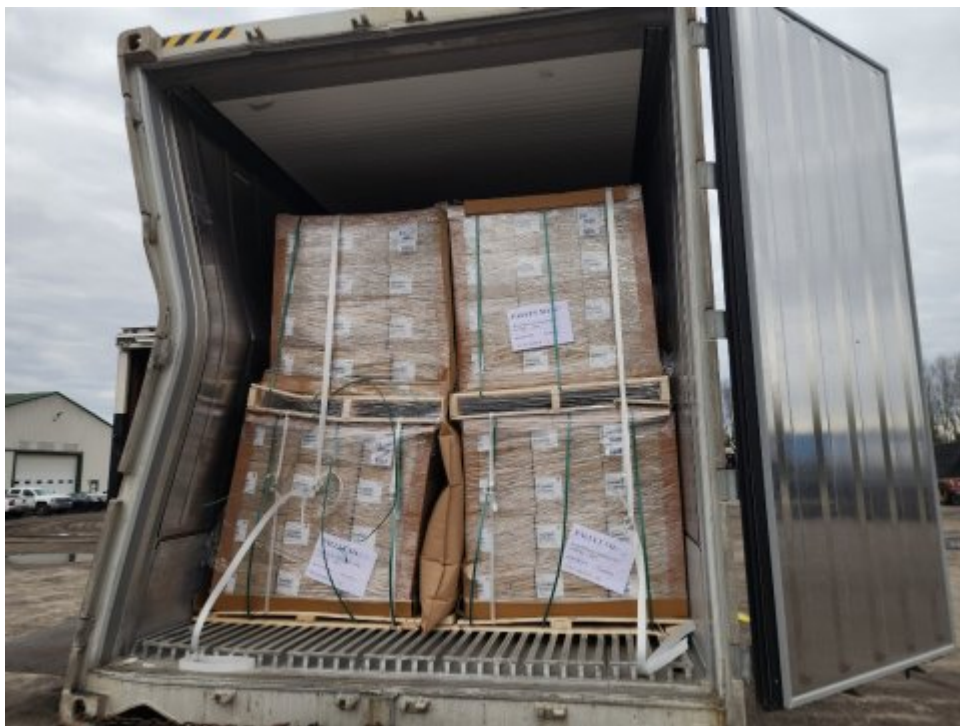
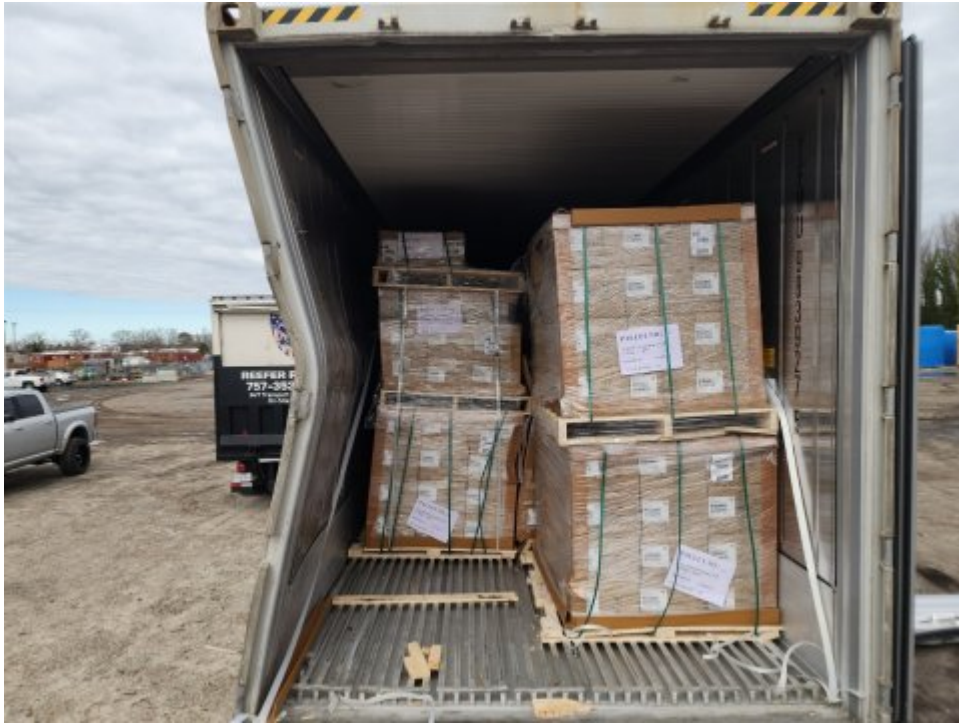
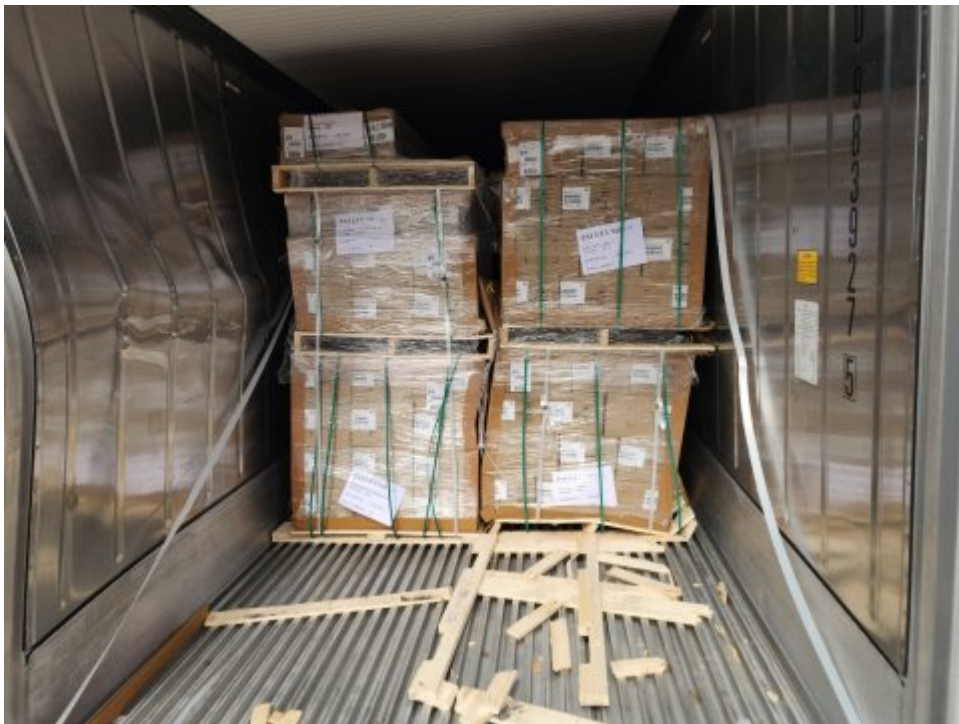
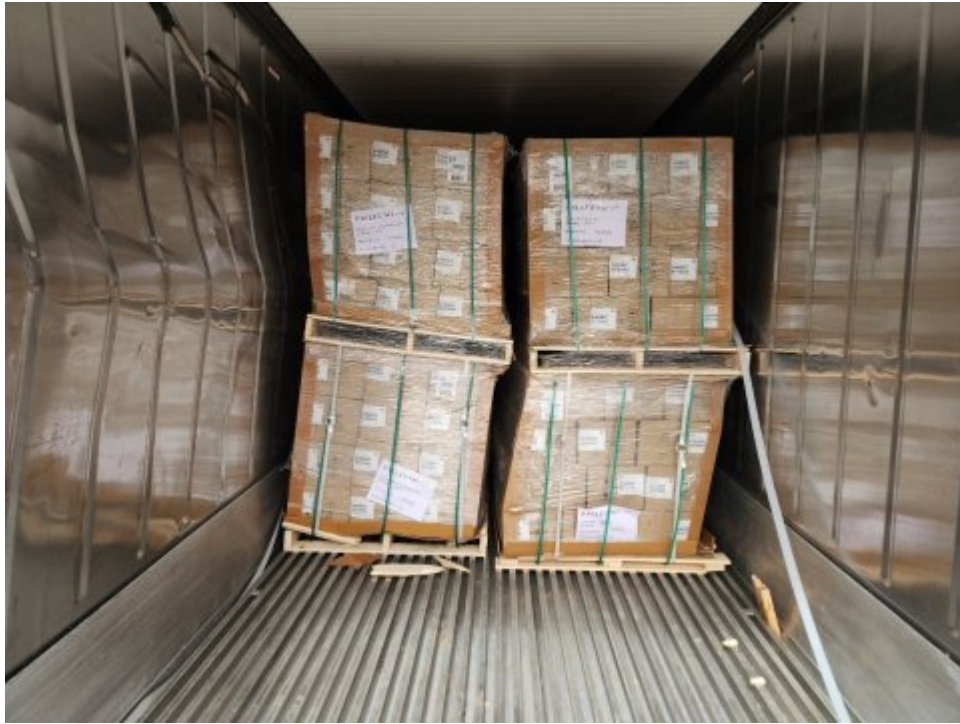
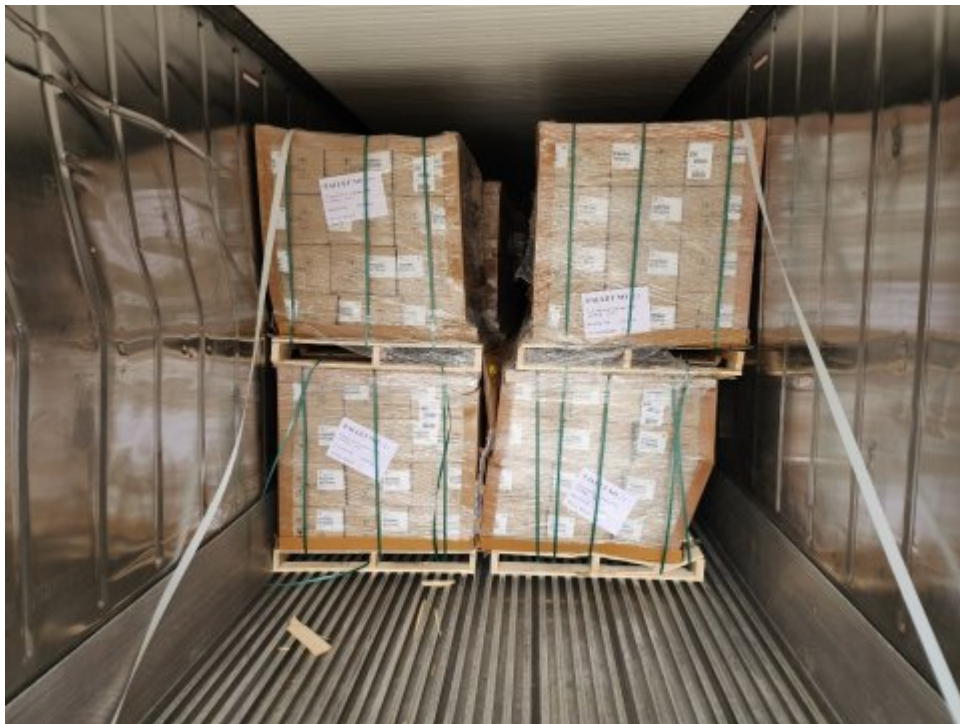
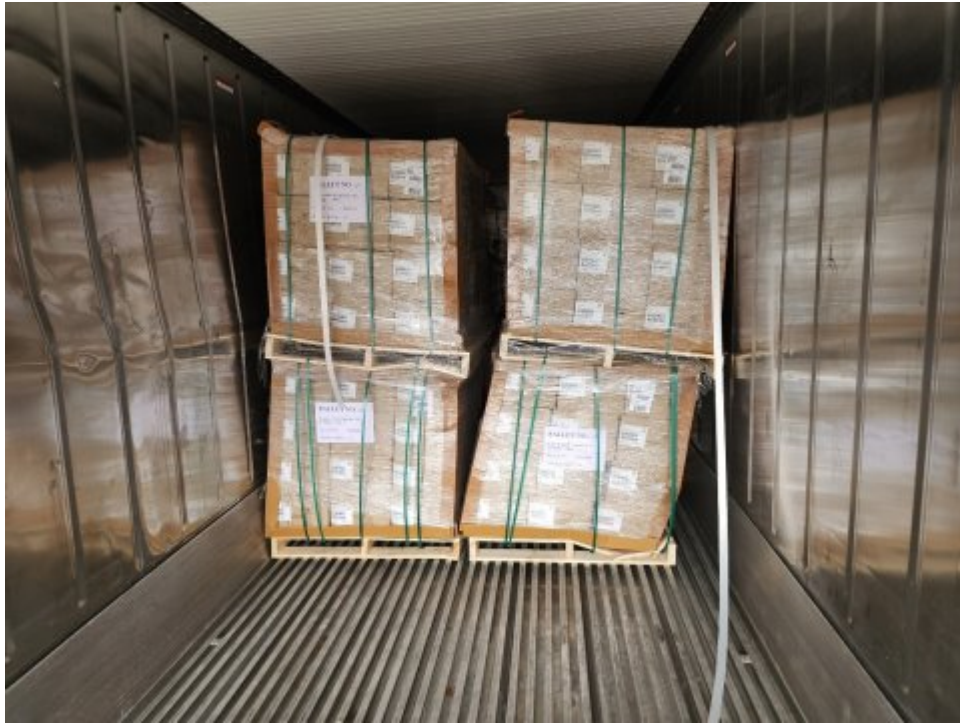
- 3) Cargo was stowed in two columns, two tiers high. Air bags were placed between the columns. All pallets shifted to the right side; air bags were crushed and deflated. Majority of the pallets sustained damage. Random master cartons were crushed.

**Cargo inside damaged container**

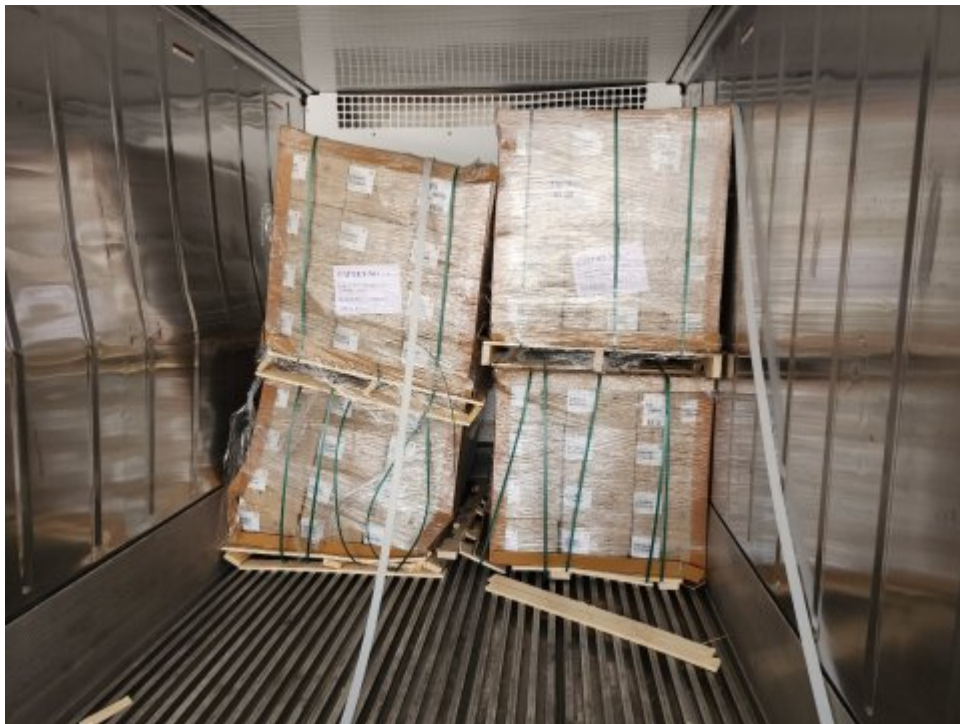
**Empty damaged container**

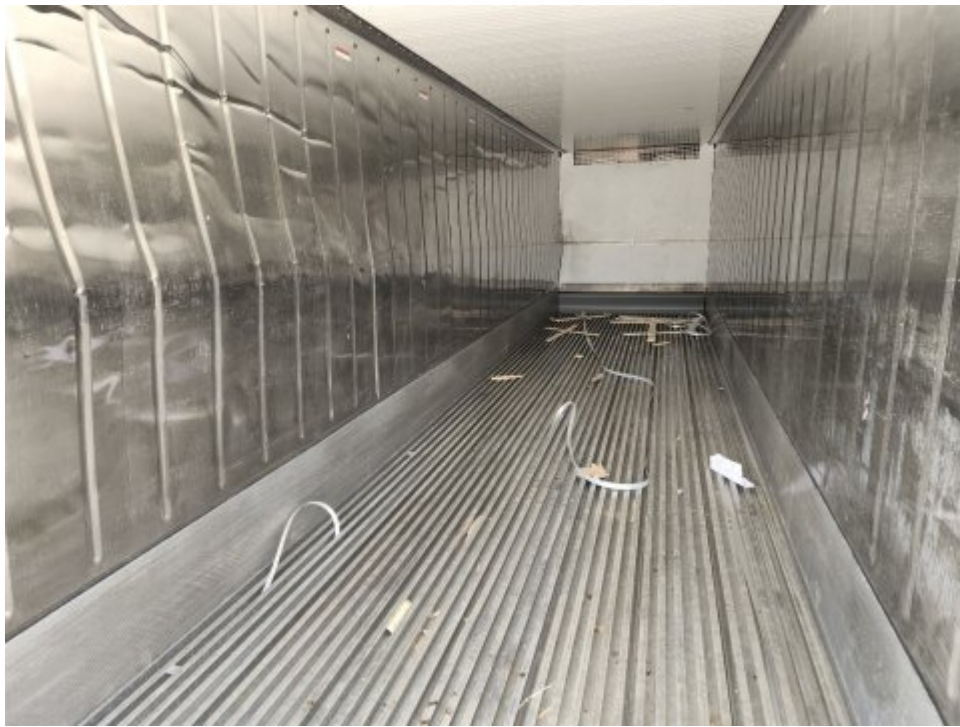
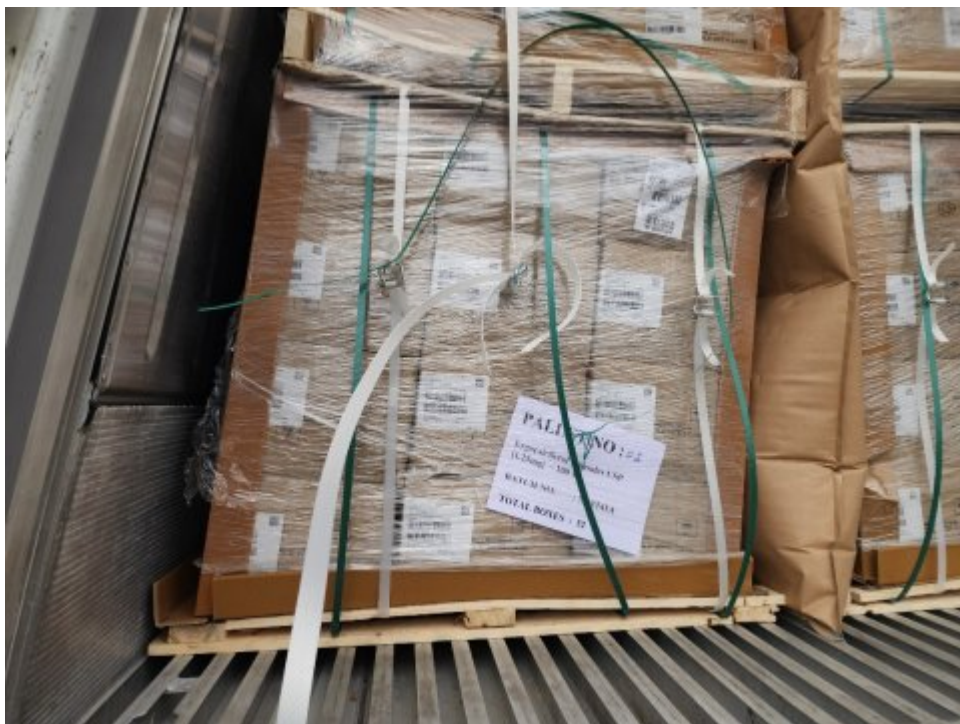
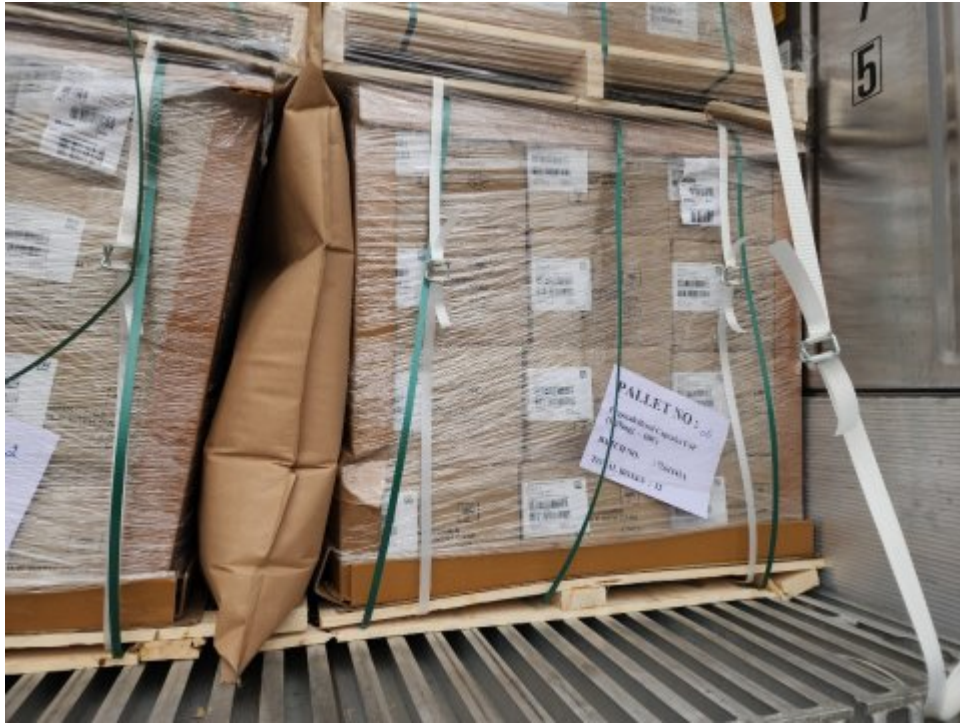
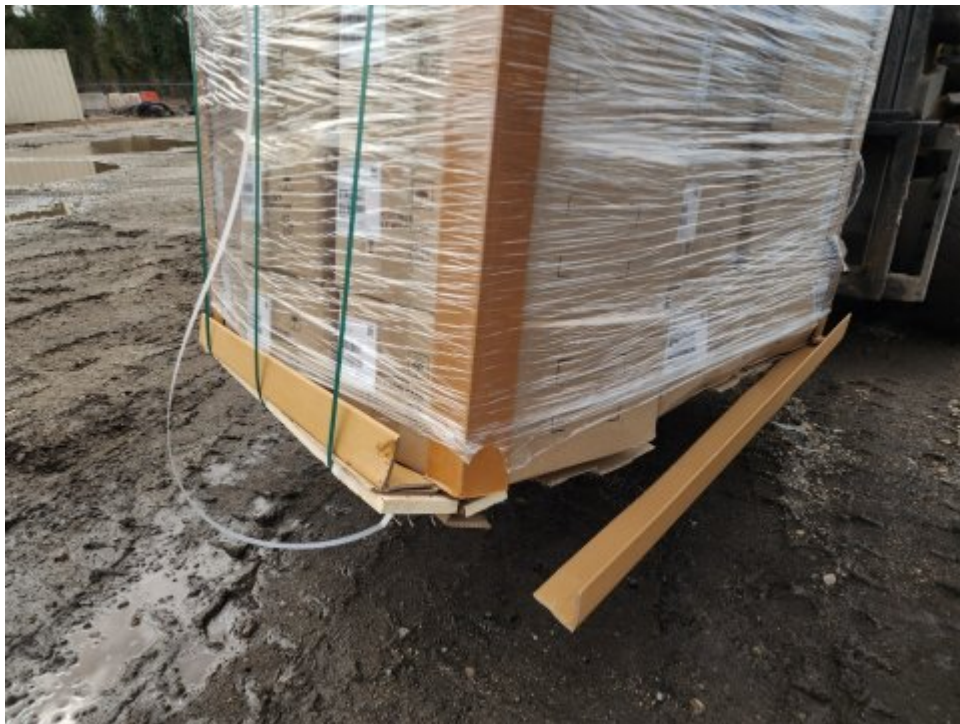
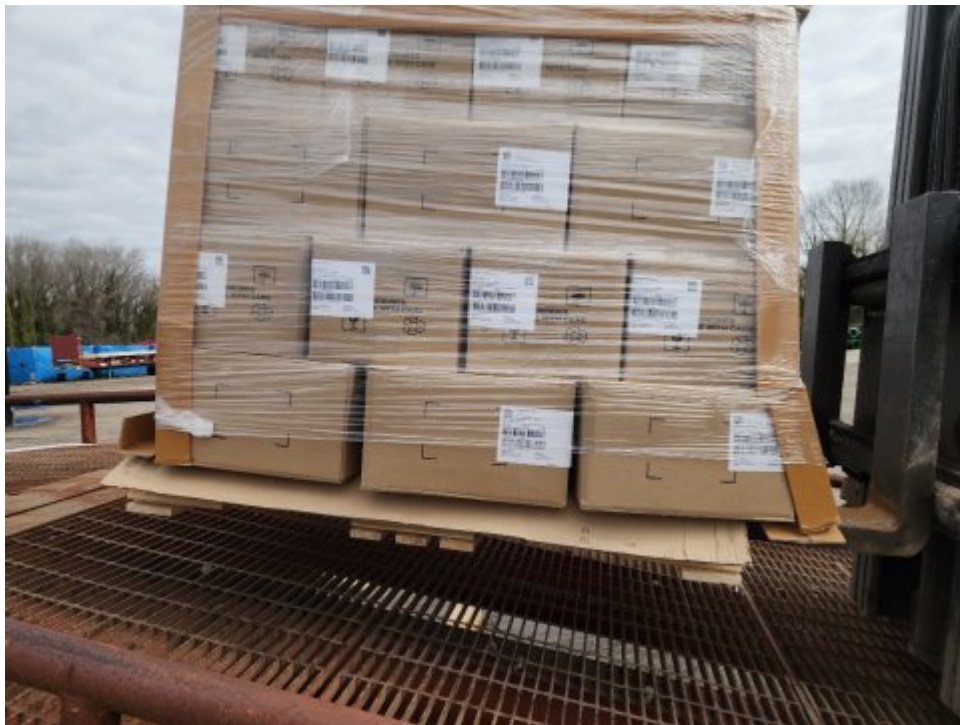
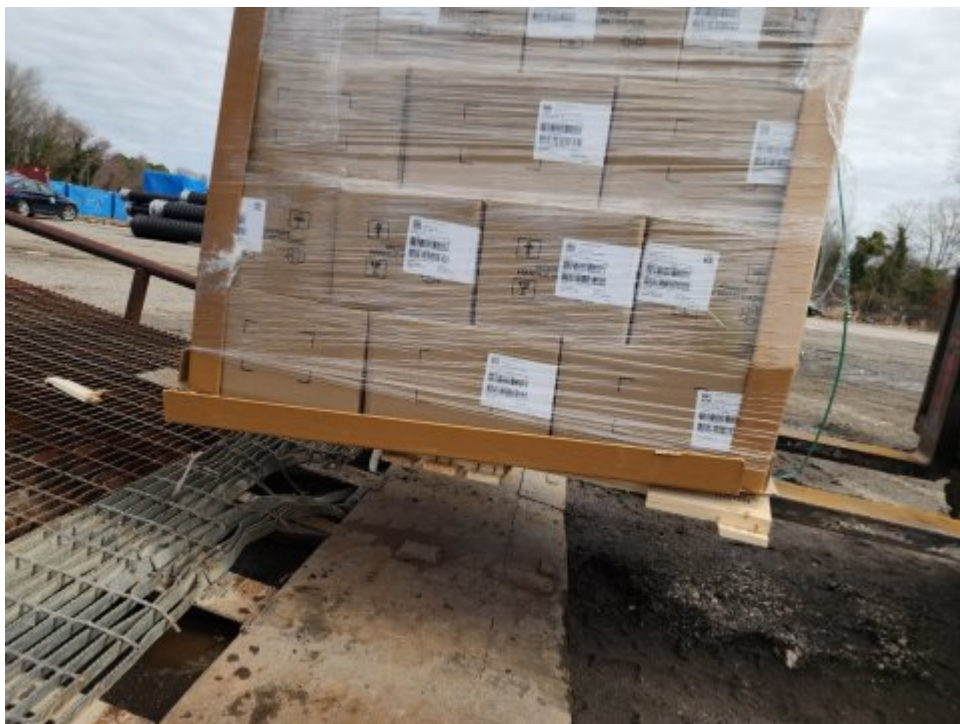
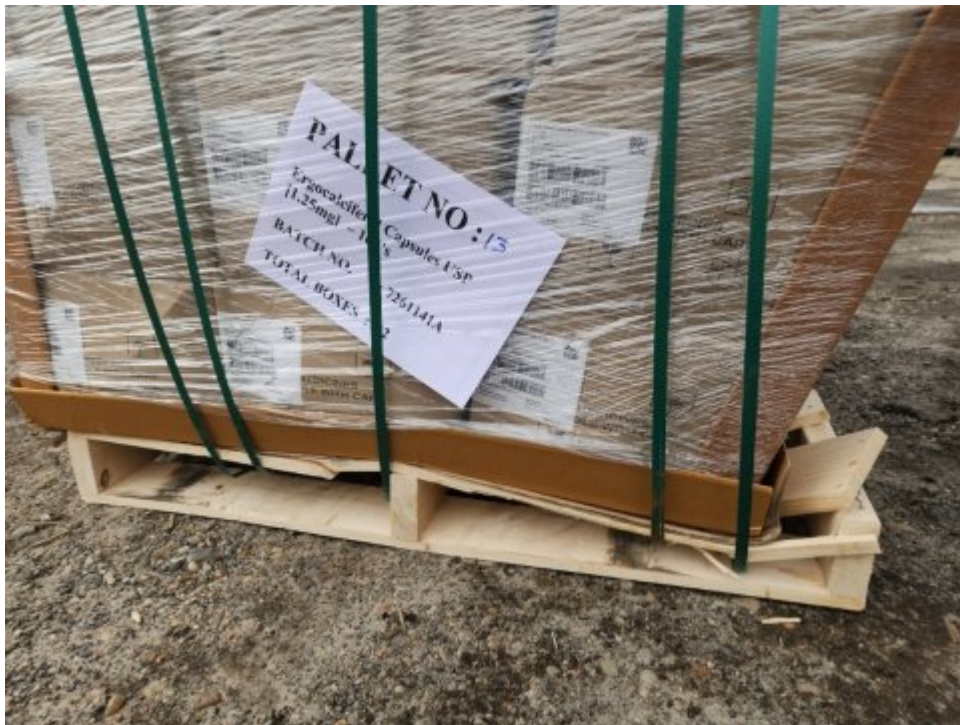
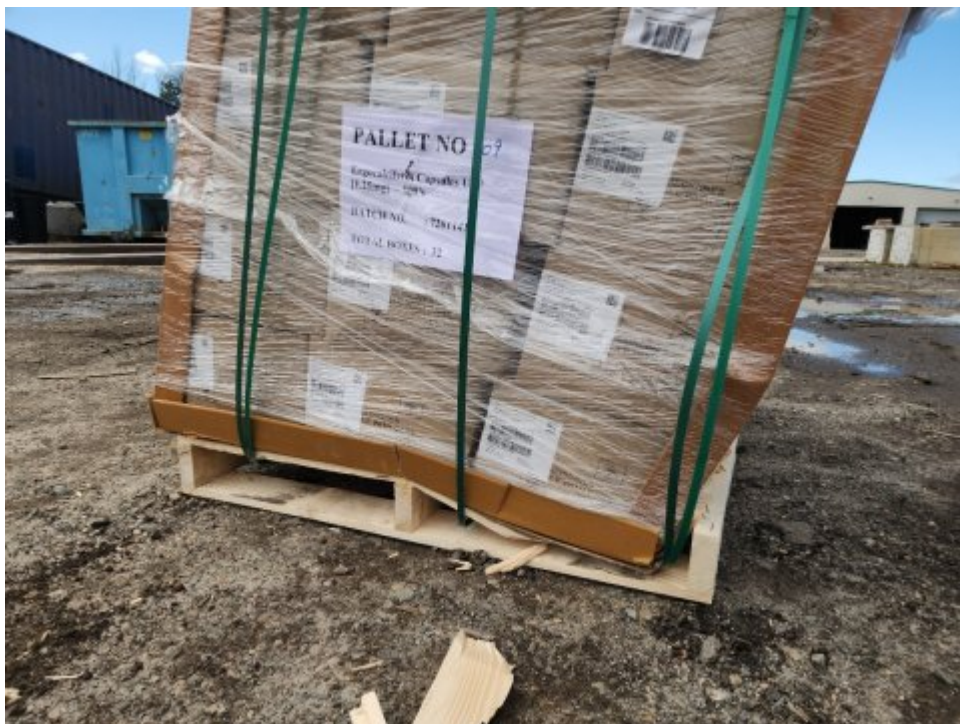
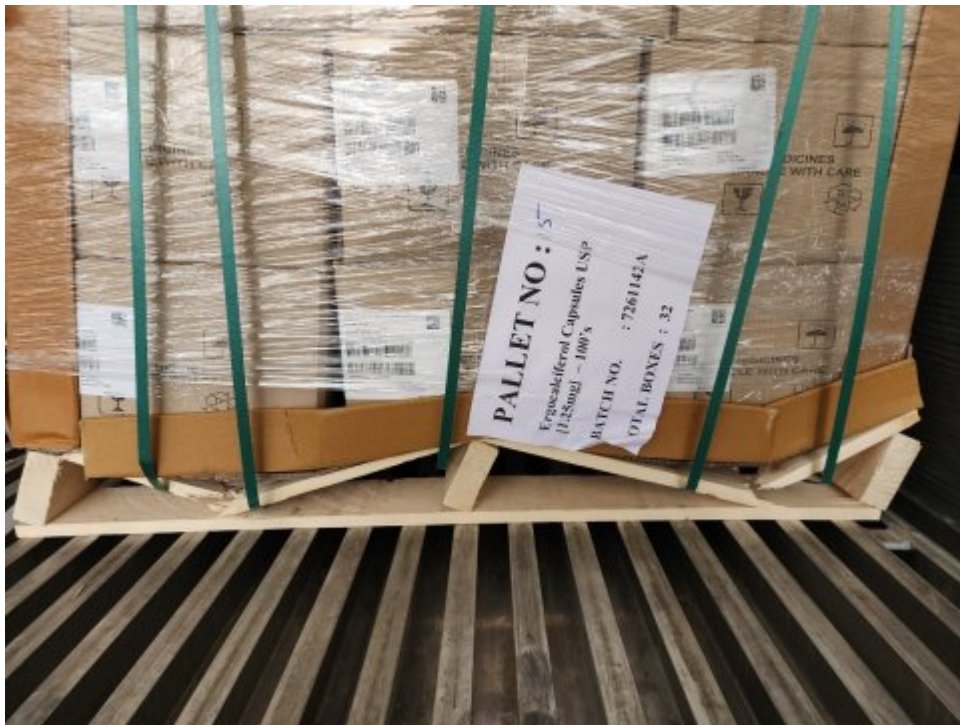
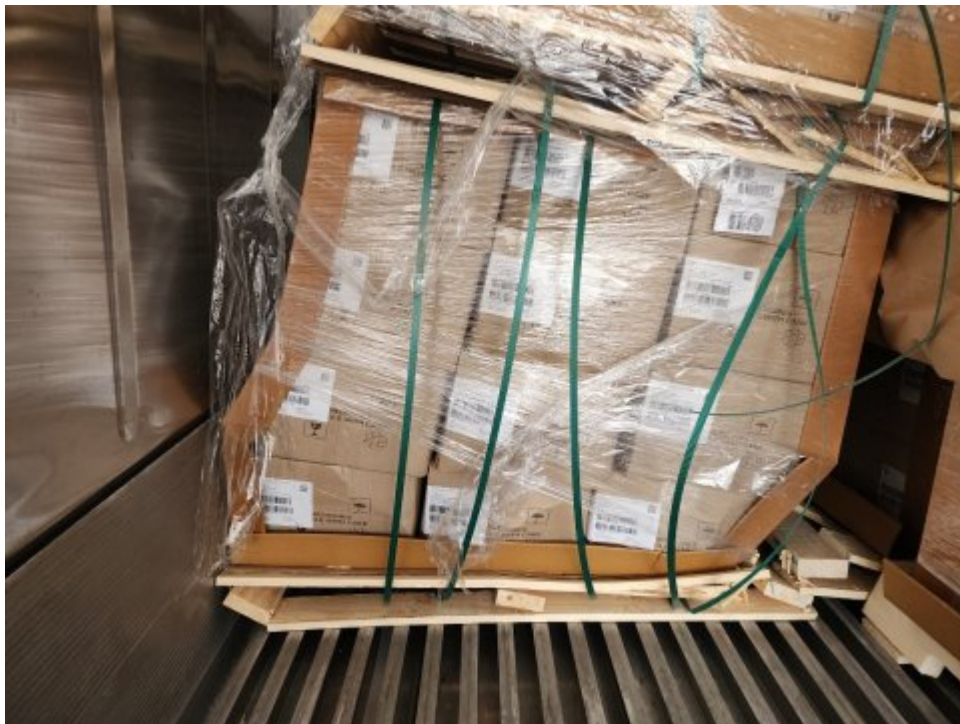
All cargo from damaged container TEMU9839275 was transloaded into replacement container SZLU9644558 at Ocean Container Solutions, Suffolk, Virginia. Most of the pallets were crushed and damaged, some of the master cartons were crushed. It did not appear that any of the merchandise was affected. One loose merchandise bottle was sighted on a pallet.

**Damaged pallet**

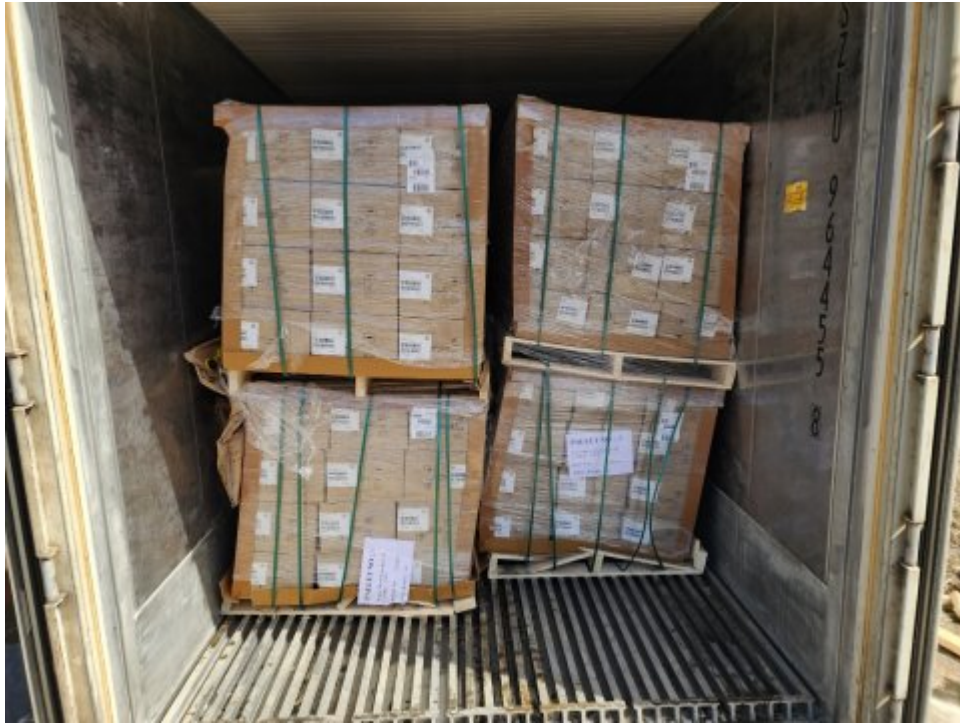
- 8) One loose retail plastic bottle was sighted on pallet. It can be fair to state that the merchandise was not damaged.

**Loose bottle found on a pallet**
