# Quality Assurance of a Diagnostic X-ray Machine

Date of experiment: 08 January 2026

## Medical Physics Laboratory II

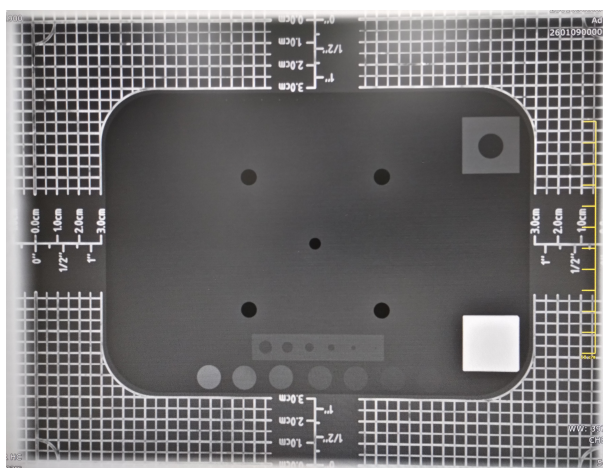
Figure 7: X-ray image of Pro-RF basic phantom.

| Dimensions (cm) | Observed shift | % of FFD | Tolerance | Remark |
|---|---|---|---|---|
| X + X' | 1.05 | 1.05 % | 2% of FFD | Within Tol. |
| Y + Y' | 0.5 | 0.5 % | 2% of FFD | Within Tol. |

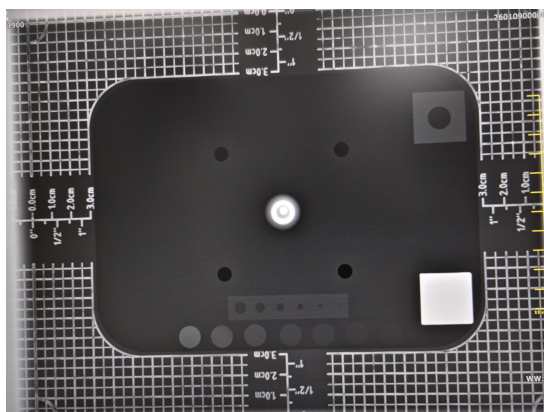
Figure 8: Verification of central beam alignment using cone test.

| Observed tilt = | < 1.5° | Remark: | Within tol. |

Tolerance: Central Beam Alignment < 1.5°

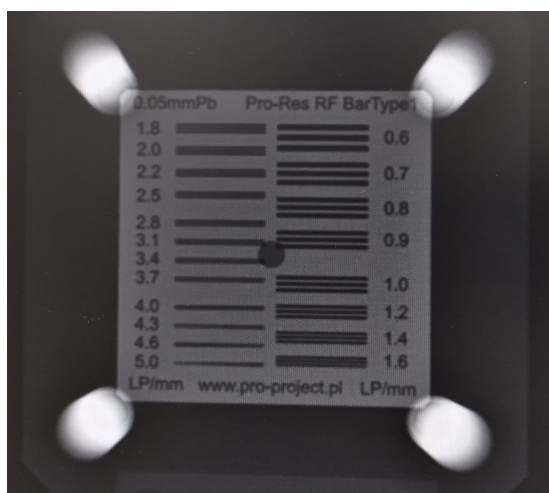
Figure 9: Parallel to the anode-cathode axis

| | The stated value of Focal Spot Size (mm x mm) | Direction | Resolution line pair (lp/mm) | The measured value of Focal Spot size (mm x mm) | Tolerance: | Tolerance | Remarks |
|---|---|---|---|---|---|---|---|
| Large Focus | 2 | Parallel | 1.6 | 2.50 | 1. + 0.5 f for f < 0.08 mm<br>2. + 0.4 f for 0.08 ≤ f ≤ 1.5 mm<br>3. + 0.3 f for f > 1.5 mm | 0.6 | Within tol. |
| Small Focus | 1 | Parallel | 2.2 | 1.82 | | 0.4 | Not in tol. |

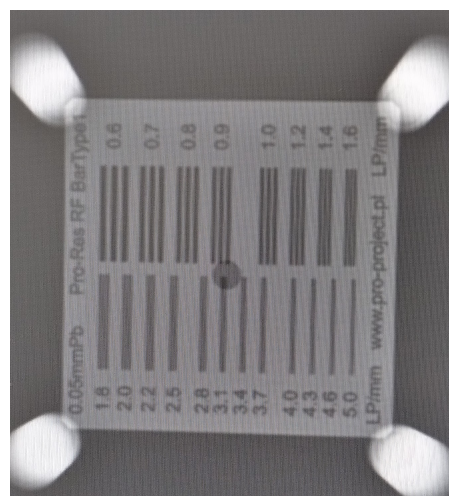
Figure 10: Perpendicular to the anode-cathode axis

| | The stated value of Focal Spot Size (mm x mm) | Direction | Resolution line pair (lp/mm) | The measured value of Focal Spot size (mm x mm) | Tolerance: | Tolerance | Remarks |
|---|---|---|---|---|---|---|---|
| | | Perpendicular | 2 | 2.00 | | 0.6 | Within tol. |
| | | Perpendicular | 2.2 | 1.82 | | 0.4 | Not in tol. |

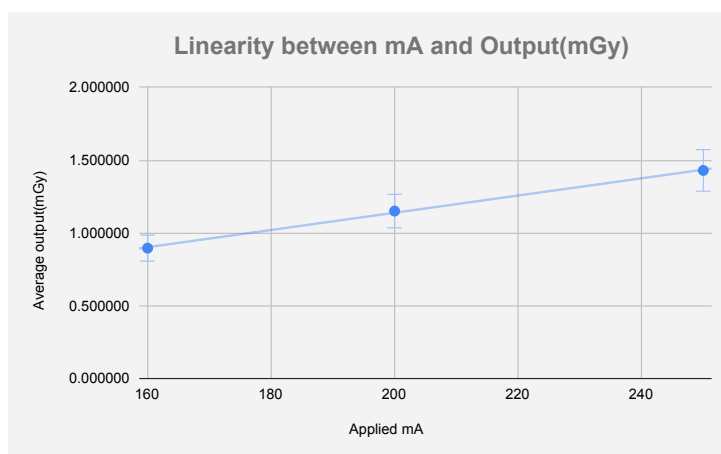
| mA applied | Radiation output (mGy) | | | Average Output | mGy/mAs (x) | Coefficient of Linearity (CoL) |
|---|---|---|---|---|---|---|
| 250 | 1.426 | 1.429 | 1.434 | 1.429667 | 0.114373 | 0.010652 |
| 200 | 1.145 | 1.151 | 1.155 | 1.150333 | 0.115033 | |
| 160 | 0.8906 | 0.8929 | 0.9036 | 0.895700 | 0.111963 | |
| Tolerance: COL < 0.1 | | | | | | |
