# Quality Assurance of a Diagnostic X-ray Machine

## Medical Physics Laboratory II

### 4.1 DETAILS OF THE DIAGNOSTIC X-RAY EQUIPMENT

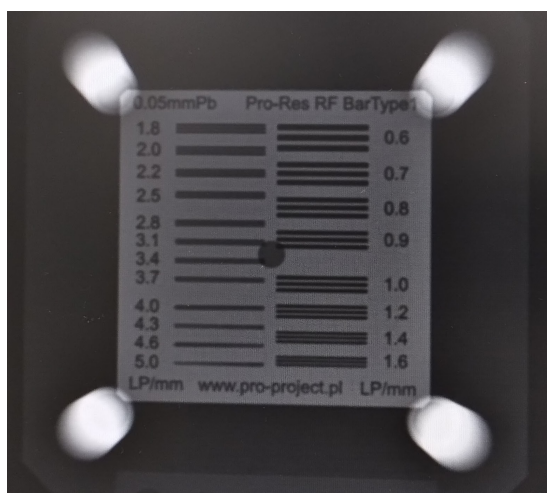
Figure 9: Parallel to the anode-cathode axis

| | The stated value of Focal Spot Size (mm x mm) | Direction | Resolution line pair (lp/mm) | The measured value of Focal Spot size (mm x mm) | Tolerance: | Tolerance | Remarks |
|---|---|---|---|---|---|---|---|
| Large Focus | 2 | Parallel | 1.6 | 2.50 | 1. + 0.5 f for f < 0.08 mm<br>2. + 0.4 f for 0.8 ≤ f ≤ 1.5 mm<br>3. + 0.3 f for f > 1.5 mm | 0.6 | Within tol. |
| Small Focus | 1 | Parallel | 2.2 | 1.82 | | 0.4 | Not in tol. |
