µHoubolt Ground Recovery Test Protocol

28.9.2022

Test summary

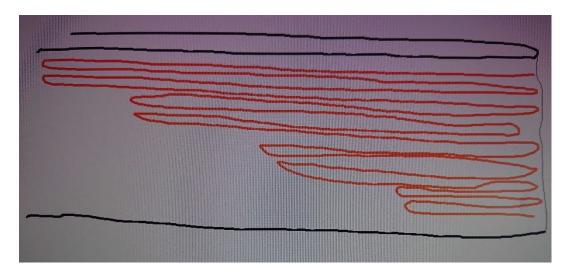
It is also clearly visible, that the shock time was spread out to a longer duration, which further reduces the load on the system. This was reached by a special sewing pattern which ensures that the absorber first breaks in less robust regions and later gradually increases the load. A sketch of the sewing pattern which has shown to yield best results after some iterations is

shown below.

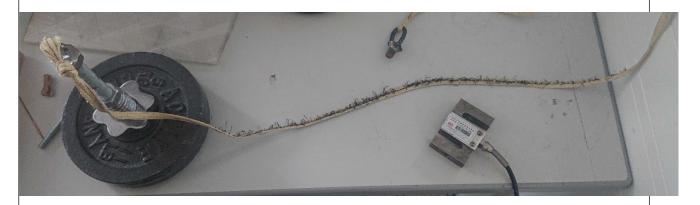
The used shock absorber, in combination with the test setup consisting of mass and load cell is shown in the following figure. The disintegration of the absorber cords is clearly visible.

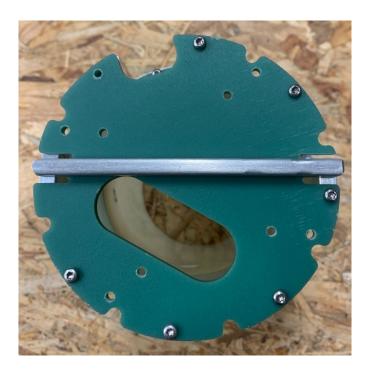
As the results from simulations and tests yielded higher values than expected, also the chute mountings were reinforced to ensure safe operation during future deployments.

The aluminium beam on the mounting points which reinforces the GFRP mountings and distributes the parachute load onto a greater area of the recovery base plate is shown in the following picture. For orientation, note that if this part would be inside the vehicle, the shown picture would be taken from the side of the engine towards the nosecone. The lines are mounted on the left and right of the aluminium bar.
