Test laboratory for paragliders, paraglider harnesses and paraglider reserve parachutes

Sustained loading test results (3)

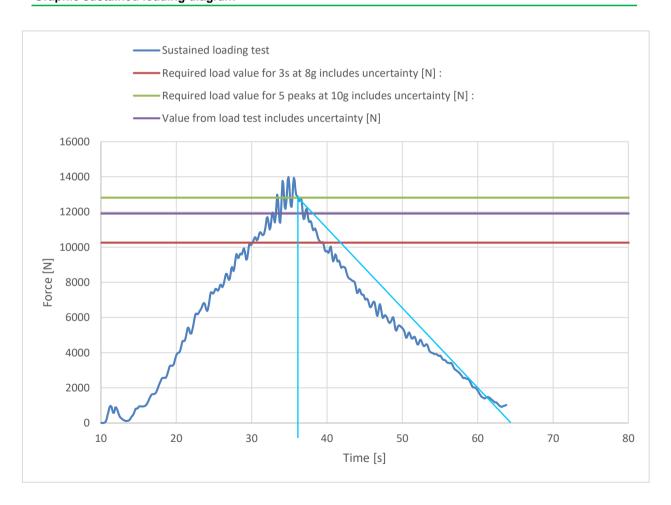
Inspection certificate number: PG_1466.2019 Dudeck V-king 23

Result : POSITIVE
Calculated max load value with 3 sec or five peaks [kg] : 151.80
