# CABLE BELT MAIN DRIVE SHEAVES

# Cable Belt Main Drive Sheaves Inspection Report

| <b>Client</b> | South32 | <b>Mine / site</b> | Wessels Mine |
| <b>Report number</b> | IRS32-Wessels-180726 | <b>Revision</b> | 1.4 |

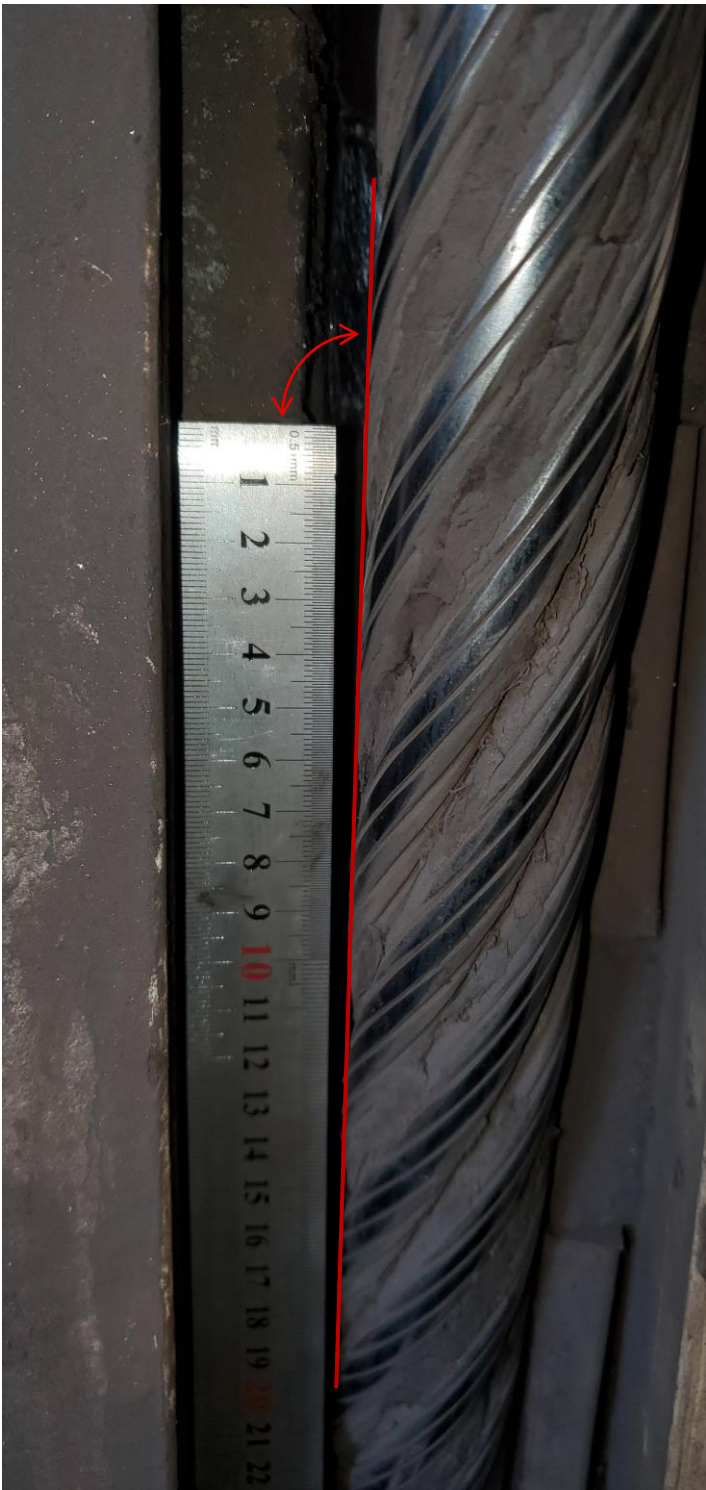
**Photo ID**  
 PHOTO-DWN-001

| Observation | Engineering assessment | Recommended action |
|---|---|---|
| The North rope is visibly positioned laterally relative to the apparent groove centerline at the Drive Wheel exit. The rule provides contextual scale only; no formal alignment value is recorded. | The photograph provides qualitative evidence of an apparent off-center rope-exit path. Together with the paired Deflector-Guide Sheave North evidence, the condition warrants verification of the sheave-pair geometry; any alignment error remains unquantified. | Include this location in the formal North sheave-pair alignment survey. Recheck the rope position after correction and inspect the rope for localized side-contact damage. |

| Defect ID | Condition rating | Severity | Priority | Recommended action | Responsible discipline | Verification requirement |
|---|---|---|---|---|---|---|
| DEF-001 | Poor | Level 3 - Significant | P2 - Urgent | Survey the Drive Wheel North / Deflector-Guide Sheave North alignment to a recorded datum and correct as required. Clean and dimensionally/profile assess the existing Drive Wheel North groove/liner to document the as-found condition and establish the pre-renewal baseline, then renew the Drive Wheel North liner assembly as part of the coordinated corrective intervention defined in Section 20. Inspect the North 45 mm rope for localized side-contact damage | Mechanical / alignment / rope specialist | Alignment survey/correction record; post-correction rope-tracking evidence; groove/liner measurements against verified criteria; rope inspection and close-out record. |

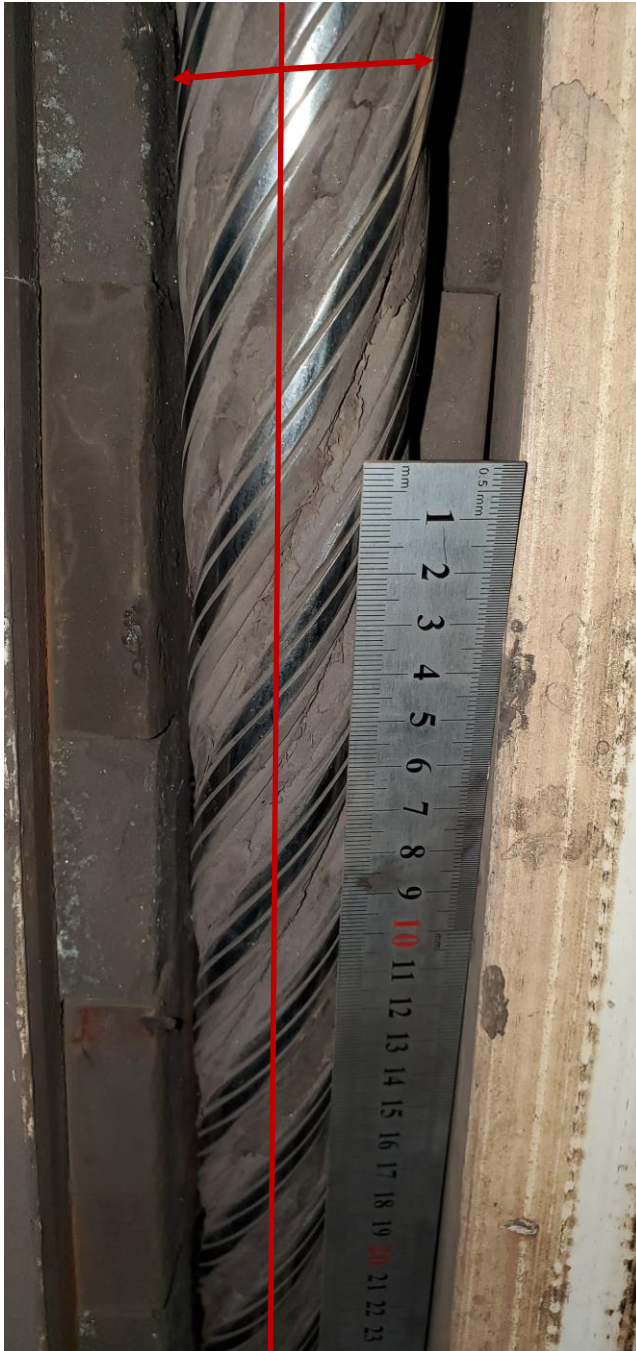
Opposing view showing apparent lateral offset of the rope path at the Drive Wheel North exit.

| Observation | Engineering assessment | Recommended action |
|---|---|---|
| The opposing view again shows the rope displaced laterally at the Drive Wheel North exit rather than centered within the apparent groove path. | This opposing view corroborates PHOTO-DWN-001 and strengthens the qualitative evidence of off-center rope departure. The presence of any relative misalignment, and if present its magnitude, direction and geometric source, remain to be established by formal survey. | Confirm the Drive Wheel North and Deflector-Guide Sheave North centerline/shaft relationship by formal survey, correct the relative alignment as required, and capture post-correction tracking photographs. |

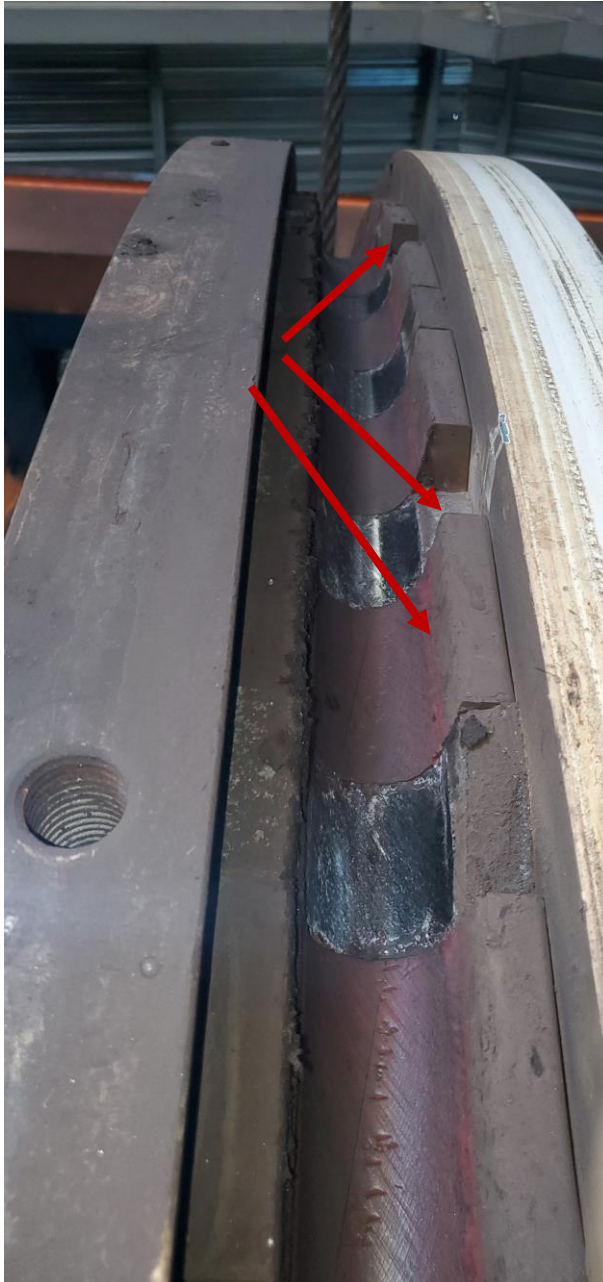
**Photo ID**  
PHOTO-DWN-003

| Observation | Engineering assessment | Recommended action |
|---|---|---|
| Localized deterioration, edge deformation and material loss are visible on one side of the segmented groove/liner assembly within the rope-exit region. | The localized damage is consistent with concentrated lateral side contact associated with the off-center rope path. When considered with the opposing-side condition and the paired Deflector-Guide Sheave North evidence, the damage supports the assessment of an asymmetric contact mechanism. Remaining liner thickness and acceptance against verified OEM/client criteria are not established by this photograph. | After alignment verification/correction, clean and dimensionally/profile assess the affected liner/groove region to document the as-found condition and establish the pre-renewal baseline, then renew the Drive Wheel North liner assembly as part of the coordinated corrective intervention. |

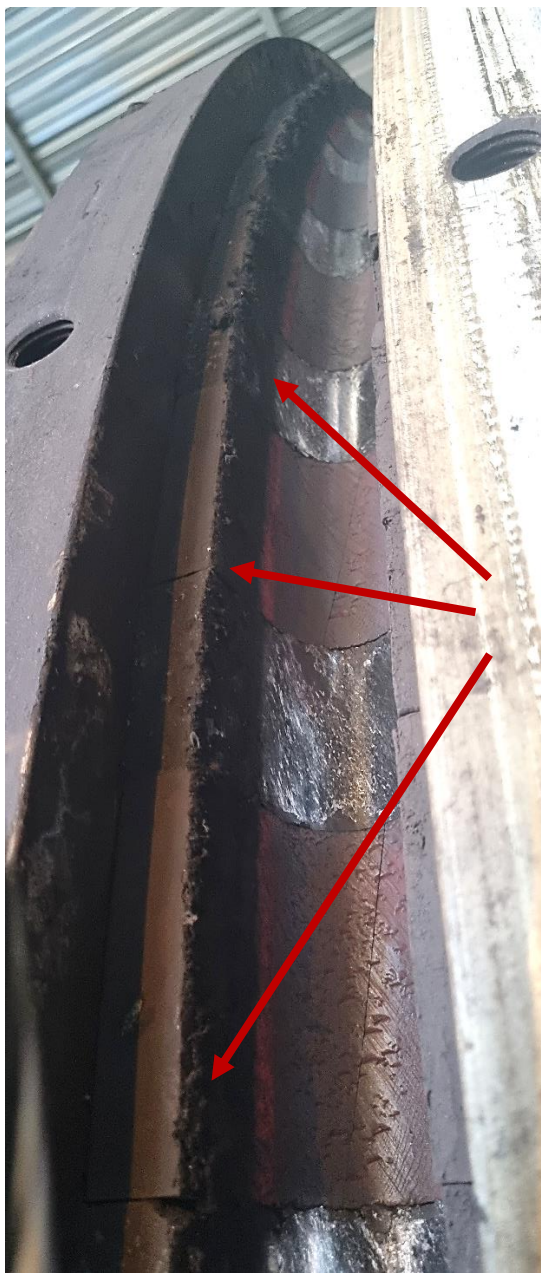
**Photo ID**  
 PHOTO-DWN-004

**Finding ID**  
 DEF-001

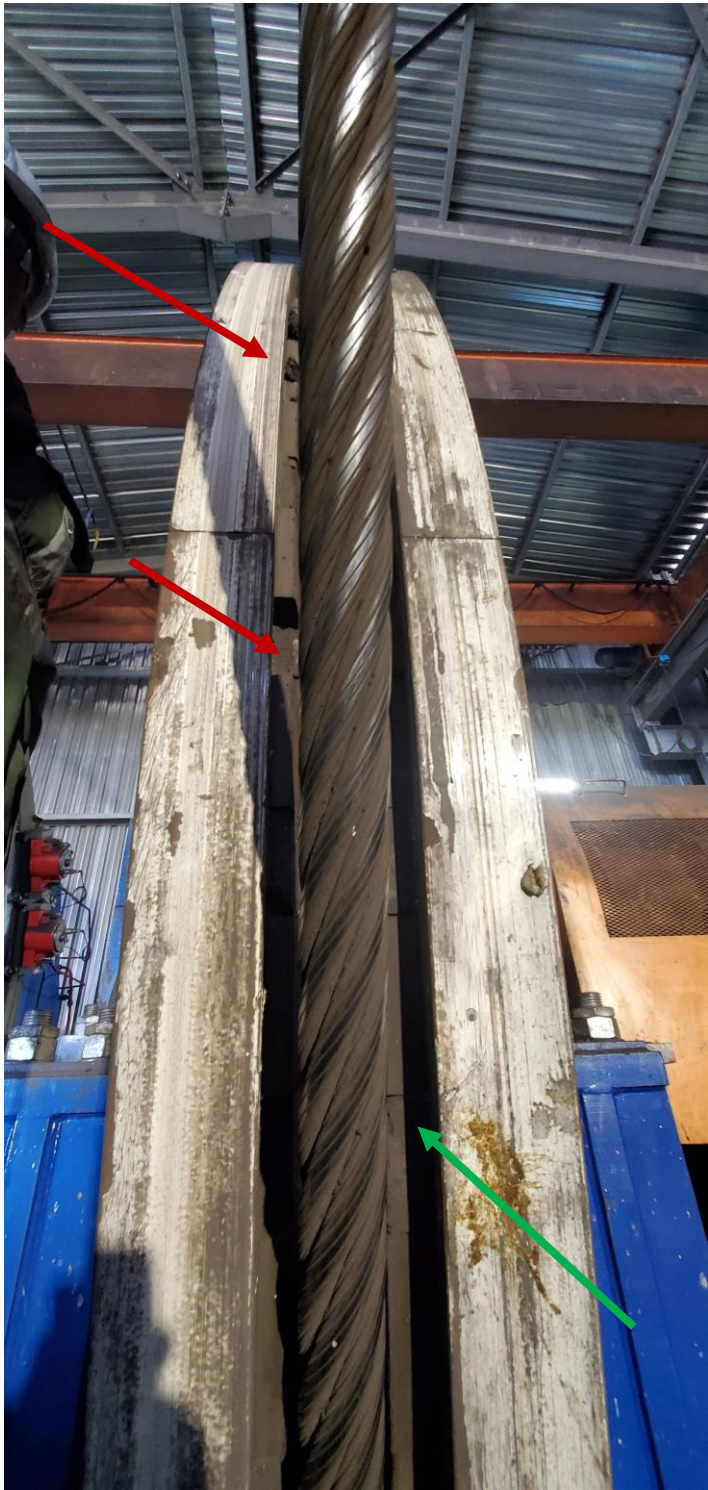
**Photo ID**  
PHOTO-DWS-001

| Defect ID | Condition rating | Severity | Priority | Recommended action | Responsible discipline | Verification requirement |
|---|---|---|---|---|---|---|
| DEF-002 | Poor | Level 3 – Significant | P2 – Urgent | Perform a formal alignment survey of the Drive Wheel South / Deflector-Guide Sheave South pair using a documented datum and correct the relative sheave alignment as required. As part of the broader system review, assess whether the rope-entry fleet angle into Drive Wheel South is non-zero. Clean and dimensionally/profile assess the existing Drive Wheel South groove/liner to document the as-found condition and establish the pre-renewal baseline, then renew the Drive Wheel South liner assembly as part of the coordinated corrective intervention defined in Section 20. Inspect the South 45 mm cable-belt rope for localized side-contact damage. | Mechanical / alignment / rope specialist | Recorded alignment survey and correction report; post-correction rope-tracking evidence; groove/liner dimensional/profile assessment against verified criteria; rope inspection record and close-out evidence. |

**Finding ID**  
DEF-002

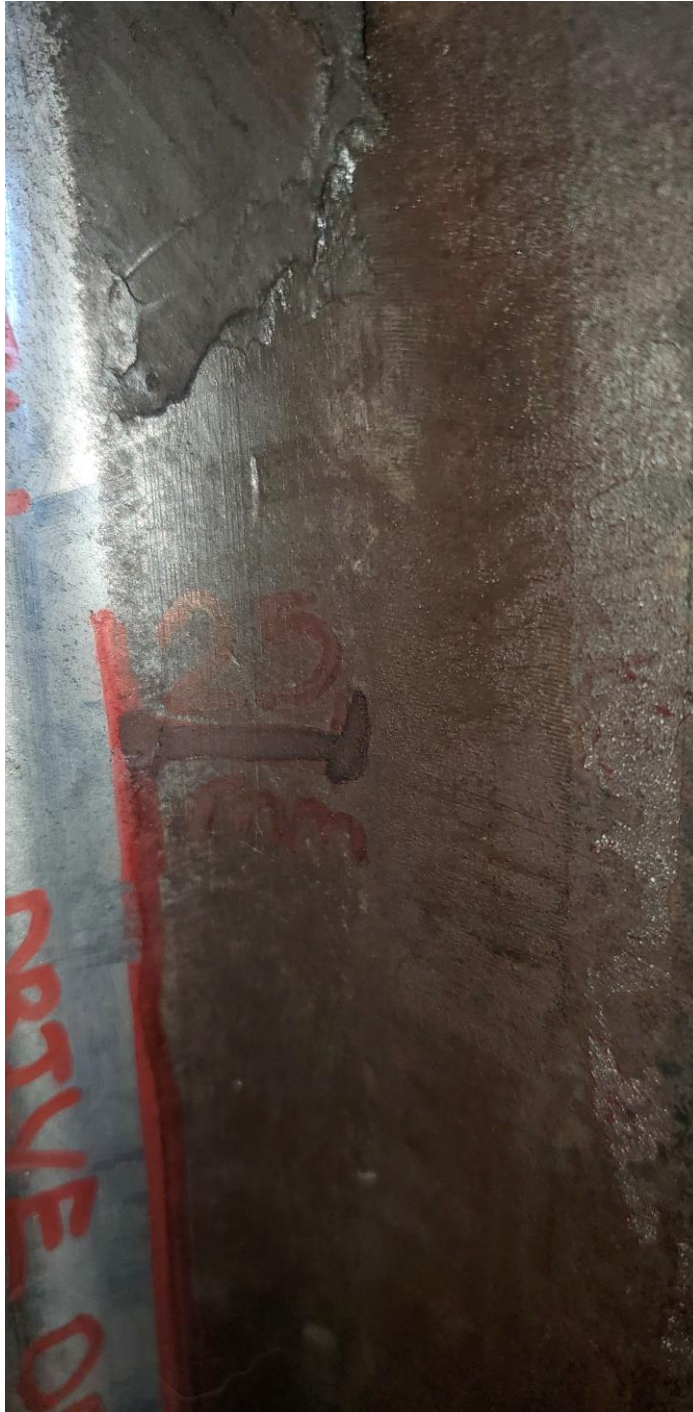
PHOTO-DGN-005  
Marked groove view illustrating lateral offset of the worn contact  
profile - North.  
Related defect: DEF-003

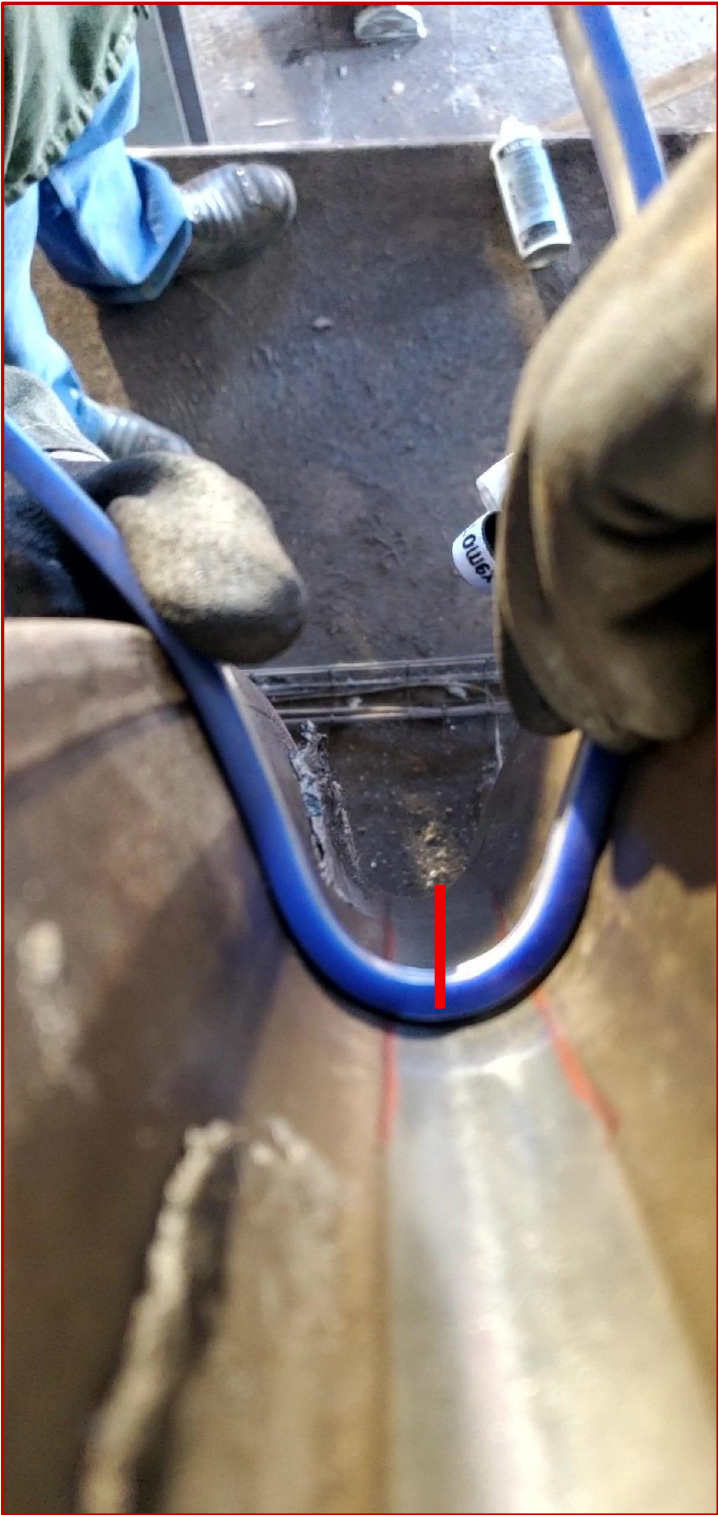
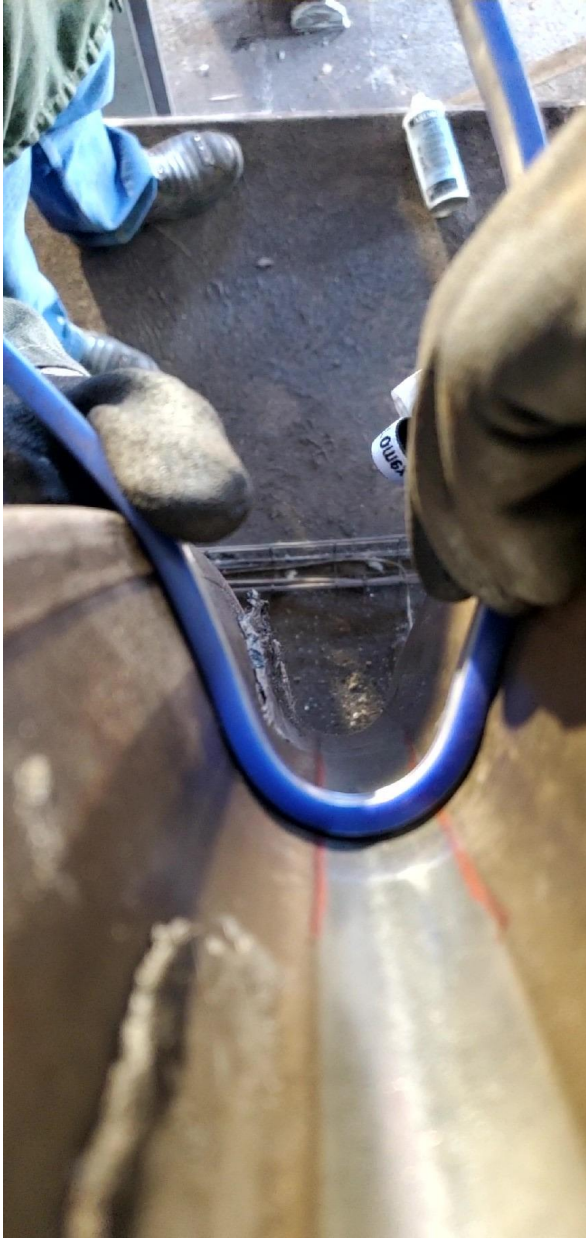
PHOTO-DGS-001  
Profile-gauge view showing the worn Deflector-Guide Sheave South groove.  
Related defect: DEF-004

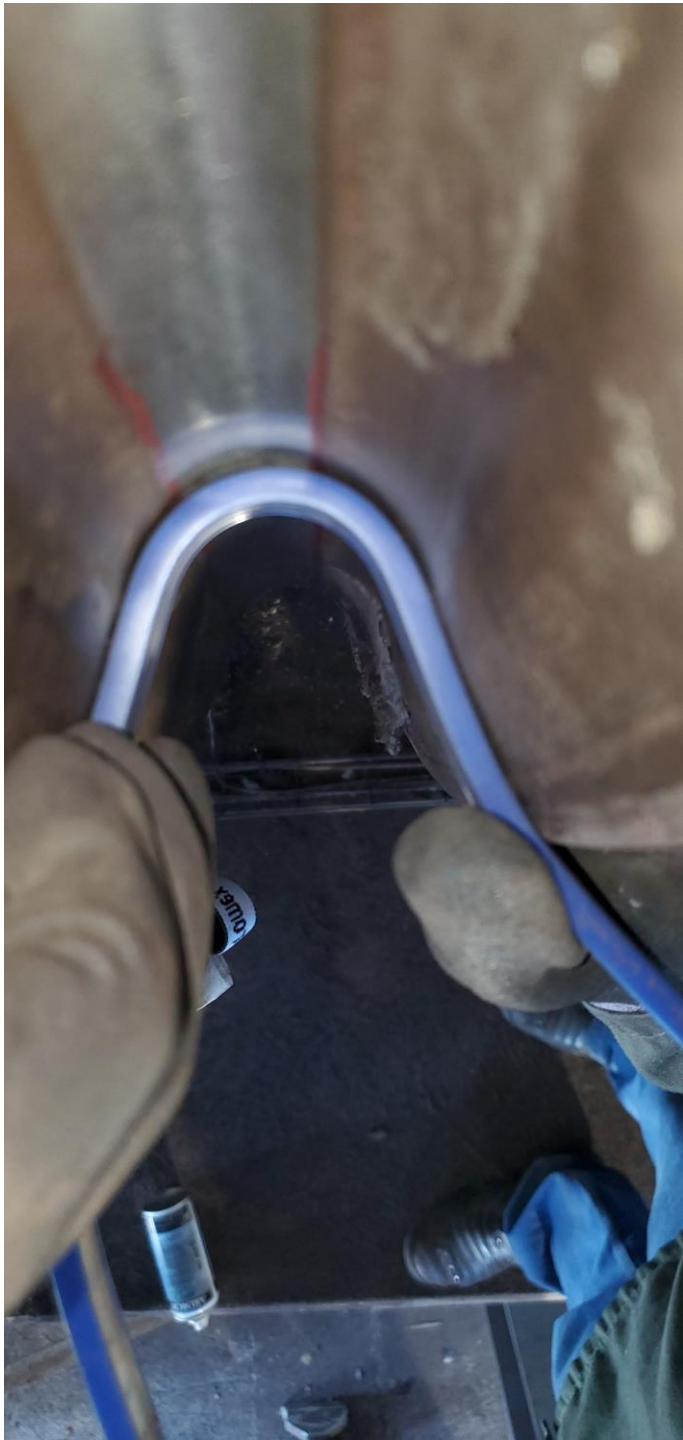
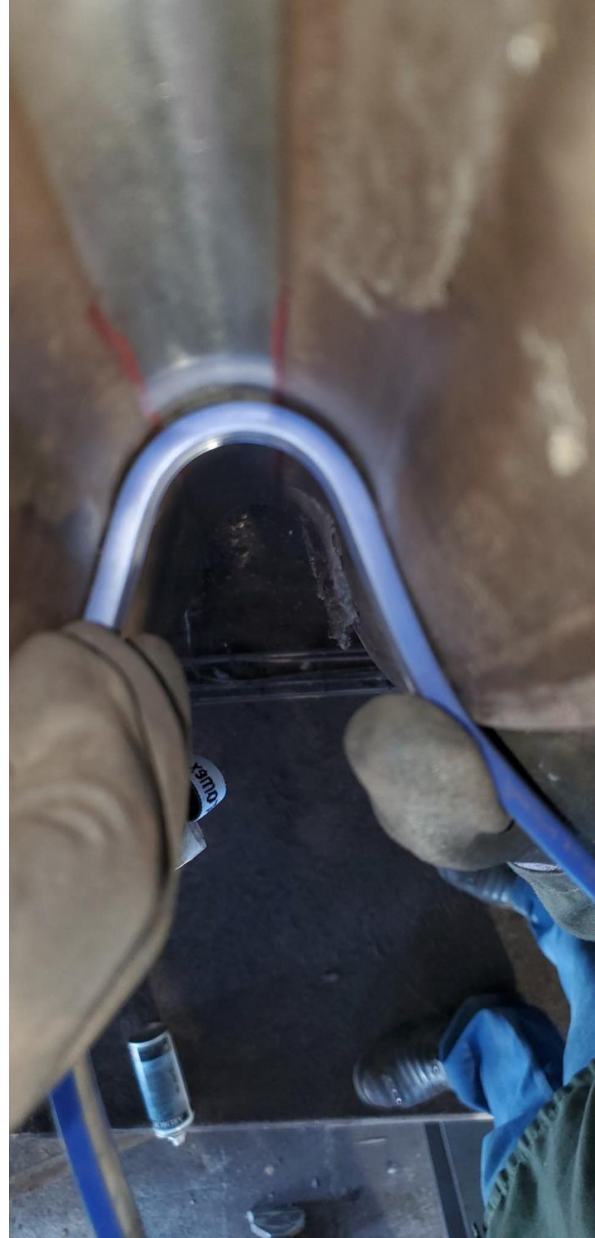
PHOTO-DGS-002  
Additional profile-gauge view of the Deflector-Guide Sheave South groove.  
Related defect: DEF-004

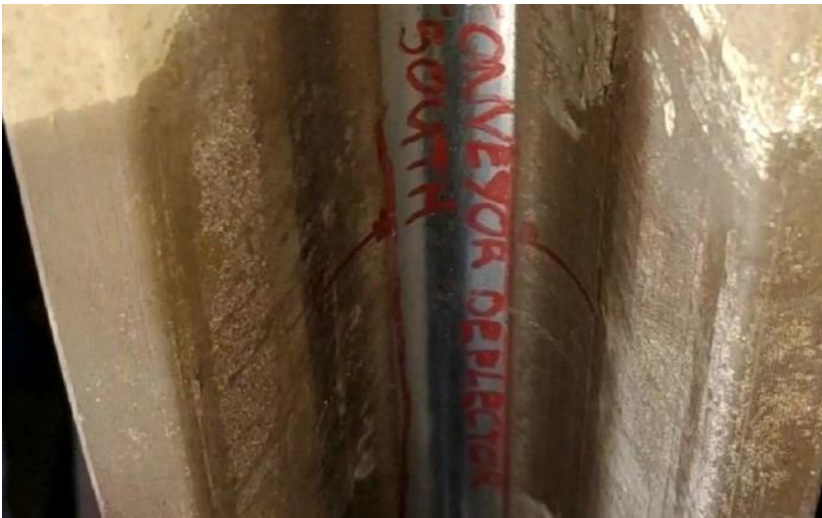
**Photo ID**  
 PHOTO-DGS-004

| Observation | Engineering assessment | Recommended action |
|---|---|---|
| The additional profile-gauge view shows the South groove from an alternative position and again demonstrates visibly unequal contact across the groove profile. | This photograph corroborates PHOTO-DGS-001 and supports the conclusion that the groove-contact profile is asymmetric rather than centered and uniform. Quantitative groove geometry and verified OEM/client criteria remain required to characterize the as-found condition and support the pre-replacement documentation and final close-out. | Record dimensional profile measurements after alignment verification/correction and retain the results as the as-found baseline before the recommended Deflector-Guide Sheave South replacement. |

**Finding ID**  
 DEF-004

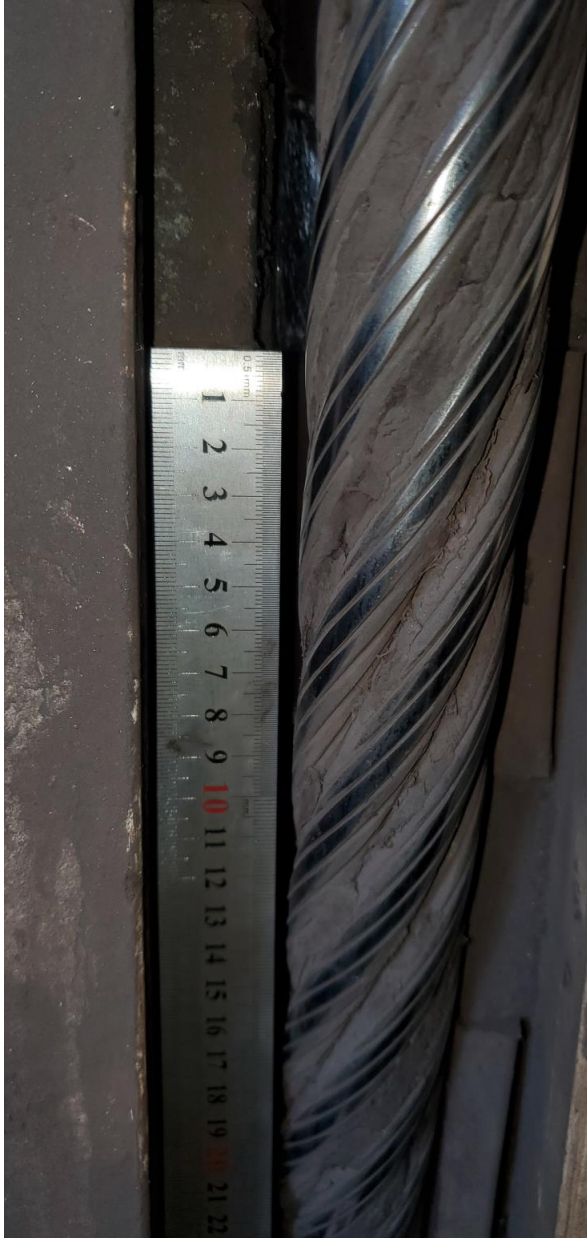
PHOTO-DWN-001

Left-side view showing the rope exiting the Drive Wheel North off the groove centerline.

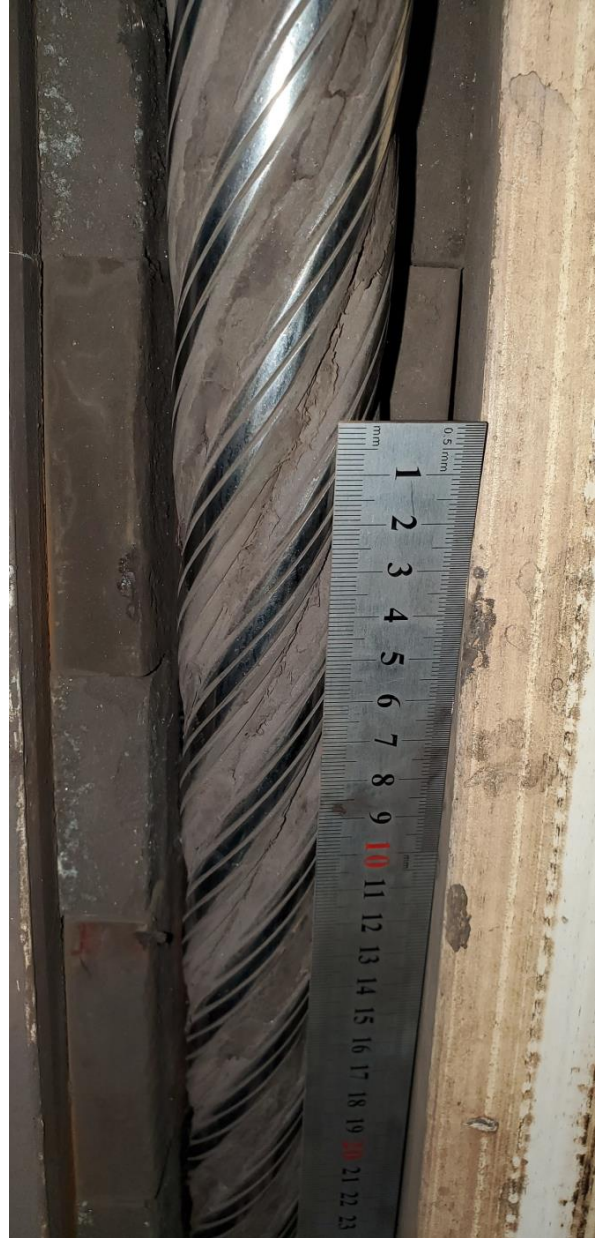
PHOTO-DWN-002

Opposing view confirming lateral offset of the rope path at the Drive Wheel North exit.

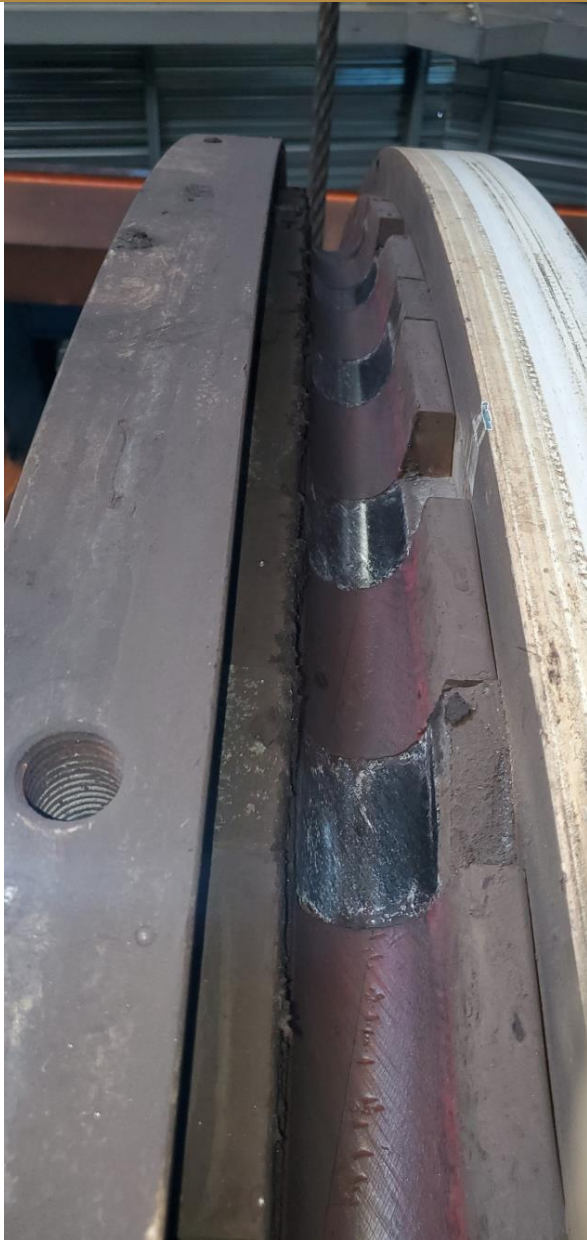
PHOTO-DWN-003  
Localized liner/groove damage on the right-hand side of Drive Wheel North.  
Related defect: DEF-001

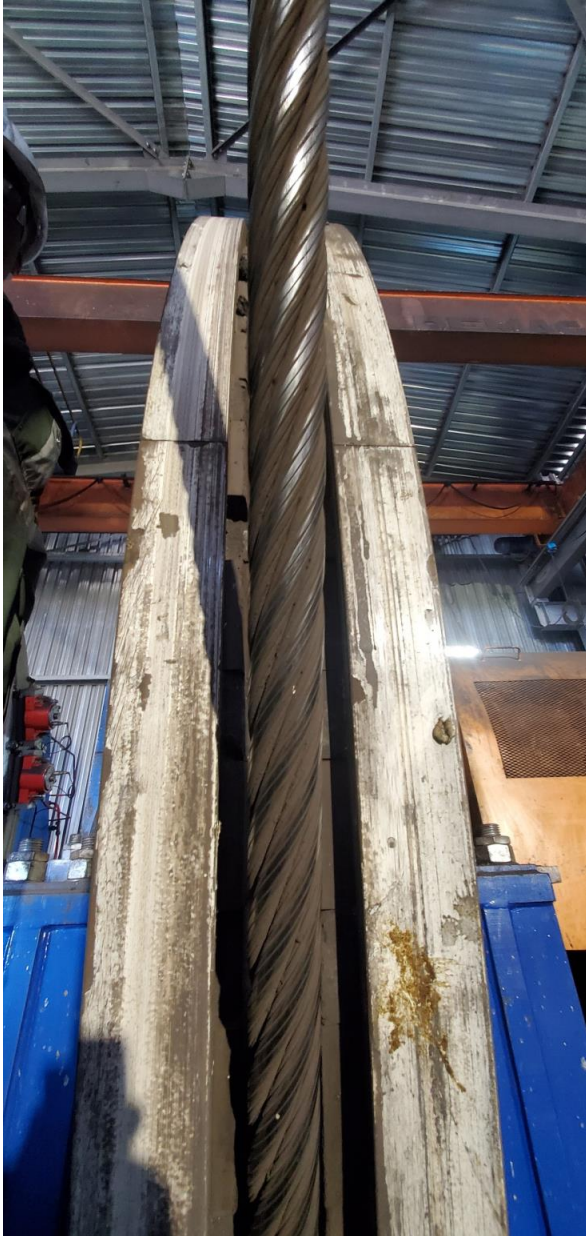
PHOTO-DWS-001  
Right-hand side of Drive Wheel South showing comparatively lower visible wear.  
Related defect: DEF-002

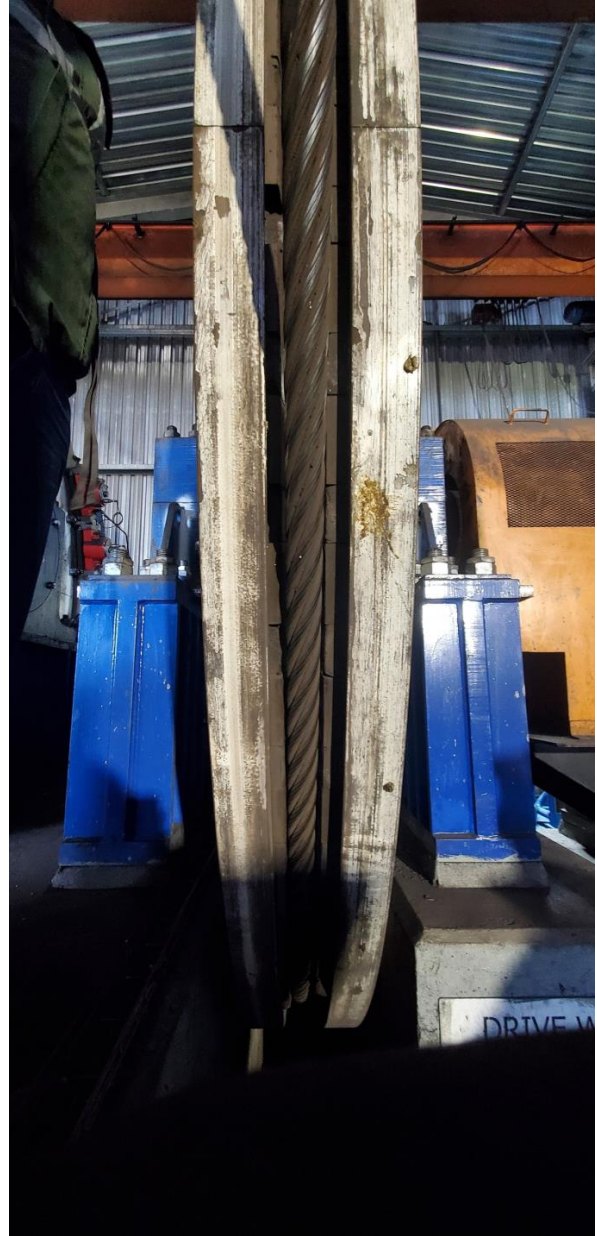
PHOTO-DWS-002  
Left-hand side of Drive Wheel South showing the more pronounced asymmetric wear/contact region.  
Related defect: DEF-002

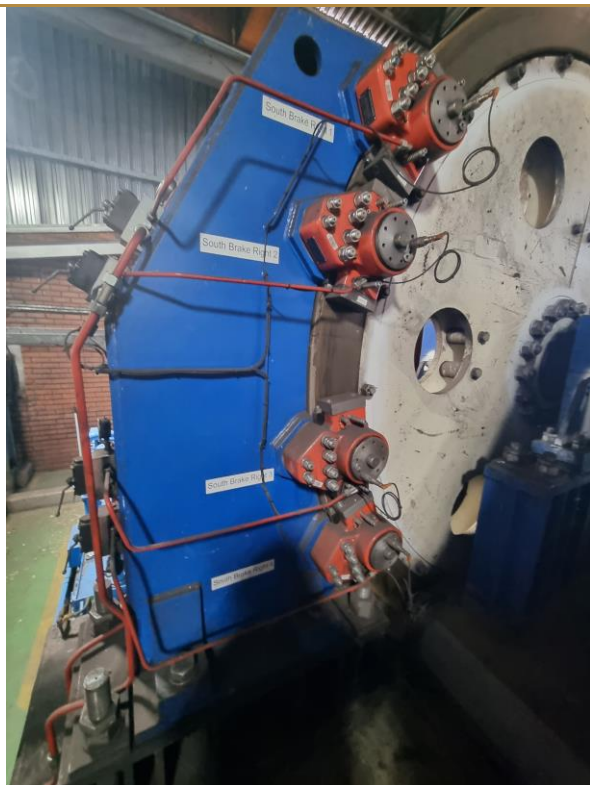
PHOTO-DWS-003

Context view of the rear of Drive Wheel South and associated brake assemblies.

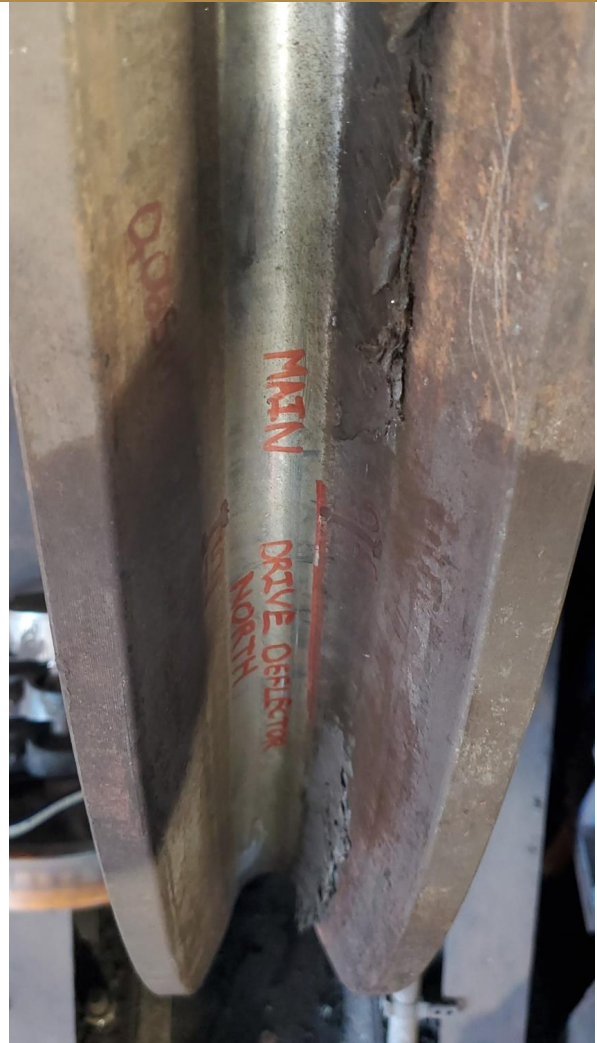
PHOTO-DGN-004  
Groove surface detail showing asymmetric polishing/wear on Deflector-Guide Sheave North.  
Related defect: DEF-003

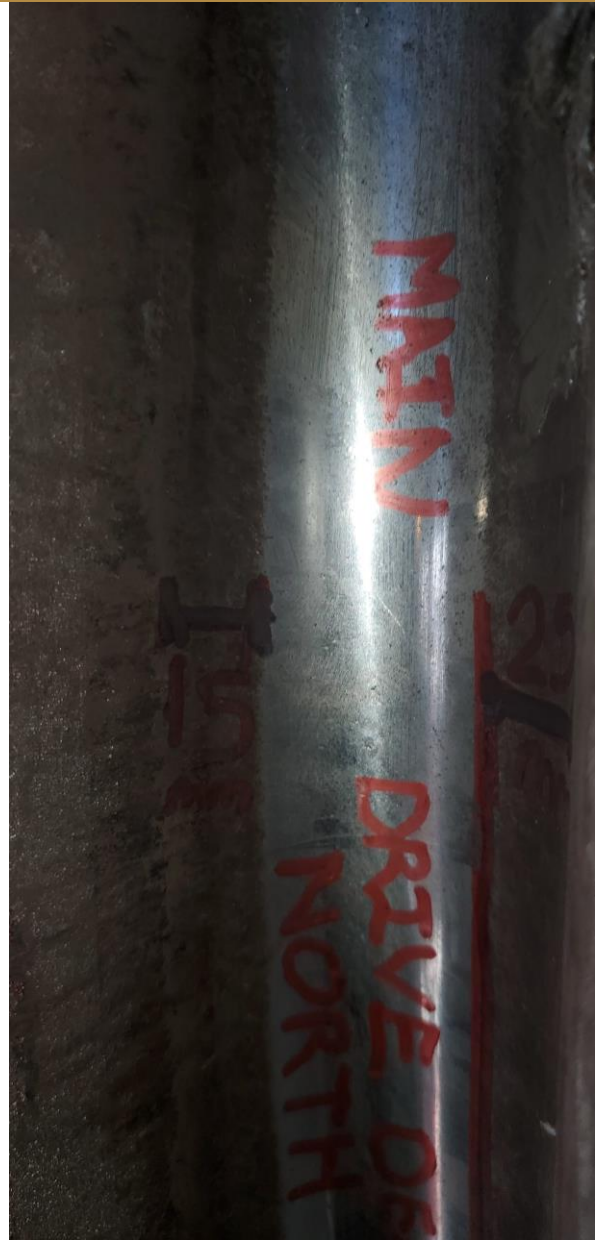
PHOTO-DGN-006  
Additional marked view illustrating lateral offset of the worn contact  
profile - North.  
Related defect: DEF-003

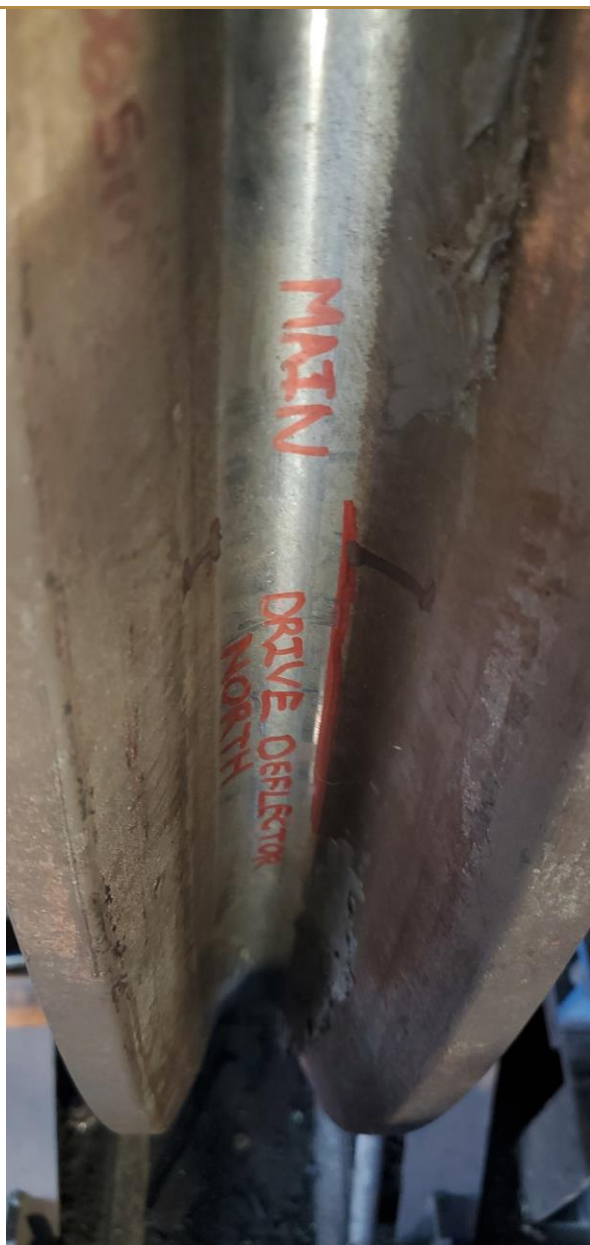
PHOTO-DGN-007

Contextual side view of the offset groove profile - North.

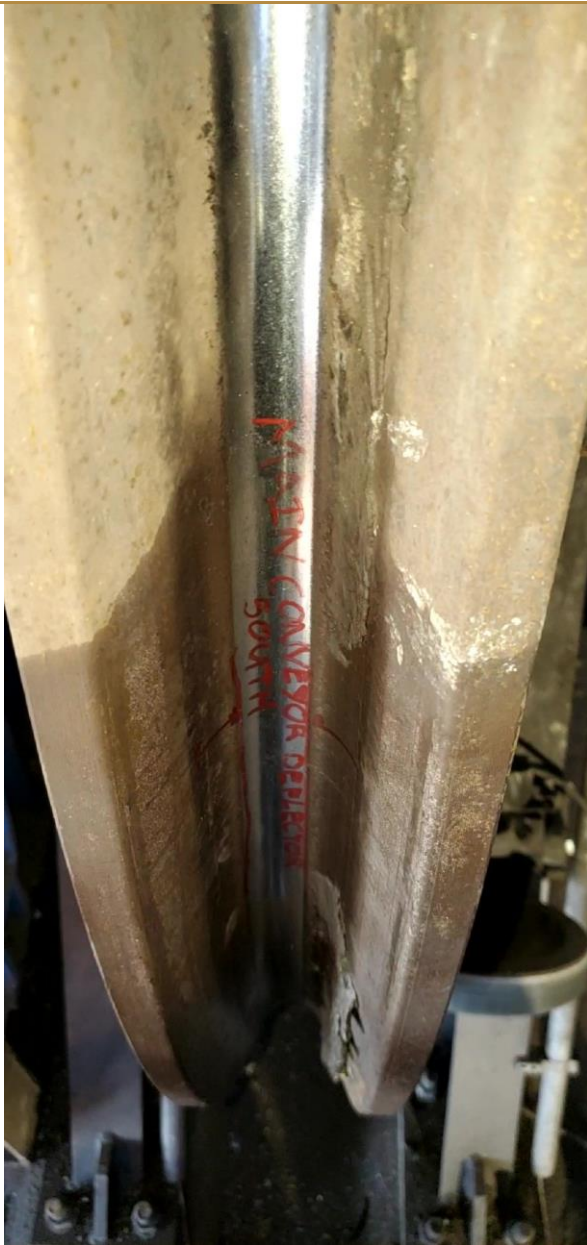
PHOTO-DGS-003

Groove surface detail showing the wear profile on Deflector-Guide Sheave South.
