### CABLE BELT LOWER ANGLE STATION SHEAVES

# Cable Belt Lower Angle Station Sheaves Inspection Report

| Report number | ISS_IRS32-Wessels-200726 | Revision | 1.1 |
| Issue date | 17/08/2026 | Inspection date | 20 July 2026 |

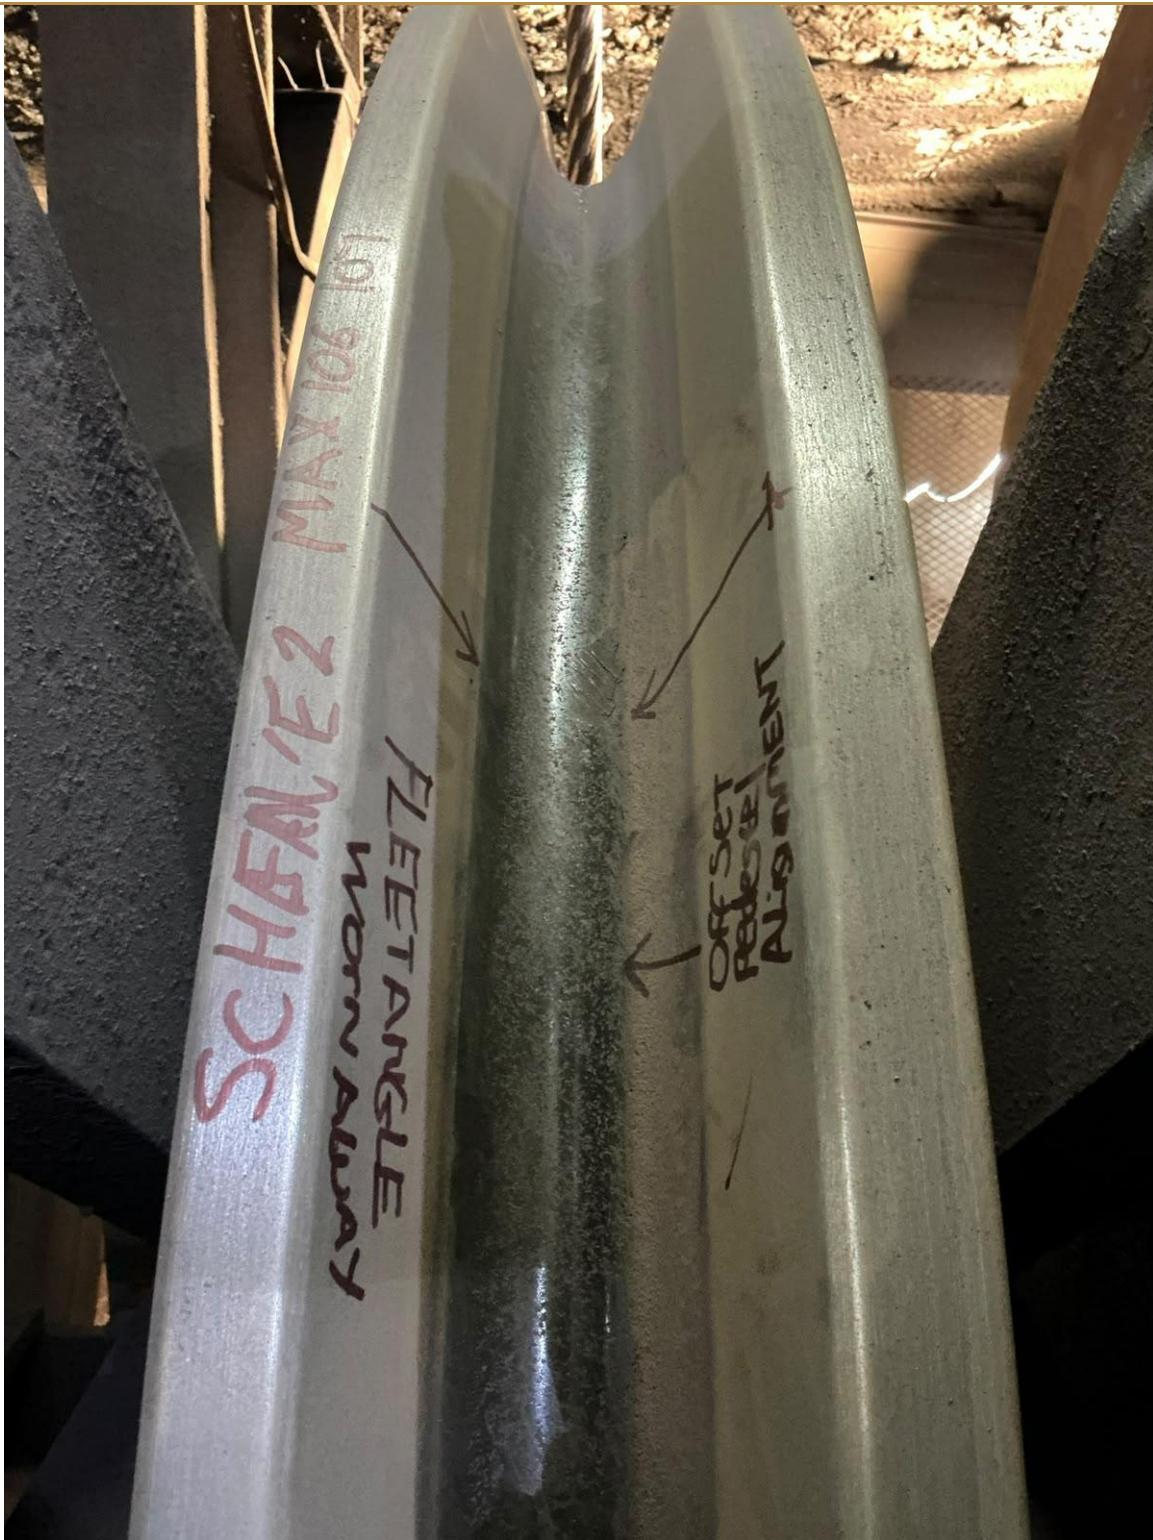
CBASSL2-REF002 - Cable Belt Lower Angle Station Sheave 2

Front-view close/contextual groove photograph showing asymmetric polished/contact wear along the groove sidewall/base on Lower Angle Station Sheave 2. The wear appears left in Front View and right in Rear View.

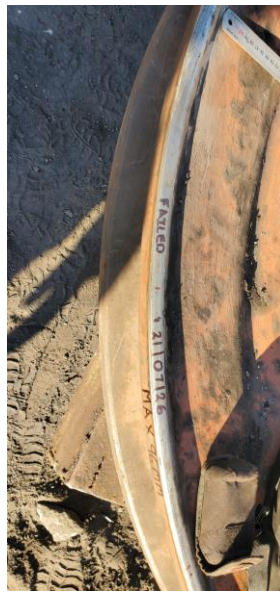
CBASSUF4-REF001-Extracted Failed upper angle station Sheave 4 post inspection.jpg - post-extraction view of the removed Upper Angle Station Sheave No. 4 groove with contextual scale/marking.

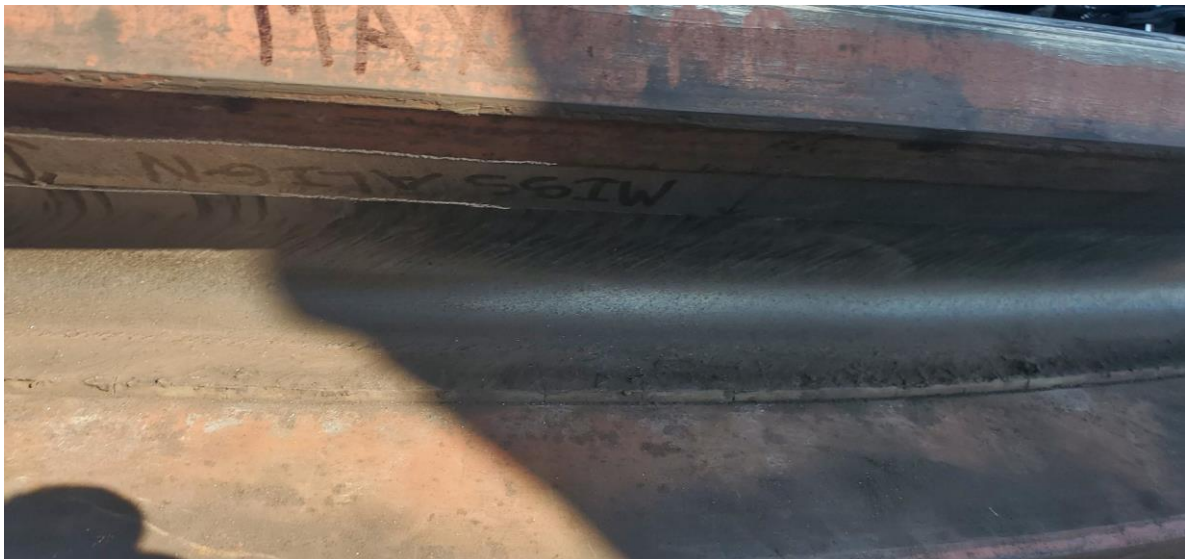
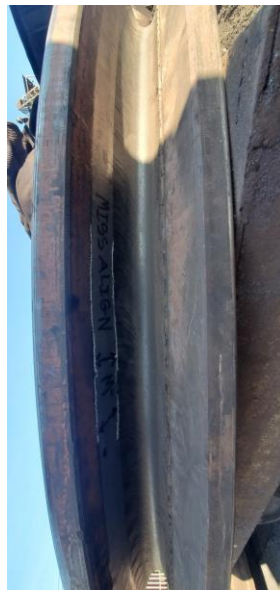
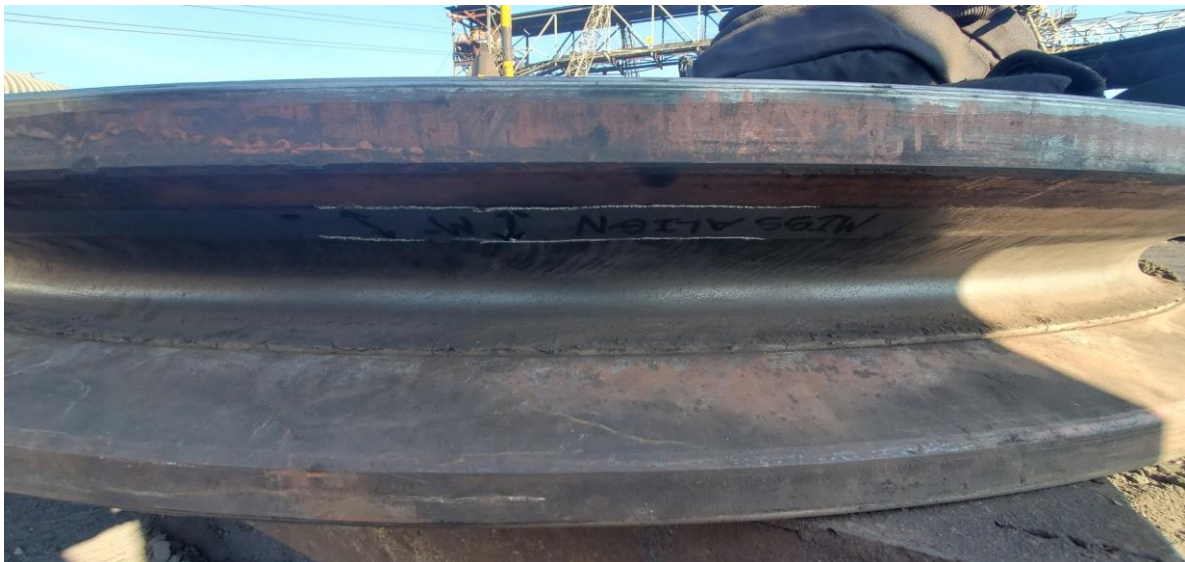
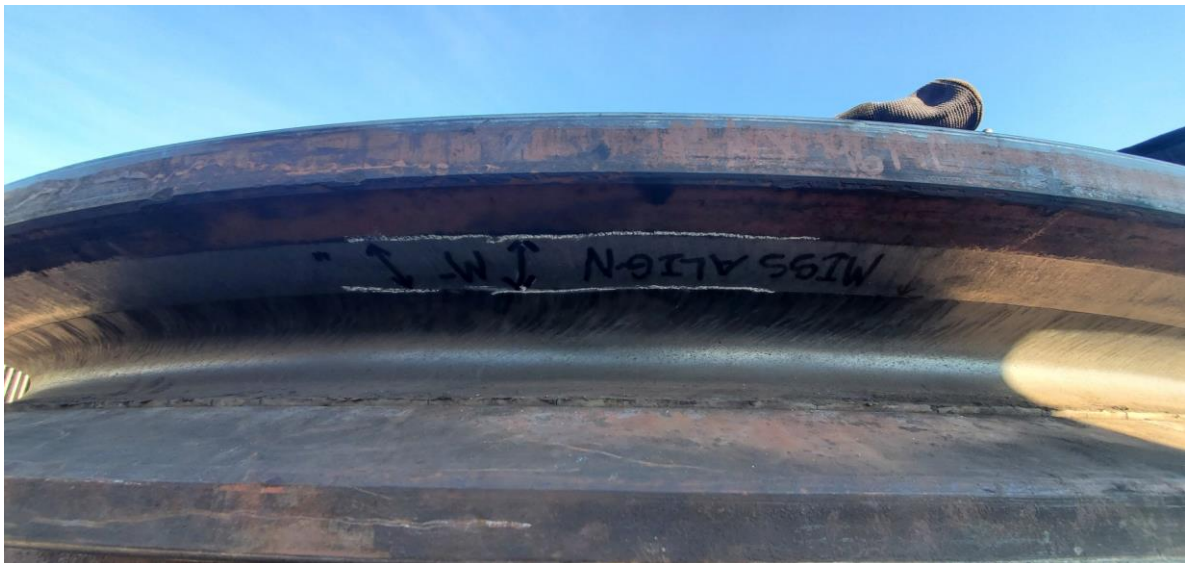
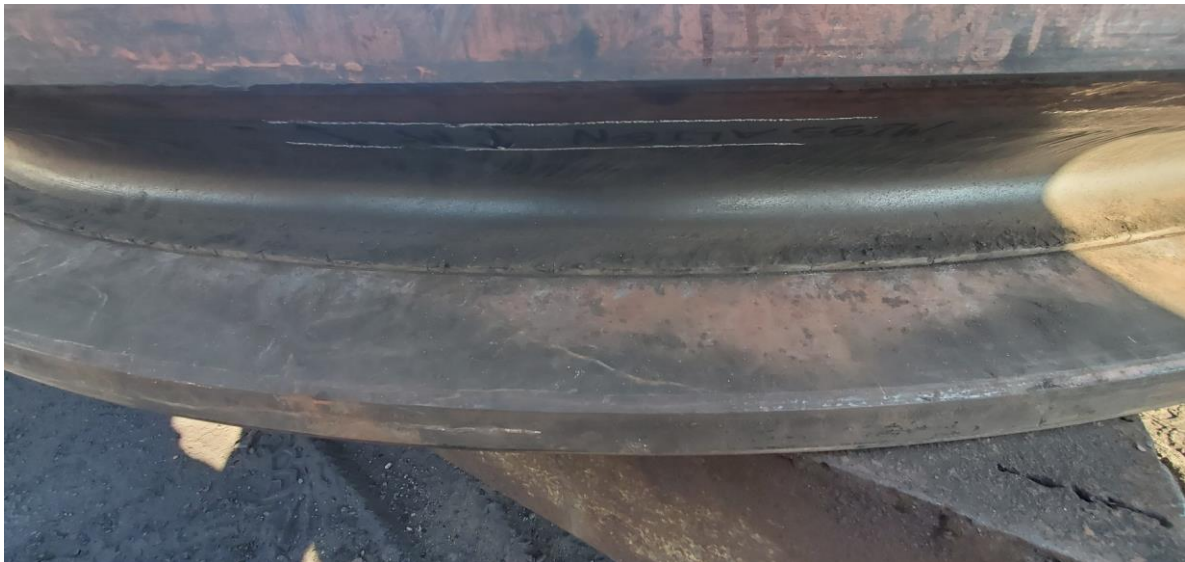
CBASSUF4-REF002-Extracted Failed upper angle station Sheave 4 post inspection.jpg - post-extraction groove view showing localized asymmetric contact/wear on the removed Upper Angle Station Sheave No. 4.

*CBASSUF4-REF003-Extracted Failed upper angle station Sheave 4 post inspection.jpg - post-extraction groove view showing localized asymmetric contact/wear on the removed Upper Angle Station Sheave No. 4.*

*CBASSUF4-REF004-Extracted Failed upper angle station Sheave 4 post inspection.jpg - post-extraction groove view showing localized asymmetric contact/wear on the removed Upper Angle Station Sheave No. 4.*

CBASSUF4-REF005-Extracted Failed upper angle station Sheave 4 post inspection.jpg - post-extraction groove view showing localized asymmetric contact/wear on the removed Upper Angle Station Sheave No. 4.

CBASSUF4-REF006-Extracted Failed upper angle station Sheave 4 post inspection.jpg - post-extraction groove view showing localized asymmetric contact/wear on the removed Upper Angle Station Sheave No. 4.

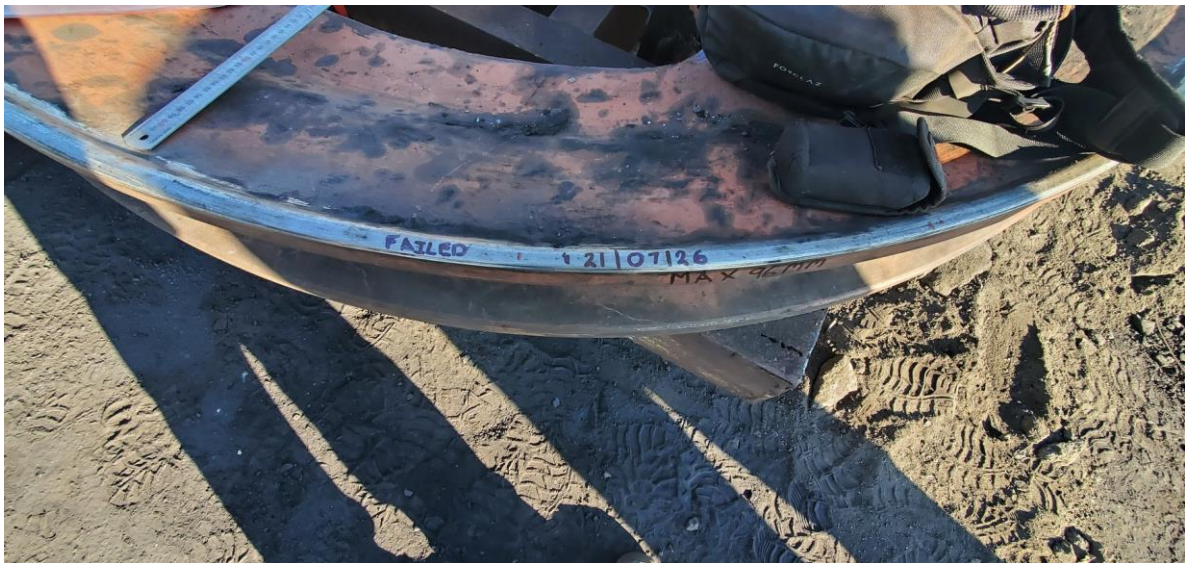
CBASSUF4-REF007-Extracted Failed upper angle station Sheave 4 post inspection.jpg - post-extraction view of the removed Upper Angle Station Sheave No. 4 groove with contextual scale/marking.

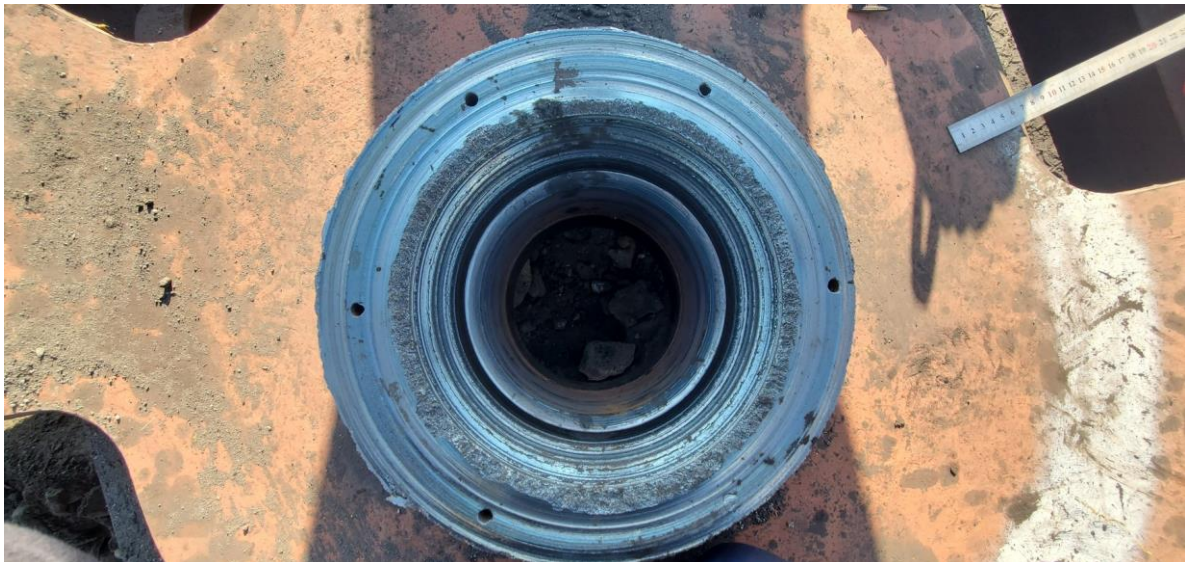
CBASSUF4-REF008-Extracted Failed upper angle station Sheave 4 post inspection.jpg - post-extraction overview of the Upper Angle Station Sheave No. 4 hub/bearing region.

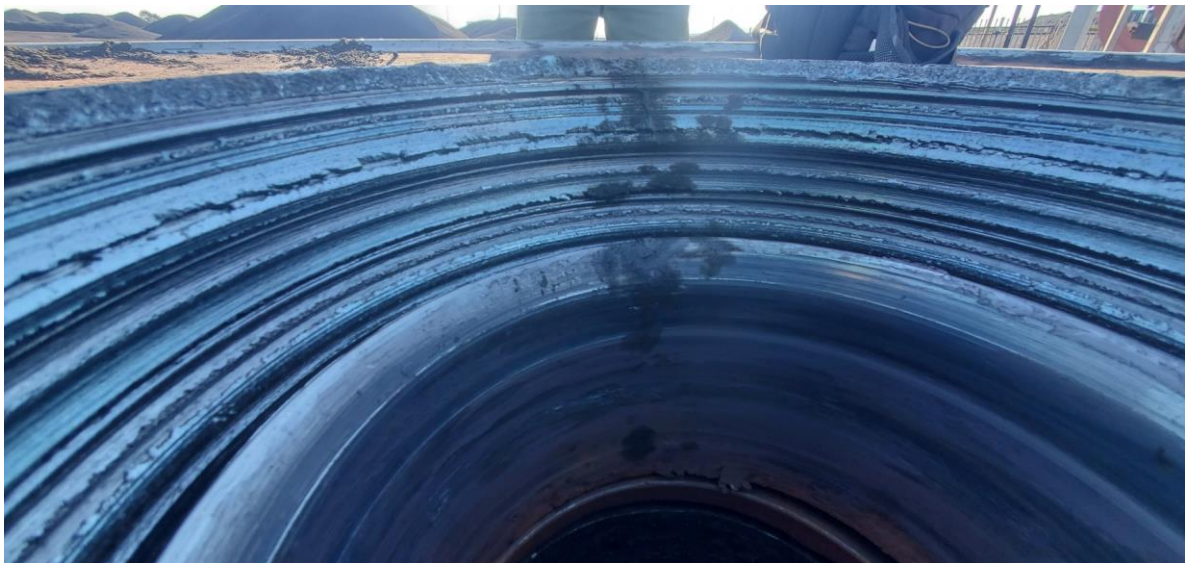
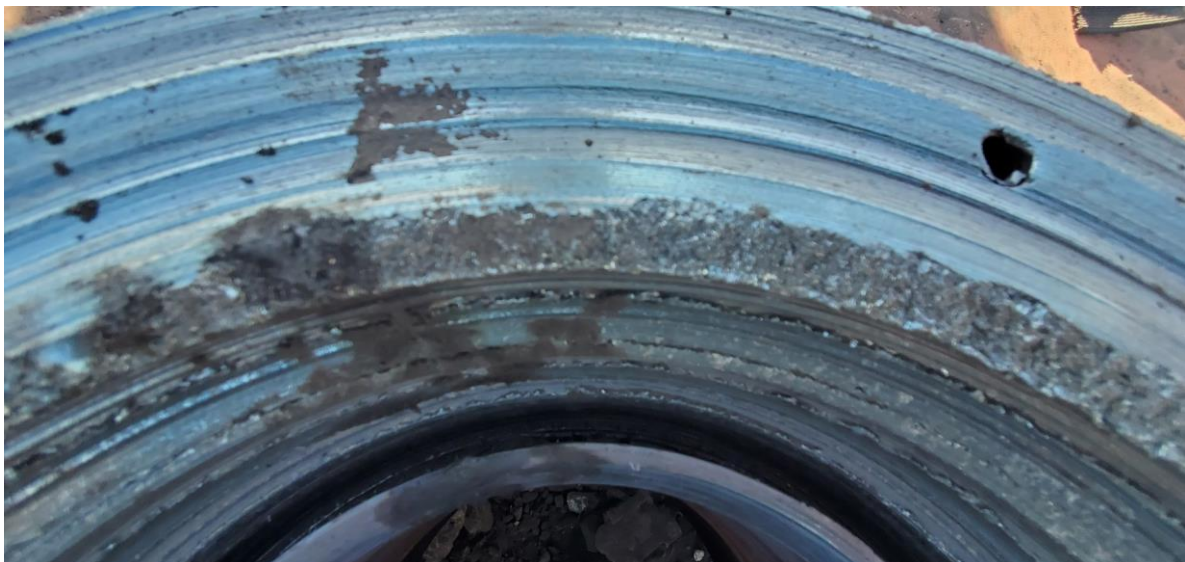
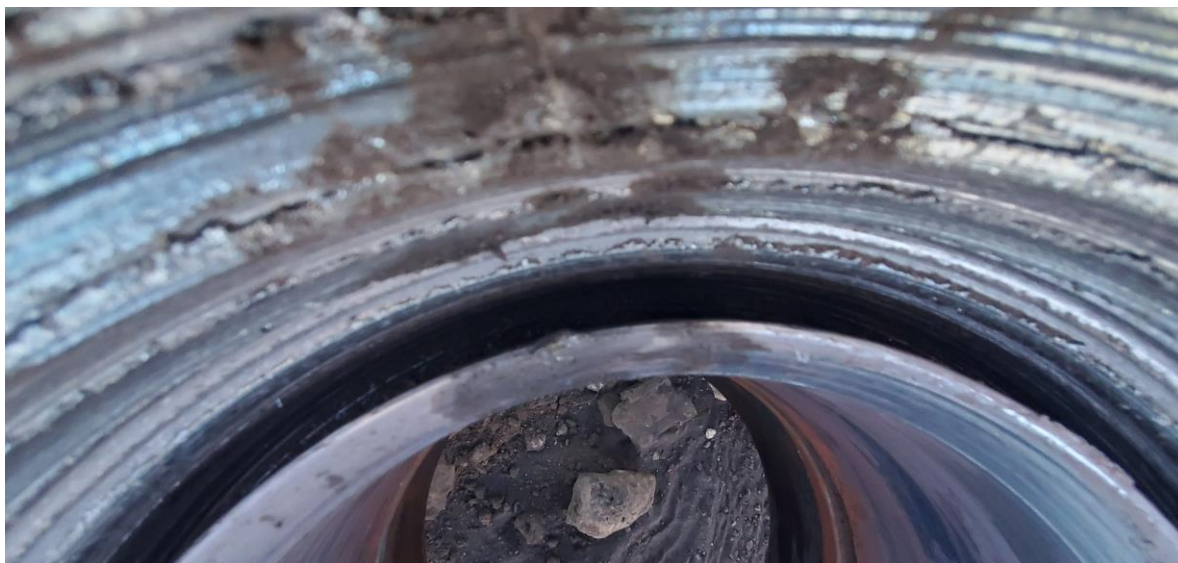
*CBASSUF4-REF009-Extracted Failed upper angle station Sheave 4 post inspection.jpg - post-extraction close-up of the hub/bearing-seat region showing severe scoring/damage associated with the failed assembly.*

*CBASSUF4-REF010-Extracted Failed upper angle station Sheave 4 post inspection.jpg - post-extraction close-up of the hub/bearing-seat region showing severe scoring/damage associated with the failed assembly.*

CBASSUF4-REF011-Extracted Failed upper angle station Sheave 4 post inspection.jpg - post-extraction close-up of the hub/bearing-seat region showing severe scoring/damage associated with the failed assembly.

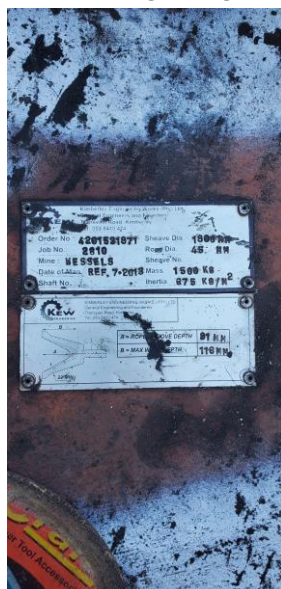
CBASSUF4-REF012-Extracted Failed upper angle station Sheave 4 post inspection.jpg - Post-extraction OEM/asset plate and groove/asset specification reference for Upper Angle Station Sheave No. 4.

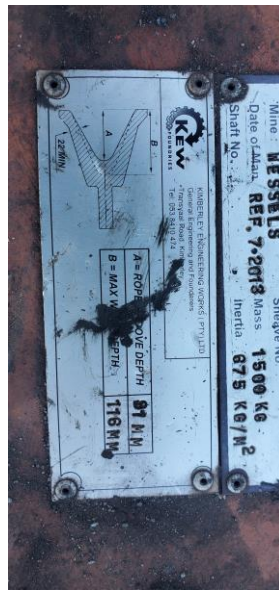
CBASSUF4-REF013-Extracted Failed upper angle station Sheave 4 post inspection.jpg - Post-extraction OEM/asset plate and groove/asset specification reference for Upper Angle Station Sheave No. 4.

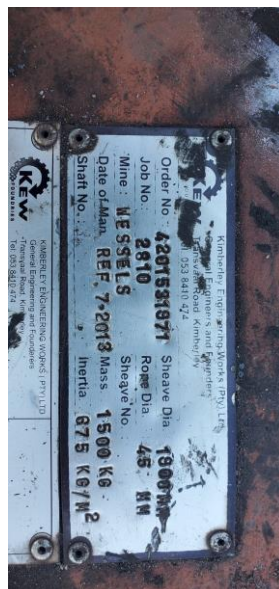
CBASSUF4-REF014-Extracted Failed upper angle station Sheave 4 post inspection.jpg - Post-extraction OEM/asset plate and groove/asset specification reference for Upper Angle Station Sheave No. 4.

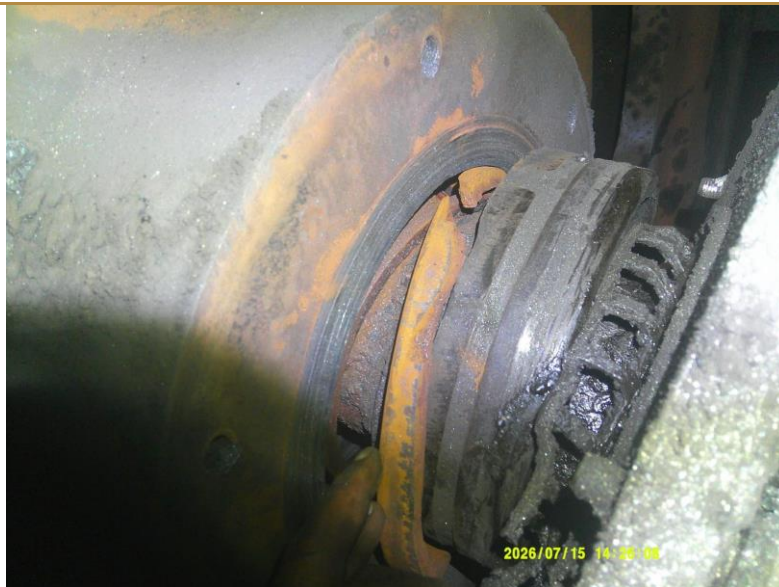
*CBASSU4-REF001-Failure Mode - Bearing.jpeg - In-situ view of Upper Angle Station Sheave No. 4 showing severe collapsed/displaced bearing components.*

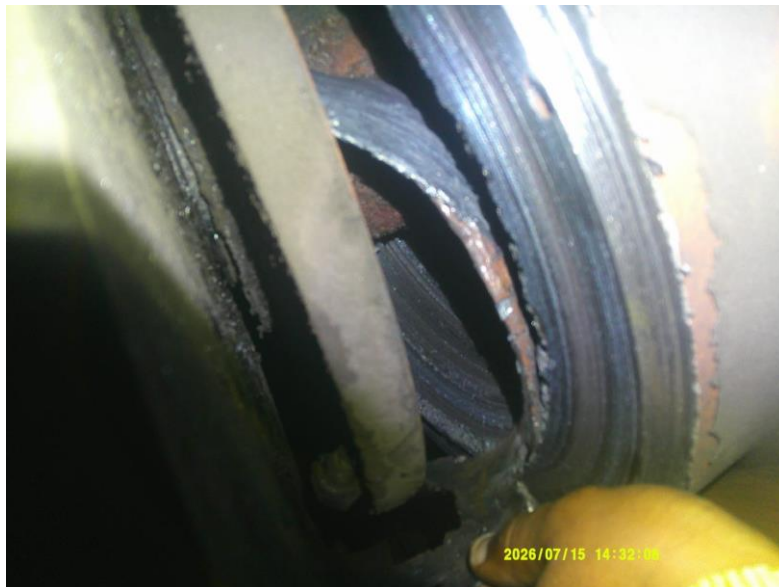
*CBASSU4-REF002-Failure Mode - Bearing.jpeg - Close in-situ view into the failed bearing/housing showing displaced and damaged internal bearing components.*

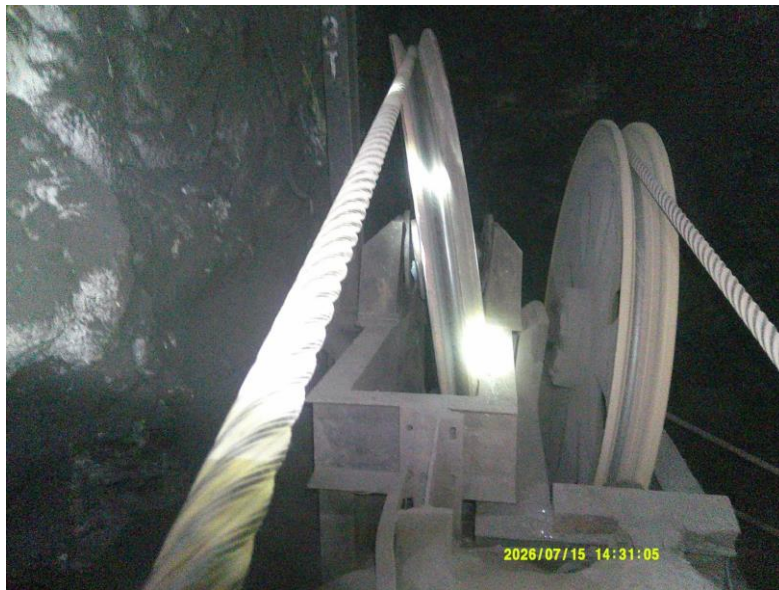
*CBASSU4-REF003-Failure Mode - Angular alignment.jpeg - In-situ side view showing the rope approaching the Upper Angle Station sheave at an angular offset relative to the sheave plane.*

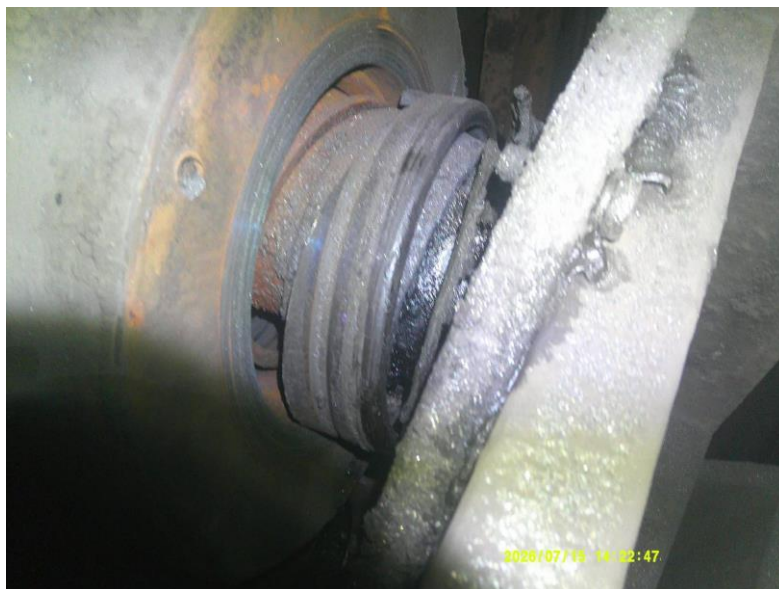
*CBASSU4-REF004-Failure Mode - Bearing.jpeg - Additional in-situ view of the collapsed/displaced bearing assembly at Upper Angle Station Sheave No. 4.*

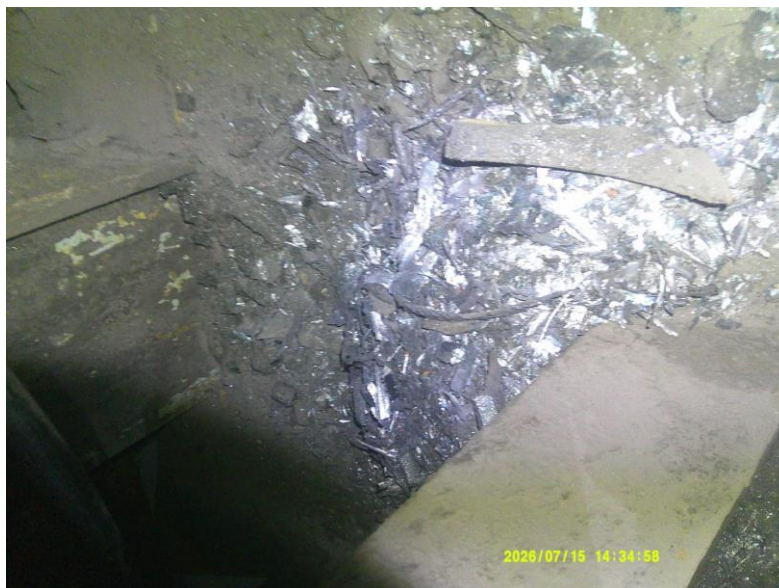
*CBASSU4-REF005-Failure Mode - Bearing Shavings.jpeg - Metallic bearing debris/shavings recorded in the vicinity of the failed Upper Angle Station Sheave No. 4 assembly.*
